Model: Ch-C1	Date: 31-Aug-13	No.: RD135000s
--------------	-----------------	----------------

RTB Reissue

Subject: Troubleshooting		Prepared by: H. Kameda, H. Kobayashi	
From: 1st Tech. Support Sec. Service Support Dept.			
Classification:	<input checked="" type="checkbox"/> Troubleshooting <input type="checkbox"/> Mechanical <input type="checkbox"/> Paper path <input type="checkbox"/> Product Safety	<input type="checkbox"/> Part information <input type="checkbox"/> Electrical <input type="checkbox"/> Transmit/receive <input type="checkbox"/> Other ()	<input type="checkbox"/> Action required <input type="checkbox"/> Service manual revision <input type="checkbox"/> Retrofit information

This bulletin is a troubleshooting guide for symptoms that have occurred in the past, all with known solutions. For most items below, there are related MBs and RTBs containing modification details and adjustment procedures.

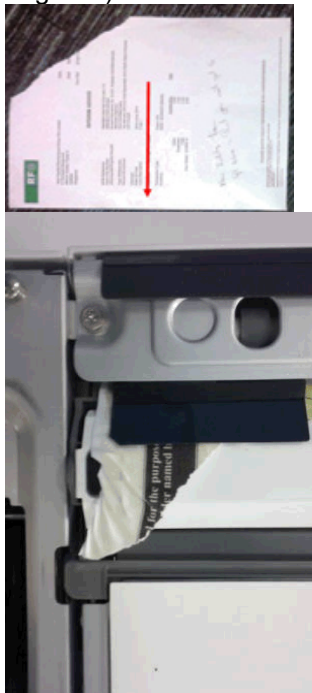
Subject	Symptom	RTB #	Cause	Solution	Rank
Jam 058		D135 158	Damaged harness for the paper size sensor, caused by opening and closing the tray	Install new parts as explained in the RTB.	
Jam 066	Jam 66 (Torn or dog-eared originals)

D135 098	The original contacts the tab on the paper feed guide	Install a modified ADF guide, or cut off the tab	
Jam 074/097	Jam 074 then 097 at the start of a duplex job	D137 093	The paper size fixed with the end fence on the tandem tray does not match the size specified on the operation panel. The shift roller in the duplex unit operates according to the paper size on the operation panel.	Make sure that the tandem tray fence positions match the settings on the operation panel. If they do not match, move the fence or change the paper size with SP 5-959-001.	
Jam 085	Jam 85	D137 128	Harness (2 nd duplex sensor) or spring (duplex driven roller) not installed correctly	Check the machine.

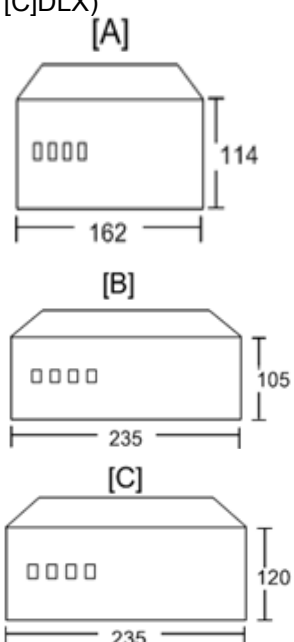
Subject	Symptom	RTB #	Cause	Solution	Rank
Envelopes	<p>Envelopes of certain sizes ([A]C6, [B]105 x 235, [C]DLX)</p>

<p>[A] 114 162</p> <p>[B] 105 235</p> <p>[C] 120 235</p>	D135 087 D137 109	Envelopes fed in the SEF direction tend to warp between the PTR unit and the fusing unit.	Feed these types of envelopes in the LEF direction with the flaps open (and from the trailing edge side) from the bypass tray.	
Envelopes	Envelopes Wrinkling	D135 086 D137 108	Depending on the type of envelope, envelope nip width may not be appropriate.	Adjust the envelope nip width (see the RTB for the details). Change the value "-5 ms" at a time and check the print result. Reduce too much and you might get poor fusing.	
Envelopes	Envelopes (a lot of envelopes are loaded, and the stack is not sufficiently flattened)	D135 100 D137 124	Air inside the envelope reduces the pressure of the pickup roller.	Flatten the envelopes to reduce the air inside them. If that does not work, use a smaller stack of envelopes.

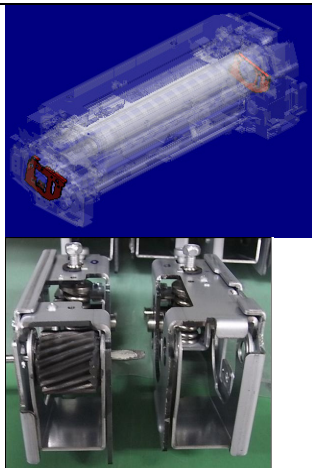
D135 062a D1370 83	The fusing pressure lever is broken.	Replace the fusing levers with the modified part (P/N: Office version D1369901, Pro version D1389904) at PM or the next visit. See the RTB for the procedure.	
Process control	Process Control error under low-temperature low-humidity conditions.	D135 002k D137 008g	Engine firmware	Install version 1.31:08 or newer.	
Process control	Done incorrectly when the machine recovers from Energy Saver mode.	D135 002k D137 008g	Engine firmware	Install version 1.31:08 or newer.	
Toner refresh	Does not work on the Cyan station	D135 002r D137 008n	Engine firmware	Install version 1.38:08 or newer.

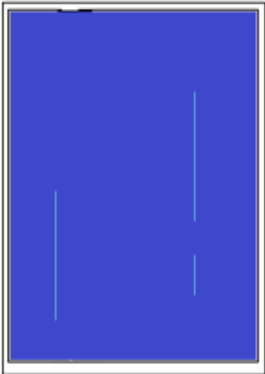
Subject	Symptom	RTB #	Cause	Solution	Rank
Streaks	Scratch marks appear randomly on solid images in the paper feed direction; coated paper

D137 075	1. Toner accumulates on the ribs on the transport guide plate adjacent to the cooling pipe. 2. Scratches, paper dust, contamination on the transport guide plate	If the problem occurs in the position of the ribs of the heat pipe entrance guide plate, clean the heat pipe entrance guide plate ribs. If the problem occurs in other places, clean the paper transport path/duplex unit.	
Streaks	Stains in the shape of horizontal streaks 76mm from the trailing edge; high coverage prints on coated paper (8002/6502 only)	D135 092	When fused toner passes through the heat pipe rollers, it sticks to the surfaces of the heat pipe rollers. The offset toner may get on paper again, causing the stains.	Remove the heat pipe unit and clean it. The RTB has a procedure for this.

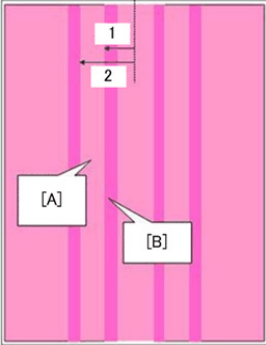
1: Approximately 30mm 2: Approximately 50mm [A]: Bands of low density (at approx. 30-50mm from center) [B]: Density is relatively high at ends of bands	D135 082 D137 103	Friction between the paper and registration roller charges some areas of the paper. (bands of low density 30-50mm from the center, and darker than usual at the ends); coated paper, low-temperature, low-humidity environment (10°C, 15%)	Reduce the PTR bias of the second side. The adjustment for the Pro version is different from the Office version; see the RTB for details There may be side effects as explained in the RTB.

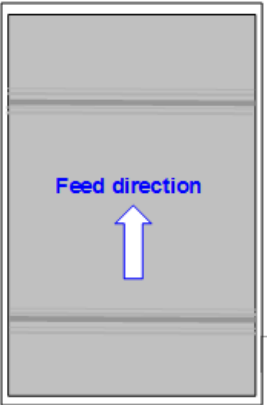
D137 039a	Difference in the rotation speed of the ITB motor and Registration motor. The paper drags the ITB, which causes the ITB to rotate slightly faster than the Bk drum.	Verify the symptom by printing a test chart. Then adjust the line speed with SP mode. See the RTB for details of how to do this. Note that image size will be reduced in the sub-scan direction.	
Fuzzy lines	<p>Unwanted lines (mainly cyan, solid or broken) at 189mm intervals (=drum circumference) in the main scan direction.</p>

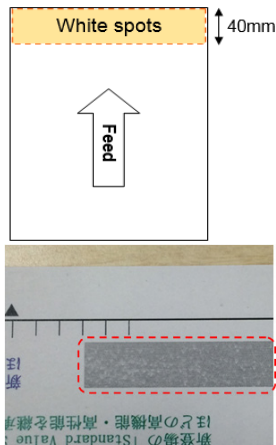
D137 090a	High electrical resistance of the paper, and low smoothness, causes electrical discharge at the PTR nip..	Reduce the transfer current using the SPs in the RTB. But if the transfer current is too low, the image may not be solid enough. Ask the customer to warm the machine up before use, and to avoid paper with rough surface and high resistance.	
White spots	When printing halftone images at low-temperature, low-humidity (10 °C/15 %) immediately after replacing developer

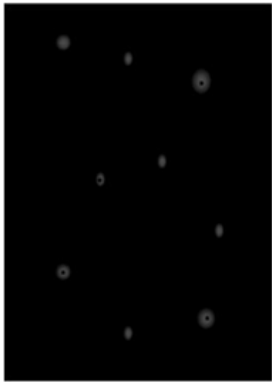
Subject	Symptom	RTB #	Cause	Solution	Rank
White spots	White spots with toner cores in solid images (high-temperature environments)

D135 080 D137 100	Toner clumps in the dev/toner supply unit, because of: a) leaving the machine unused for a long time, b) Strong shock to the PCDU, causing toner stuck to the wall to fall inside the developer, c) Toner is left outside the moisture-proof bag for a long time.	Remove toner clumps from the development unit using the procedure in the RTB.	
White spots	White fish-shaped spots ('medaka') in the feed direction at 189 mm intervals (solid images)

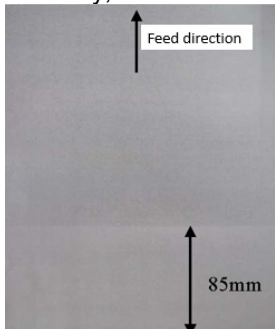
Subject	Symptom	RTB #	Cause	Solution	Rank
Uneven density	0-85 mm from the trailing edge; low-temperature, low-humidity, halftone

D135 083 D137 104 D135 050 D137 170	Variations in attractive force and distance between the ITB and the paper immediately before the transfer process. After the paper passes the registration rollers, toner is scattered before the transfer section.	Adjust the speed of the registration rollers with SP mode. If the density is high, adjust it to a lower value. If the density is low, adjust it to a higher value. Change the value 1% at a time.	
Uneven density	Pro models only: Indentations in the paper are white; thick, textured paper, low image rate prints (5% or less) are made continuously. (ProC5100/5110 only)

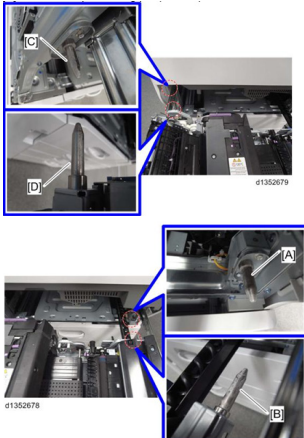
D135 089 D137 111	The grease on the positioning pins became insufficient over time.	Periodically apply grease (Barrierta S552R) to the drawer unit positioning pins, as explained in the RTB.	
Drawer unit	Derailed off the slide rail and may fall out of the machine when it is pulled out to clear a jam.
