Model: CH-C2/CH-C2 Pro	Date: 14-Oct-16	No.: RD257015a
-------------------------------	-----------------	----------------

Subject: Firmware Release Note: PS3		Prepared by: K. Hamada	
From: 1st Tech Service Sect., MFP/Printer Tech Service Dept.			
Classification:	<input type="checkbox"/> Troubleshooting	<input type="checkbox"/> Part information	<input type="checkbox"/> Action required
	<input type="checkbox"/> Mechanical	<input type="checkbox"/> Electrical	<input type="checkbox"/> Service manual revision
	<input type="checkbox"/> Paper path	<input type="checkbox"/> Transmit/receive	<input type="checkbox"/> Retrofit information
	<input type="checkbox"/> Product Safety	<input checked="" type="checkbox"/> Other (Firmware)	<input checked="" type="checkbox"/> Tier 2

Model: CH-C2a		Date: 30-Nov-16	No.: RD257020
Subject: Part of a FAX image is missing with Memory Unit Type M26		Prepared by: Y.Taniguchi	
From: 1st FQM Sect., 1st FQM Dept.			
Classification:	<input checked="" type="checkbox"/> Troubleshooting	<input type="checkbox"/> Part information	<input type="checkbox"/> Action required
	<input type="checkbox"/> Mechanical	<input type="checkbox"/> Electrical	<input type="checkbox"/> Ser

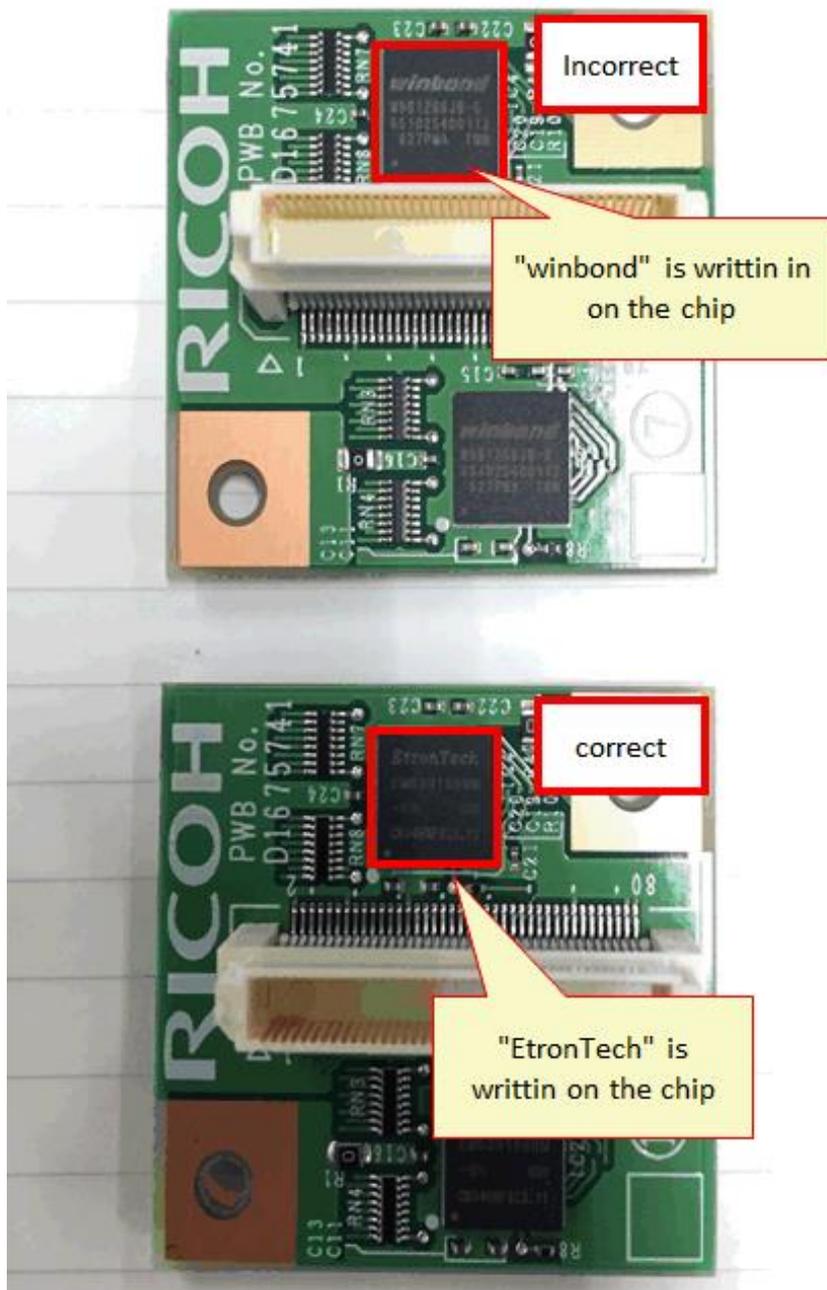
- Incorrect (affected) is the chip with "winbond" written on it.
- Correct (Not affected) is the chip with "EtronTech" written on it.

Replace the Fax Memory Unit with the modified one.

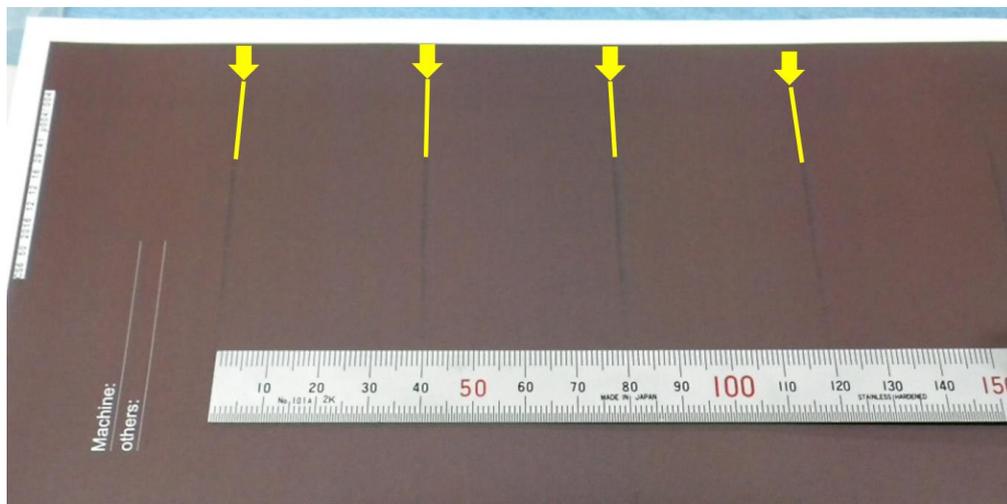
Horizontal lines appear on the image at intervals equal to the charge roller (40mm) at machine installation.

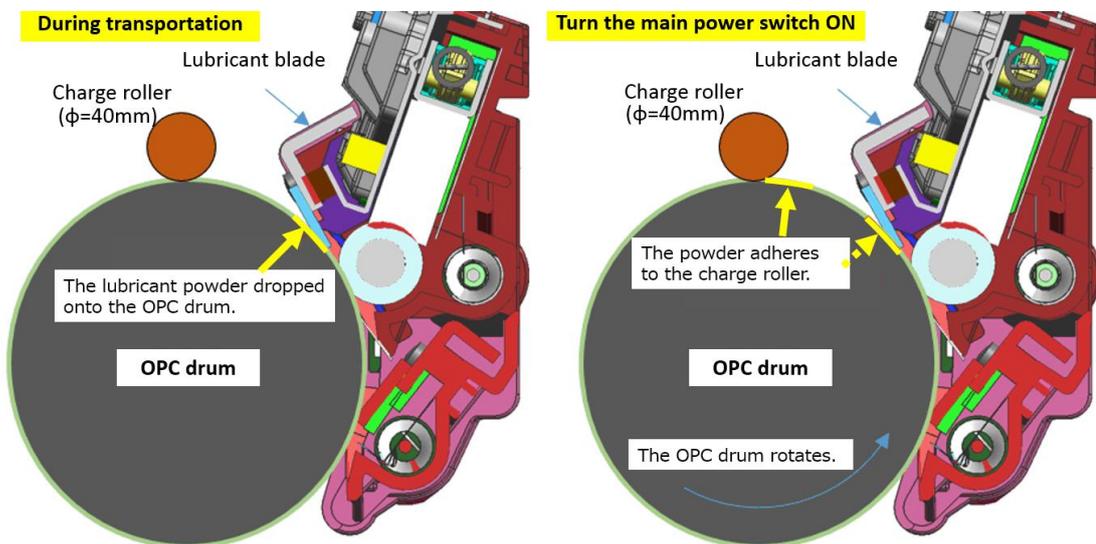
Due to the error, lubricant powder is applied to the lubricant blade in a quantity that is larger than the defined amount. As a result, the powder drops onto the OPC drum during transport from the factory, and then moves to the charge roller when the machine power is turned on for the first time.

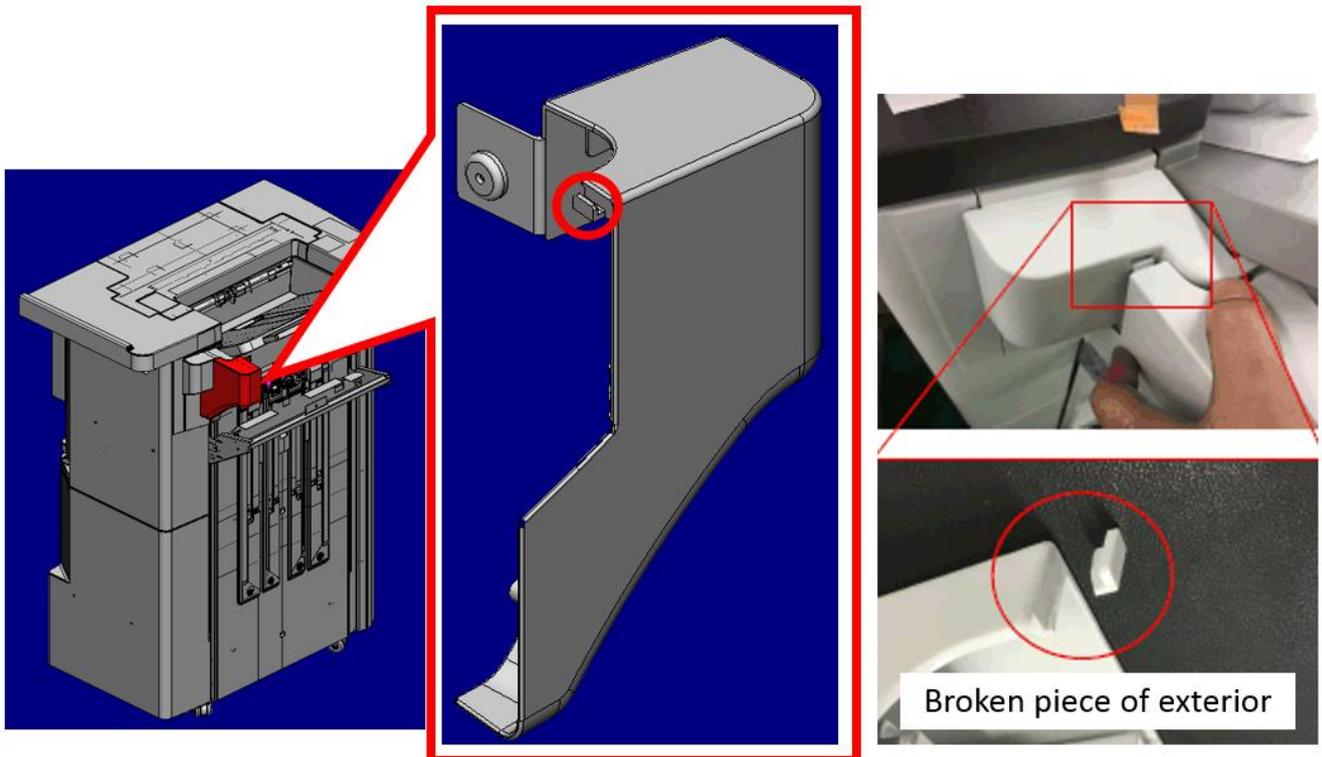
Fig.1

The broken piece drops into the clearance between the paper guide (GUIDE: PAPER: REAR: ASS'Y) and the exterior cover (COVER: PAPER: GUIDE) circled in YELLOW.

This prevents the paper guide from returning to the home position.

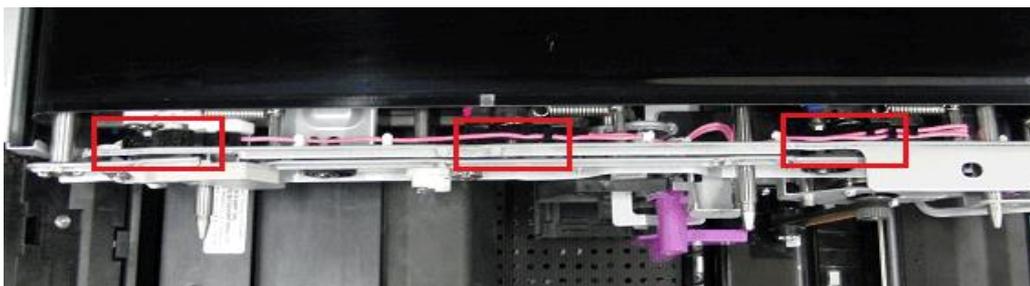
Fig.1

One of the bias brackets (D1366124) **[A]** in the intermediate transfer unit comes loose or out of position when the intermediate transfer unit is installed. As a result, the bracket bumps against the bearing **[B]**, and the intermediate transfer roller **[C]** cannot rotate.

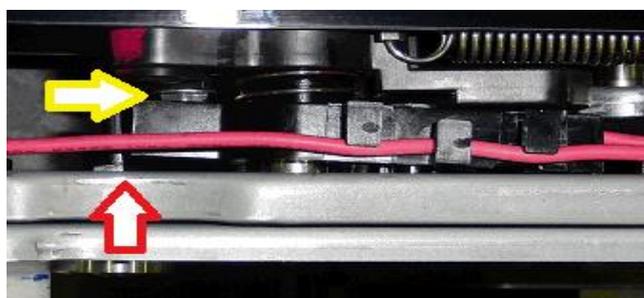
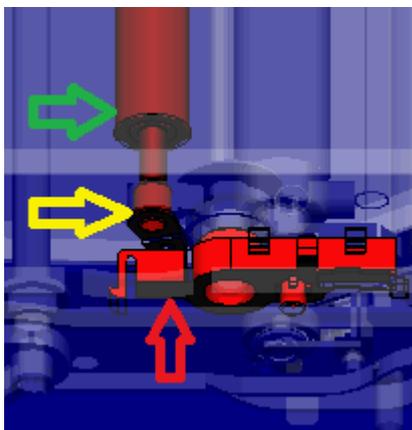
**INCORRECT**
(bracket has come loose)

- [A]: Red arrow (bias bracket)
- [B]: Yellow arrow (bearing)
- [C]: Green arrow (intermediate transfer roller)

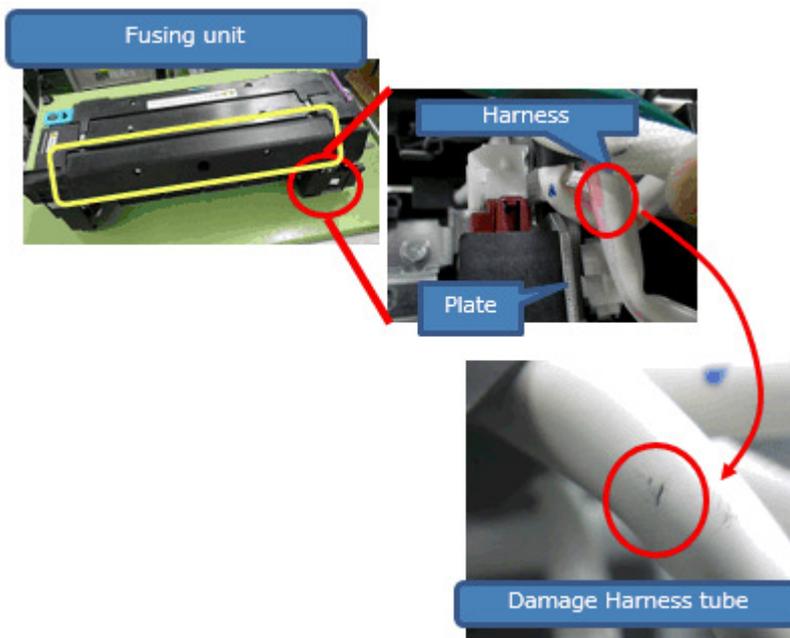
The harness layout was changed when the factory assembly team was changed in January 2017. As a result, the following harness tube in the fusing unit was damaged, causing it to contact the metal plate.

1. Check the target harness tube.
2. If it is damaged, cover the harness with Teflon tape.
3. Cover the edge of the bracket with Teflon tape.

Note: The recommended Teflon tape is 3M PTFE Film tape 5490 (24mm).

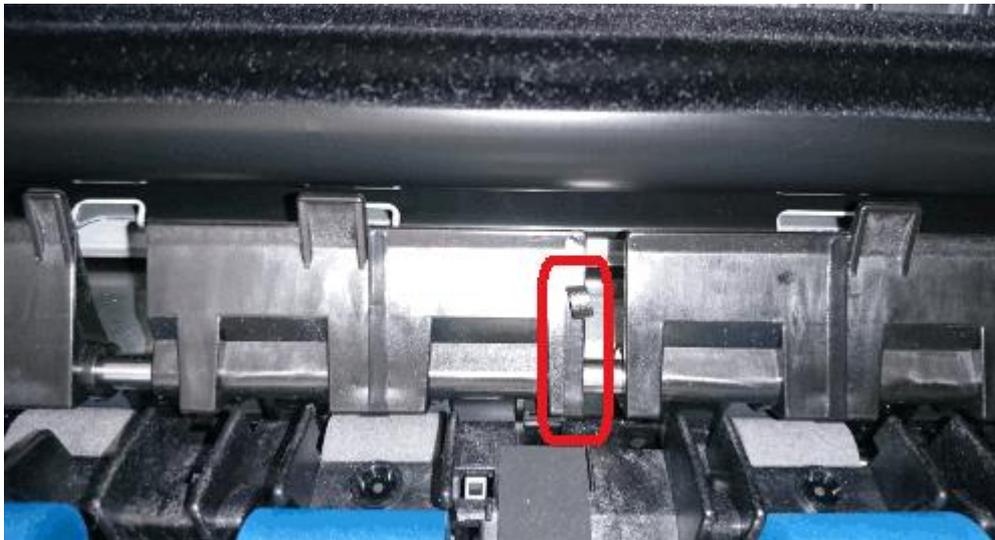
Curled paper hits the edge of the gate pawl sheet in the paper exit unit, or jammed paper hits this edge when a jam is cleared. As a result, the sheet peels off.

- If the machine does not print out many solid images, remove the gate pawl sheet.
Note: This is because the sheet is there to improve paper transport when printing out solid images.
- If the machine prints out many solid images, replace the gate pawl with the following new part (which has a modified sheet attached to prevent peeling).

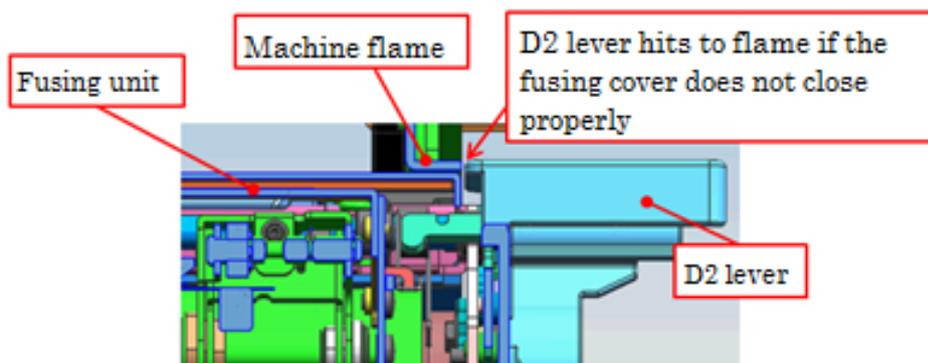
The fusing unit D2 lever is broken and SC583 occurs.

The D2 fusing unit lever hits the machine frame and breaks if the cover of the fusing unit does not close properly.

Replace the fusing unit D2 lever with the new part.
