Model: CH-C2 Pro	Date: 20-Dec-16	No.: RD260003
------------------	-----------------	---------------

Model: CH-C2 Pro		Date: 29-Mar-17	No.: RD260017
Subject: Electrical leak from fusing unit		Prepared by: S. Watanabe	
From: PP CS Section, PP FQM Dept., QAC			
Classification:	<input checked="" type="checkbox"/> Troubleshooting	<input type="checkbox"/> Part information	<input type="checkbox"/> Action required
	<input type="checkbox"/> Mechanical	<input checked="" type="checkbox"/> Electrical	<input type="checkbox"/> Service manual revision
	<input type="checkbox"/> Paper path	<input type="checkbox"/> Transmit/receive	<input type="checkbox"/> Retrofit information
	<input type="checkbox"/> Product Safety	<input type="checkbox"/> Other ()	<input checked="" type="checkbox"/> Tier 2

Model: CH-C2 Pro		Date: 28-Jun-17	No.: RD260022
Subject: Troubleshooting Grainy Image		Prepared by: H.K.	
From: PP CS Section, PP FQM Dept.			
Classification:	<input checked="" type="checkbox"/> Troubleshooting	<input type="checkbox"/> Part information	<input type="checkbox"/> Action required
	<input type="checkbox"/> Mechanical	<input type="checkbox"/> Electrical	<input type="checkbox"/> Service manual revis

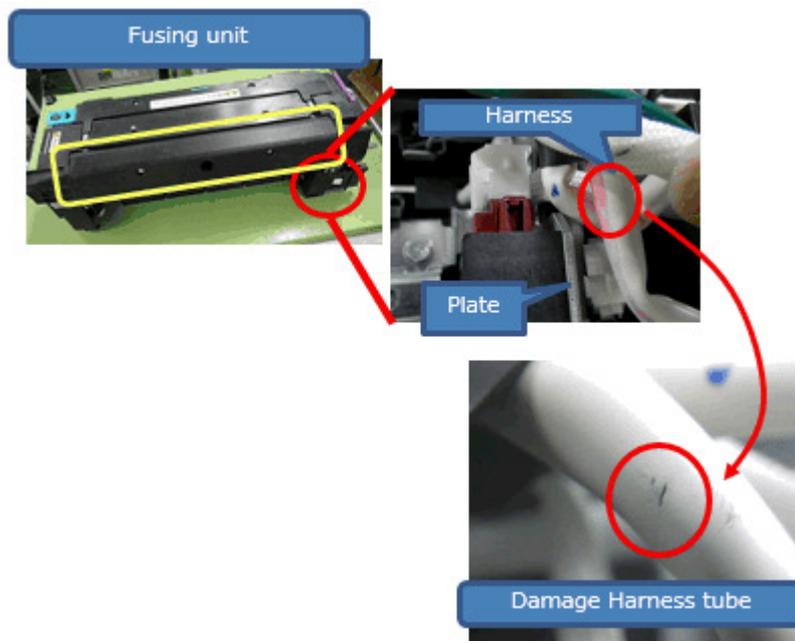
The harness layout was changed when the factory assembly team was changed in January 2017. As a result, the following harness tube in the fusing unit was damaged, causing it to contact the metal plate.

1. Check the target harness tube.
2. If it is damaged, cover the harness with Teflon tape.
3. Cover the edge of the bracket with Teflon tape.

Note: The recommended Teflon tape is 3M PTFE Film tape 5490 (24mm).

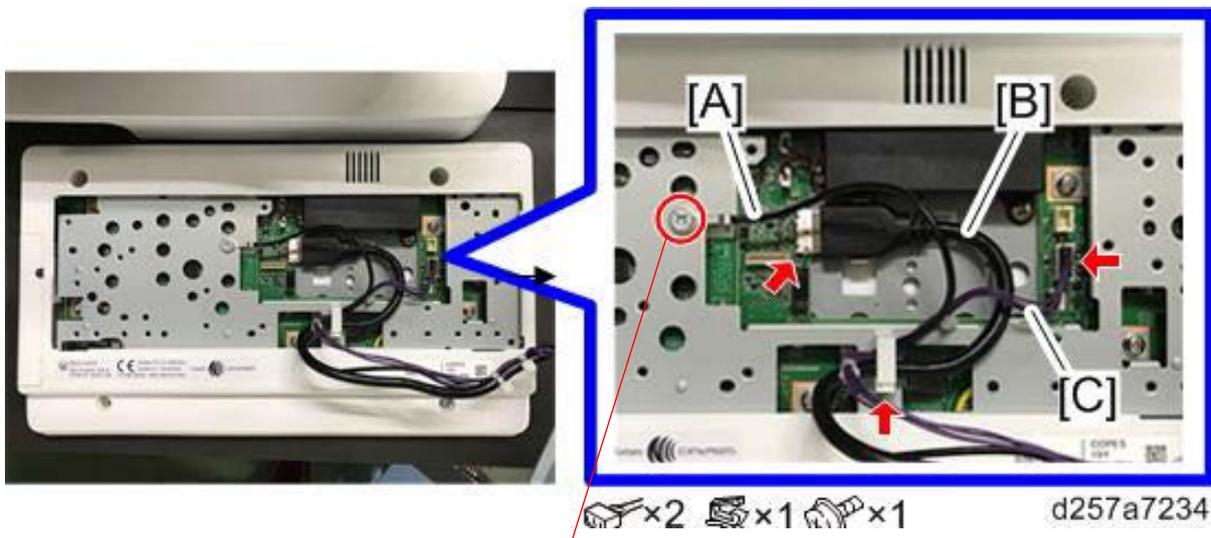
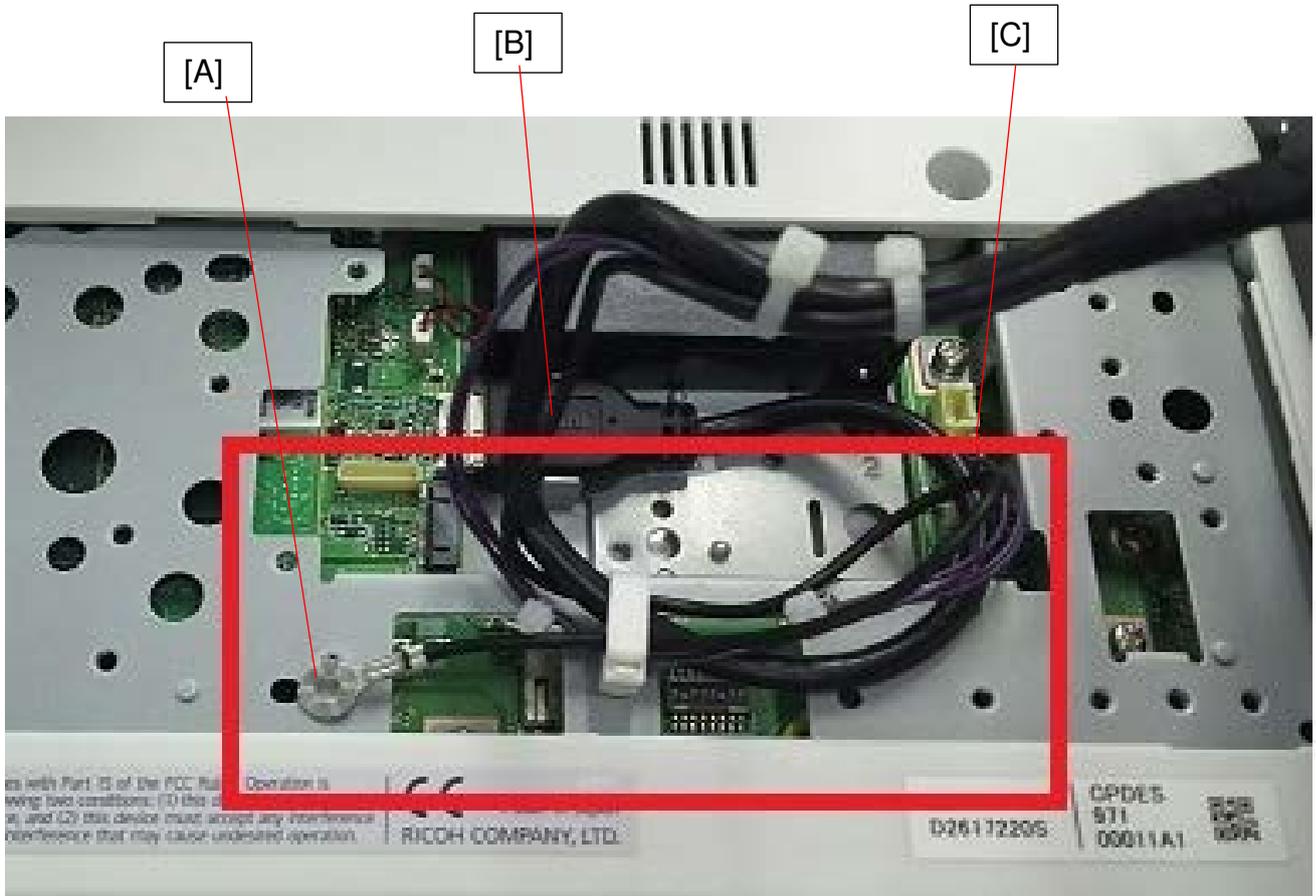
When installing the Smart Operation Panel, fixing the ground cable before attaching the arm bracket has the risk of damaging the IC chip in the panel and cause a blank screen, because the screw used for fixing the ground cable may have contact with the IC chip.

11. Connect the harnesses [B] and [C] to the operation panel, and then route them as shown below.
12. Fix the ground cable [A].

Do not install the screw.

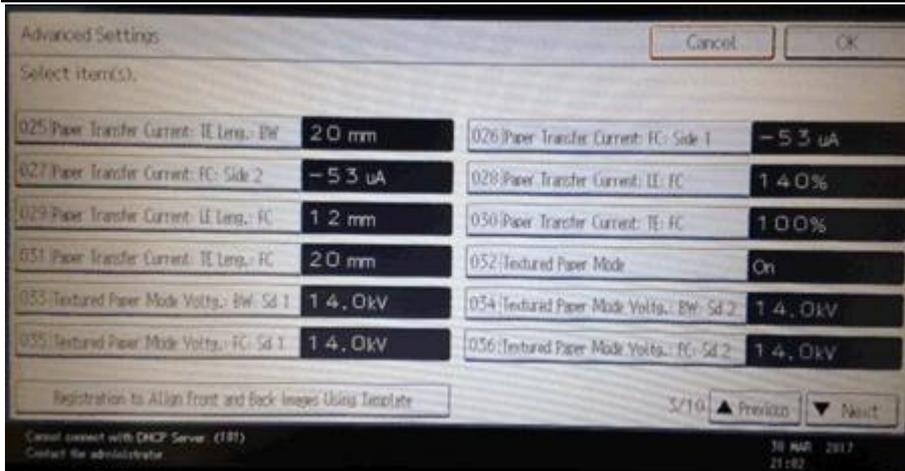
NOTE: Increasing the transfer bias improves Grainy Image, but may cause toner scattering around texts and thin lines.

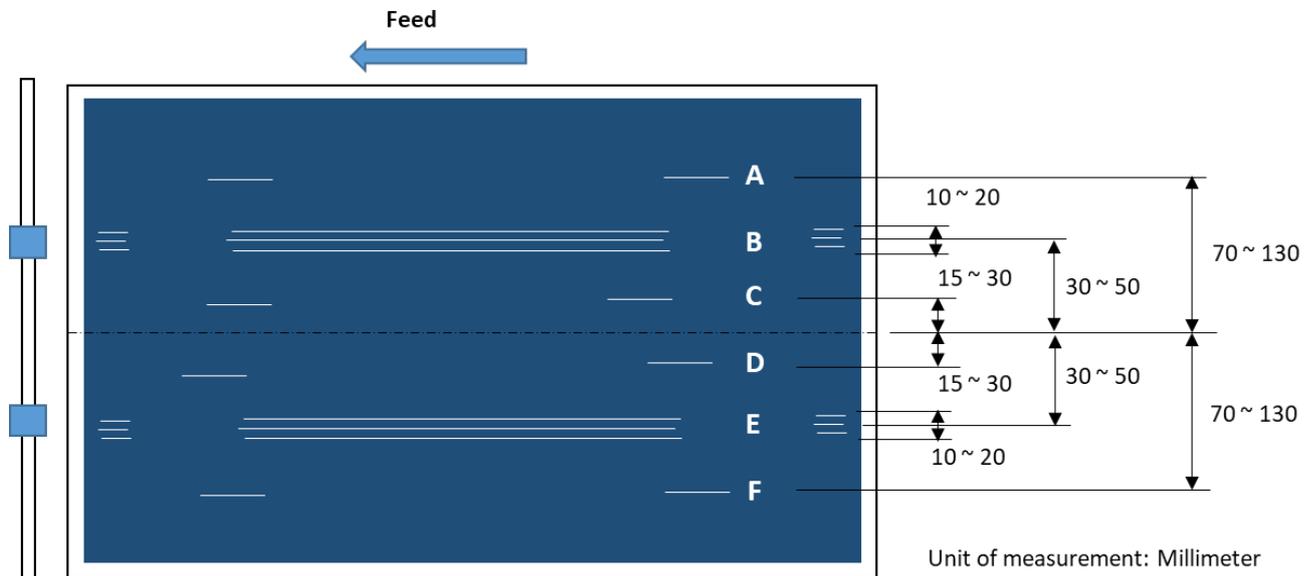
The location of the roller marks / scratches A ~ F shown above correspond to the rollers and guide plates shown in the pictures on the following page.
