Model: Mo-C1	Date: 07-Dec-12	No.: RD124001f
--------------	-----------------	----------------

Subject: Firmware Release Note: Engine		Prepared by: Y. Kurohashi	
From: 2nd PP Tech Service Sect., PP Tech Service Dept.			
Classification:	<input type="checkbox"/> Troubleshooting	<input type="checkbox"/> Part information	<input checked="" type="checkbox"/> Action required
	<input type="checkbox"/> Mechanical	<input type="checkbox"/> Electrical	<input type="checkbox"/> Service manual revision
	<input type="checkbox"/> Paper path	<input type="checkbox"/> Transmit/receive	<input type="checkbox"/> Retrofit information
	<input type="checkbox"/> Product Safety	<input checked="" type="checkbox"/> Other (Firmware)	<input checked="" type="checkbox"/> Tier 2

This RTB has been issued to announce the firmware release information for the **Engine**.

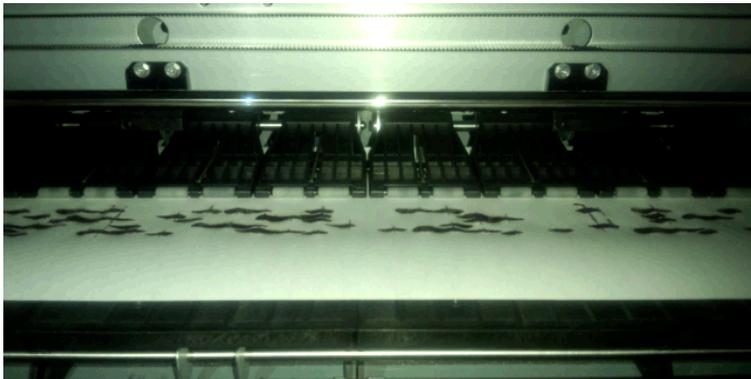
SC293 (OCFS Ink Timeout During Filling) occurs and ink is ejected unexpectedly if the following conditions are met simultaneously.

- Conditions
  - "Ink End" alert for yellow or magenta is displayed.
  - The control panel displays "Home screen", or "Scanner screen".
  - The "Paper Input Location" on the control panel is changed, or a new paper roll or ream of cut paper is loaded.

Firmware bug

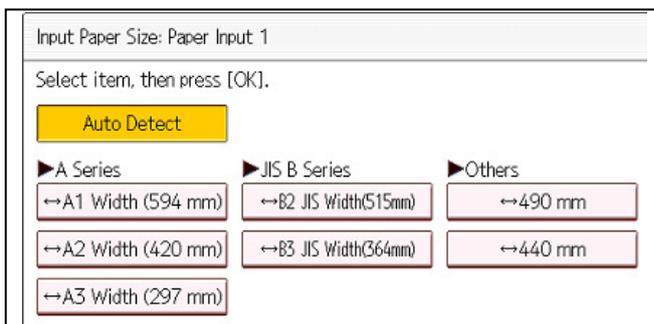
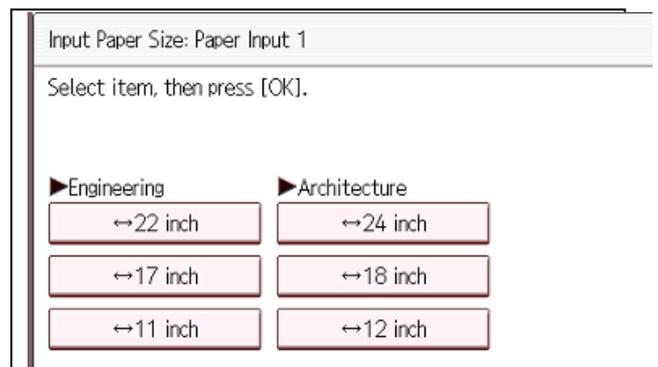
Large paper sizes (A0, 914mm, 30/34/36 inch, etc.) are not displayed in User Tools after the MCU is replaced, making it impossible to specify these sizes.

- The NVRAM on the old MCU was not removed and attached to the new MCU, or
- The NVRAM was carried over to the new MCU, but the value of **SP5807-001** (Area/Model Selection Area Code Setting) was not changed

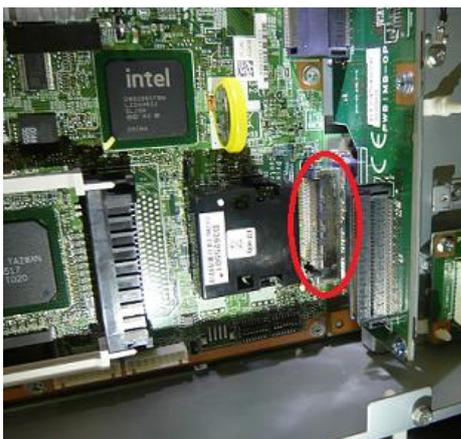
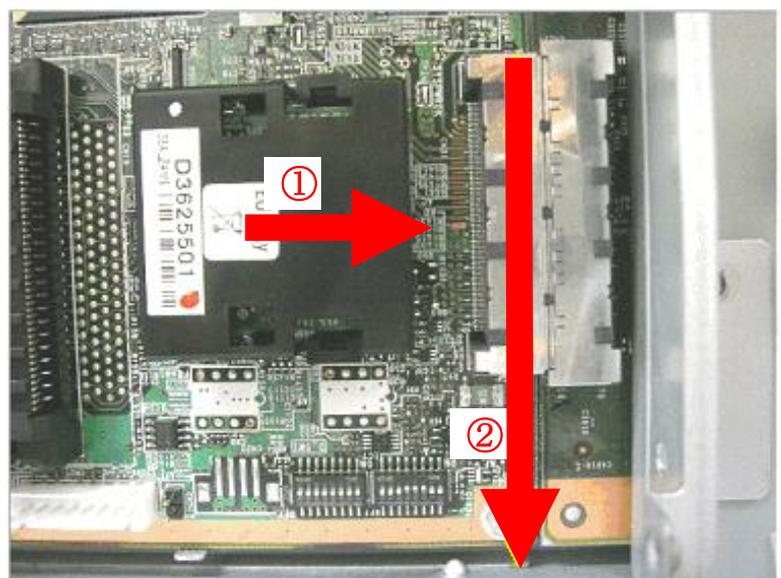
The machine displays the "Please wait" message and does not boot up at power ON if the controller board was just replaced.

Loose connection at the connector that joins the controller board and IPU

4. Tighten the screws all the way.

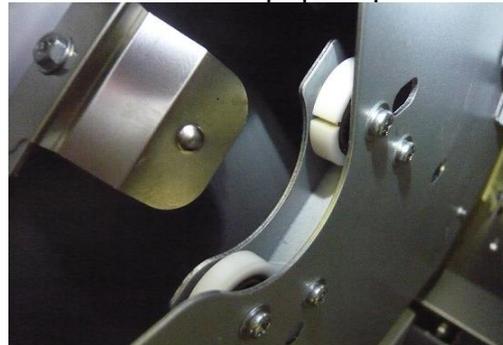
&lt;Guide rollers for paper spool&gt;

The following occur due to a break/cracks in the bearing's resin coating:

Bubbles formed during the application of the bearing's resin coating, which compromised the coating's integrity.

Replace the following parts at the next site visit.

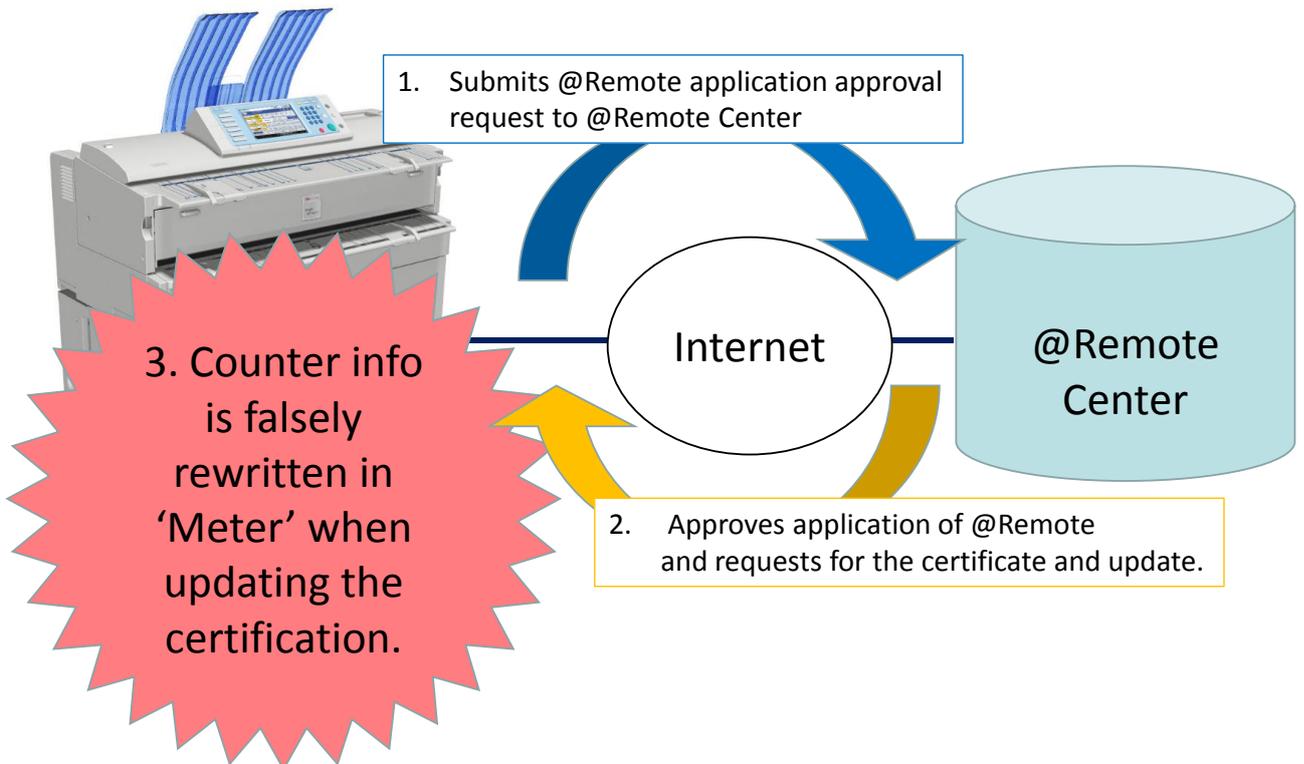
Accounting counter SP5045-002 is falsely rewritten as "0: meters" when devices are connected to @Remote center via Embedded @Remote to update the certificate information. This causes a discrepancy between the customer's service contract and the accounting counter setting.

The problem may occur in either of the following conditions:

- When initially setting up the embedded @Remote
- When re-attempting to approve @Remote application after failing to connect to @Remote (\* This condition applies only to MPCW2200.)

A software bug

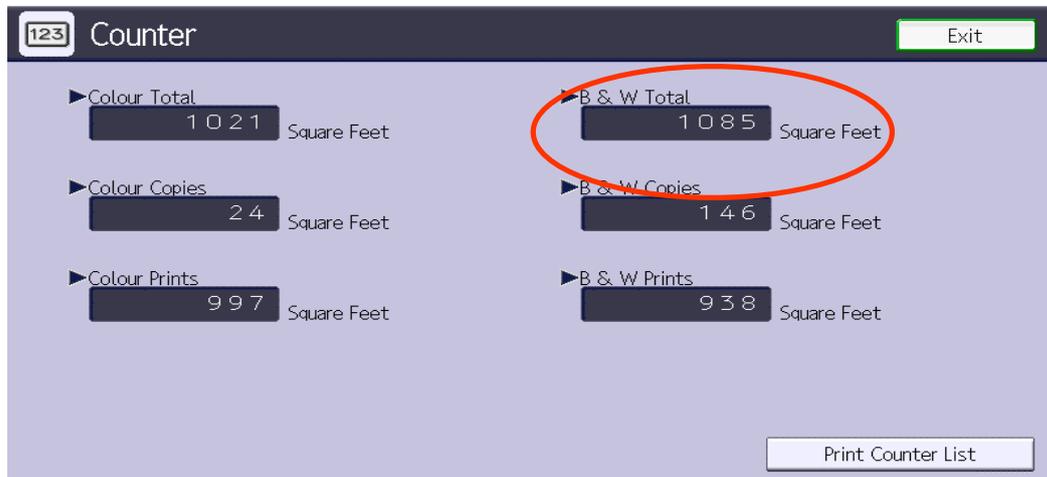
B&W Total counter indicates the total print volume of the month as 1085 square feet.

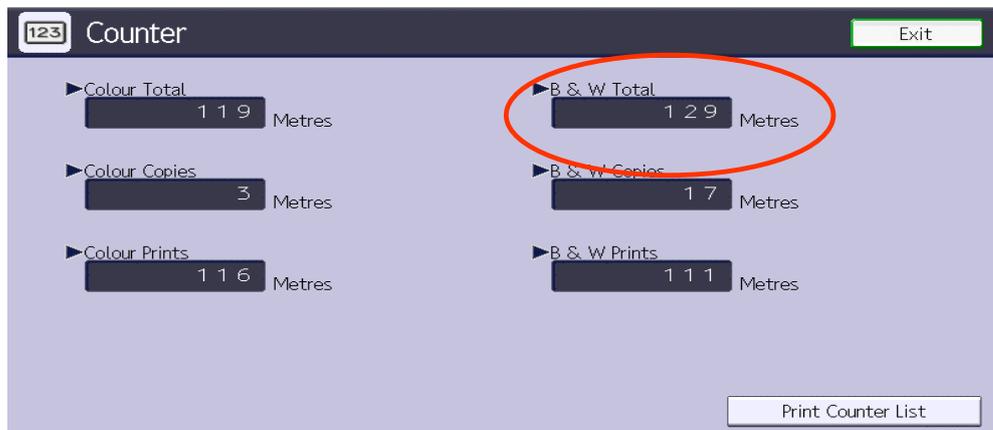
Incorrect status (after SP5045-002 is falsely rewritten in meters)

The B&W Total counter unit indicates the total print volume of the month as 129 meters.

Click worth 956 square feet (1085-129) is not charged to your customer. This is because data sent from @Remote disregards unit of measure.

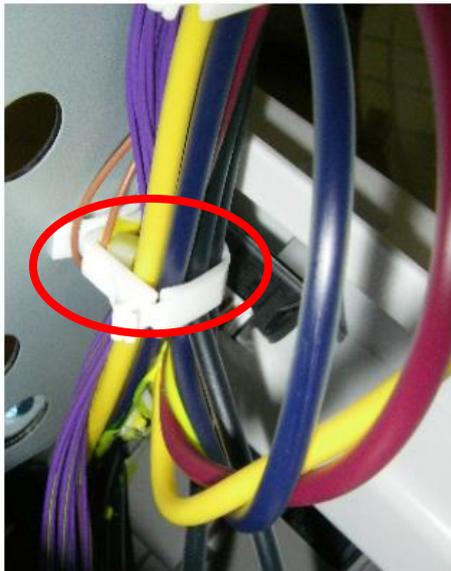
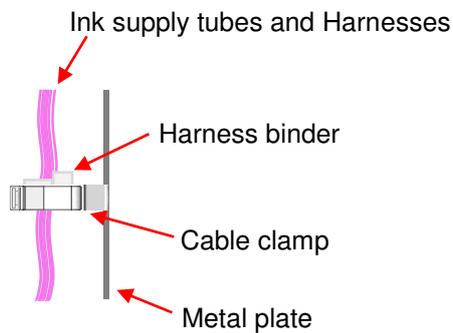
Ink leaks from a crack in the tube in the location circled in red below.

Replaced the cable clamp with a larger one since Feb 1, 2015.

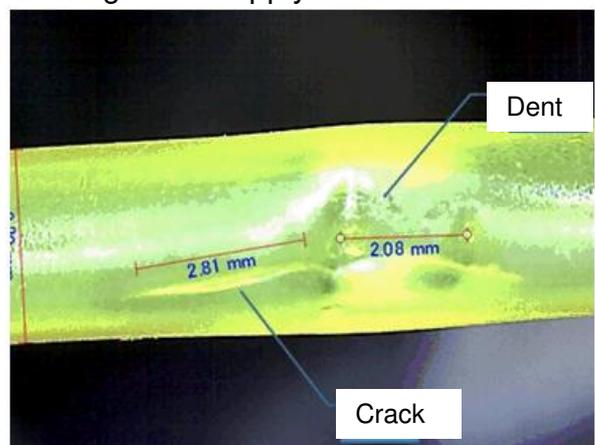
Damaged ink supply tube

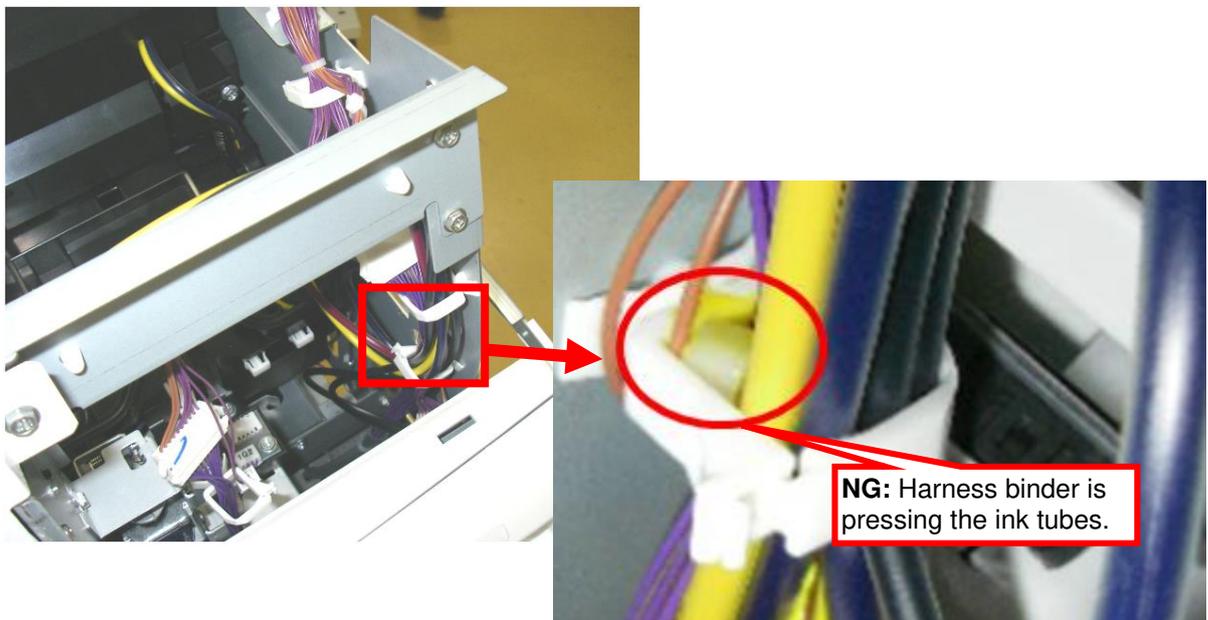
2. Check the position of the harness.

- OK : The binder is positioned either under or above the cable clamp.
- NG : The binder is positioned inside the cable clamp.

If the harness binder position is NG, unlock the cable clamp and shift the position of the harness binder either above or under the clamp

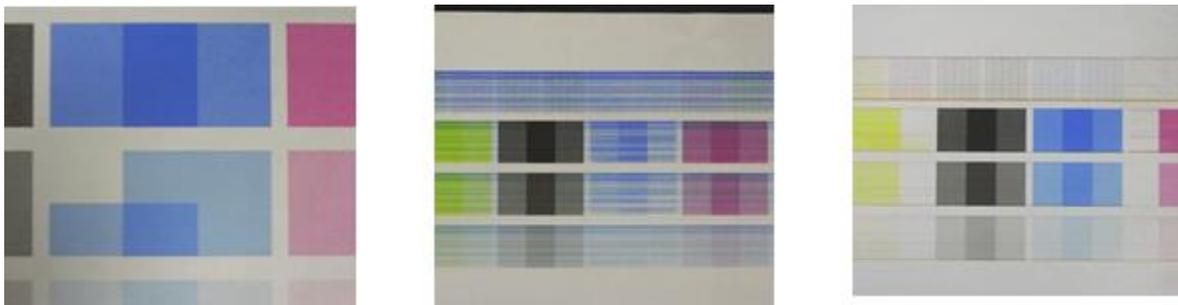
Following are examples of image quality issues observed shortly before the fuse (FU13) blows where images can be partially missing or ink is continuously ejected. In such cases, cleaning the print head does not resolve the problem.

**Replace all of the following 3 parts together. Power ON the machine only after replacing all 3 parts.**

1. Replace the print heads (both BK and Color).  
**See *IMPORTANT* note below.**
2. Replace the HRB.
3. Replace the MCU.

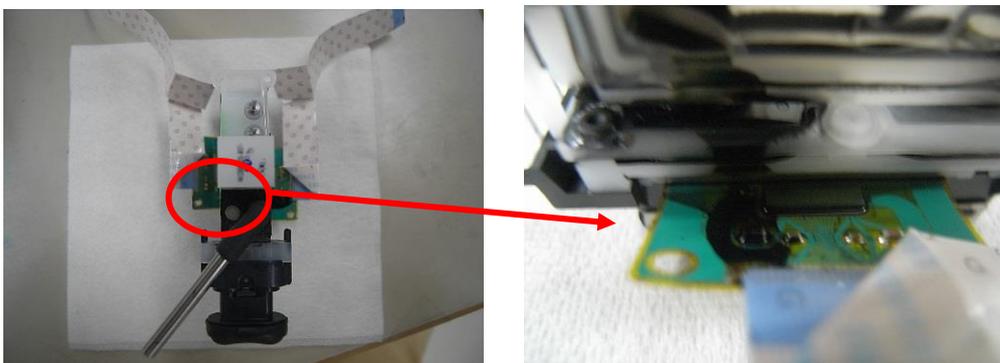
**Ink leaked on the print head control board**

***Ink leaked on the print head control board shorts the 37V power circuit and damages the following components on the MCU.***

***Photos below show a short circuited print head control board caused by ink leakage. Note that the short circuit may not be noticeable from visual inspection.***

- ***Make sure to replace all of the above 3 parts before turning ON the machine power. Turning ON the machine power after replacing only one or two among the 3 parts will damage the newly replaced part(s) again.***
- ***Depending on the condition of the print head control board, both BK and Color print heads may not have to be replaced to resolve the problem. See “C” of the Reference section for the check procedure on how to make this judgment.***  
***However, it is recommended to replace both print heads in case mistakes occur in the check procedure.***
- ~~It is very important that the components are replaced in the above order to prevent the fuse from blowing again.~~
- After replacing the print heads and HRB, confirm secure connection of the flat cables connecting the print heads and HRB. Loose connection of these cables can cause a short circuit.

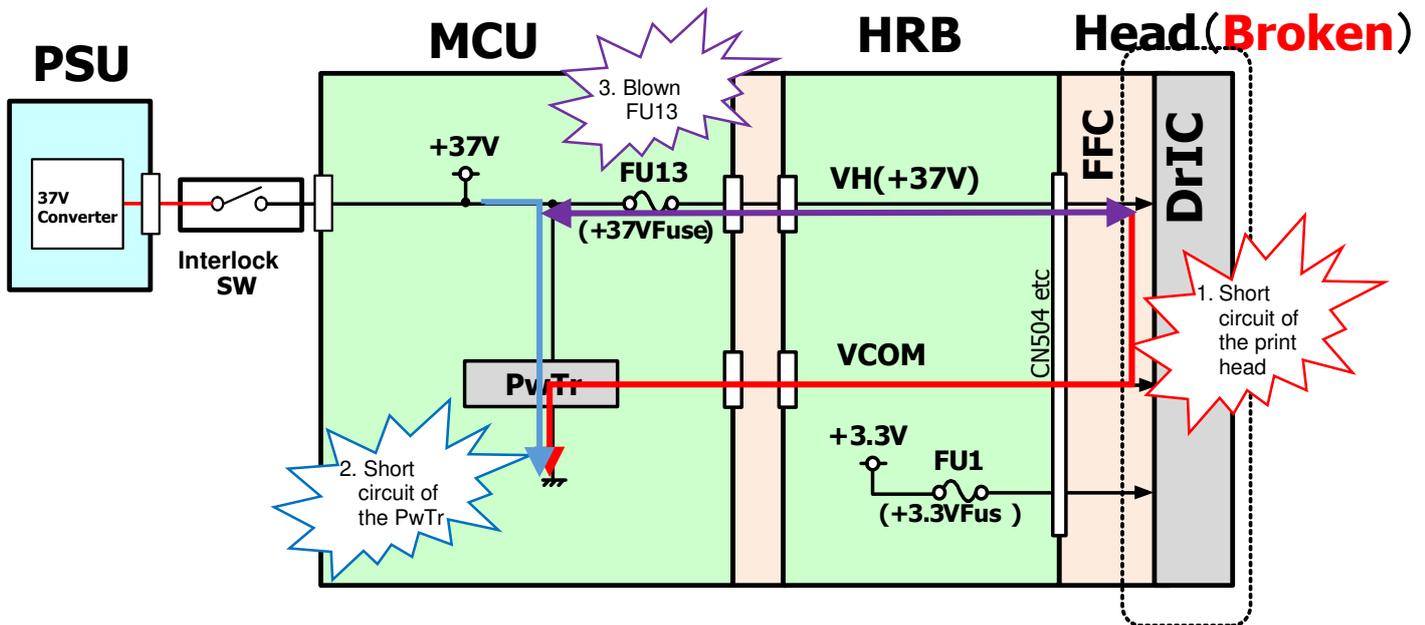
**A) The ink leak causes the symptom**

The following diagram describes an example of a short circuit that may occur when the ink leaks on the print head control board.

Note that the symptom could occur even if fuse (FU13) has not been blown and a short circuit only of the PwTr.

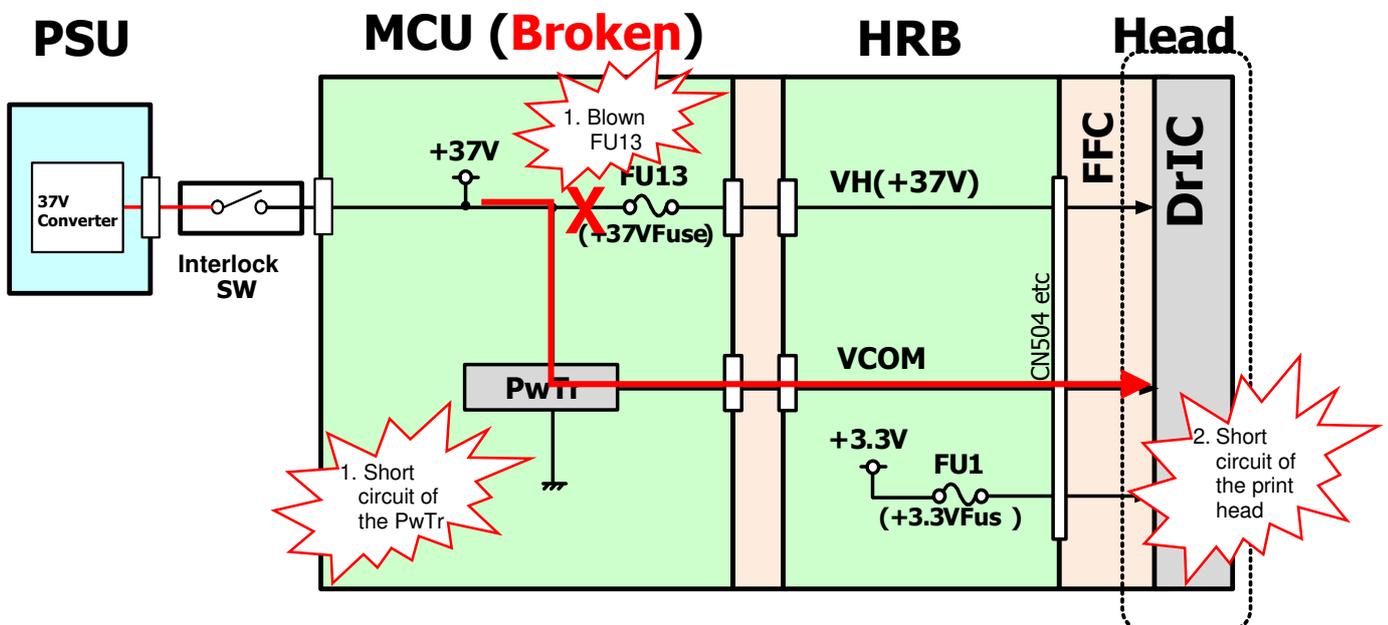
**B) Damaged MCU causes the symptom**

The following diagram shows an example of a short circuit that may occur when the MCU was broken.

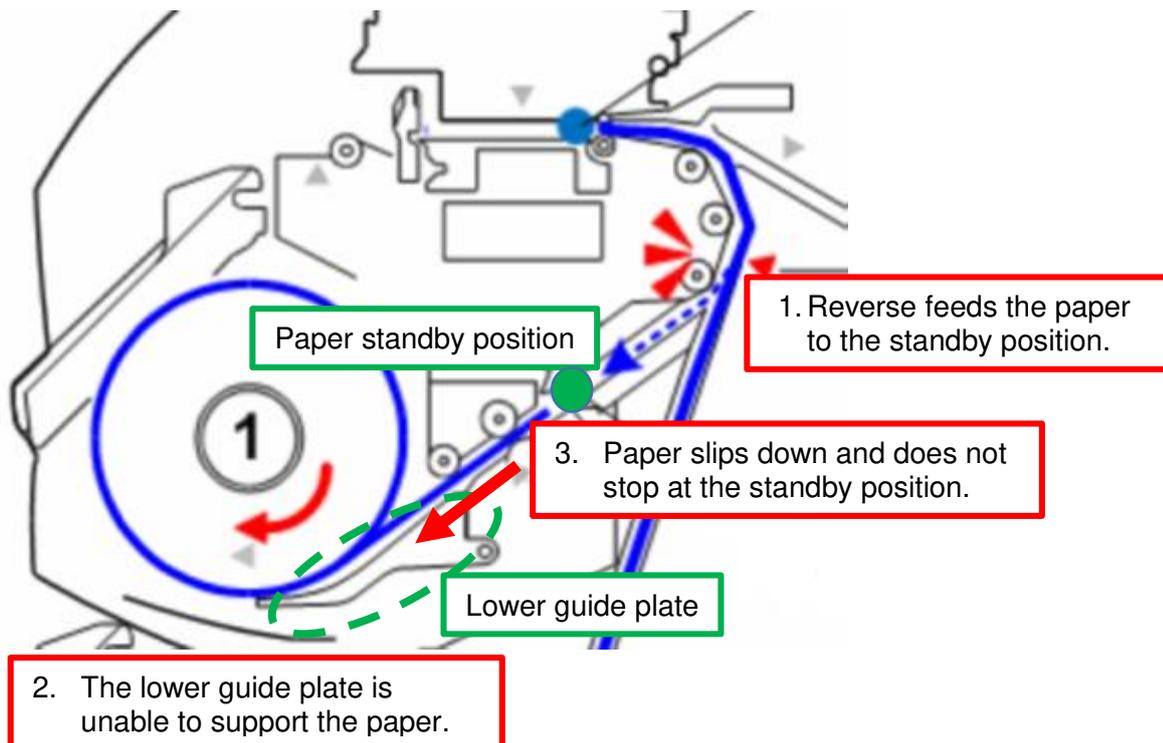
Friction is too low for the lower guide plate to support the paper when reverse feeding during the roll initialization process, causing the paper to slip down and the leading edge to pass the paper standby position.

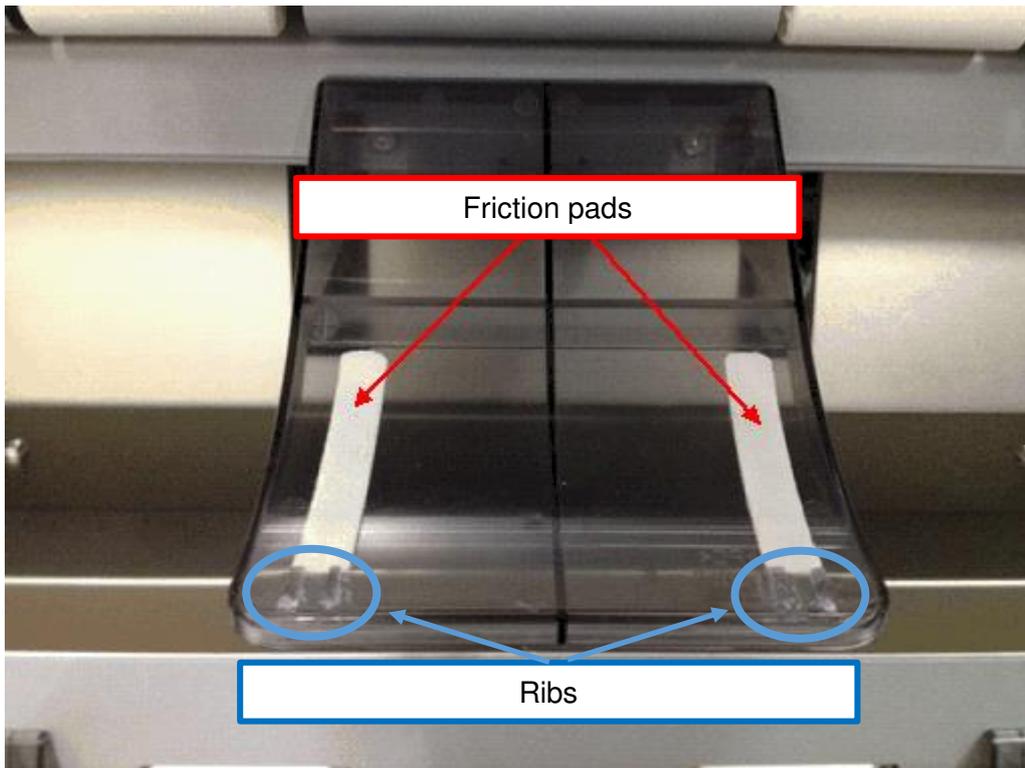
**Lower guide plate**

Friction pads and ribs were attached to the lower guide plate for better grip against paper that is low in stiffness.

Replace with the modified lower guide plate, if the problem occurs.

**NOTE:** When replacing the guide plate for Tray 1, procure and replace a total of 3 guide plates.
