Technical Bulletin

Model: Mo-C2

Subject: Firmware Release Note: PowerSaving Sys			Prepared by: Y. Kurohashi
From: 1st PP Tech Service Sect., PP Tech Service Dept.			
Classification:	Troubleshooting	Part information	n 🛛 Action required
	🗌 Mechanical	Electrical	Service manual revision
	Paper path	Transmit/receiv	e Retrofit information
	Product Safety	Other (Firmwar	e) 🛛 Tier 2

Model: Mo-C2		Date: 22-Jan-17		17	No.: RD262044	
Subject: Troubleshooting for SC665-01 and SC666-01			Prepared	d by: A. S	Shigeta	
From: Tech. Supp	ort Sec., Product Marketing Dep	ot.				
Classification:	☑ Troubleshooting [☑ Mechanical [☑ Paper path [☑ Product Safety [☐ Part inf ⊠ Electric ☐ Transm ☐ Other (al		Servio	n required ce manual revision fit information

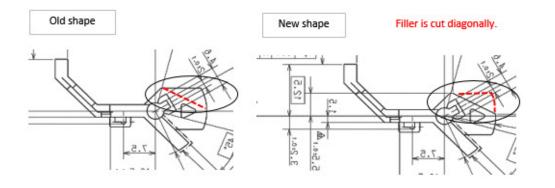
The shape of the filler was changed so as to create more space between the filler and K2 cap holder.

- (3) Touch the K2 cap lightly with your finger.
 - If the cap falls out of place very easily, replace the maintenance unit with the new one that contains a modified filler (See below).

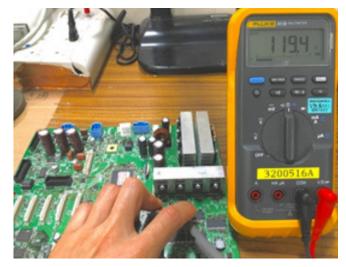
- Normal range $: 0.1\Omega \sim 0.9\Omega$
- Abnormal range : Few K Ω ~ Few M Ω , or O.L
- 2. BiCU condition can be checked with the resistance level by tester.

Note) Below is an image for examination.

Step 2: Replace following parts all together then power on the machine. For the detail explanation, please see the index B. in **Reference** section.

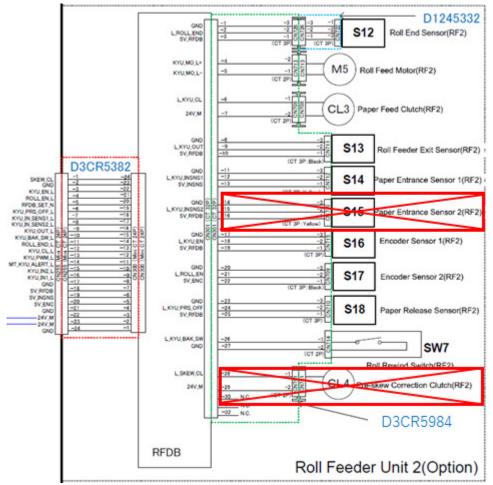
P to P diagram for Roll Feeder Unit 2 (Section: 9-10/ C-D) was corrected as follows.

Harnesses for Paper Entrance Sensor 2 and Pre-skew Correction Clutch are not included in D3CR5984.
