Model: Neptune-P1	Date: 27-Aug-07	No.: RG180001a
-------------------	-----------------	----------------

Subject: Firmware Release Note: Engine		Prepared by: F.Noguchi	
From: 2nd Tech. Support Sec. Service Support Dept.			
Classification:	<input type="checkbox"/> Troubleshooting <input type="checkbox"/> Mechanical <input type="checkbox"/> Paper path <input checked="" type="checkbox"/> Other ()	<input type="checkbox"/> Part information <input type="checkbox"/> Electrical <input type="checkbox"/> Transmit/receive	<input type="checkbox"/> Action required <input type="checkbox"/> Service manual revision <input type="checkbox"/> Retrofit information

This RTB has been issued to announce the firmware release information for the **Engine**.

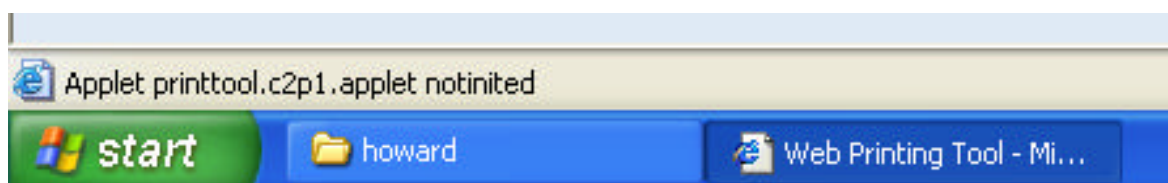
"Applet printtool.c2pl applet notinited" (error message) is displayed if WebPrint is used together with Java 6 Update 2, Version 1.6.0_2.

Note: This does not occur if Java 6 Update 2, Version 1.6.0_1 or earlier is installed.

The default setting for "Temporary Internet Files" in the Java Control Panel was changed from Java 6 Update 2, Version 1.6.0_2.

Change the "Temporary Internet Files" setting in the Java Control Panel.

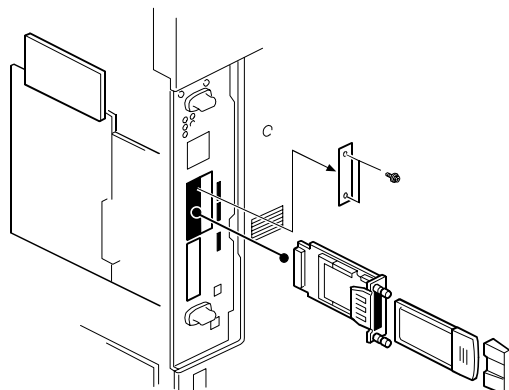
Previous types:
PCB, LAN card, and cover are
separate

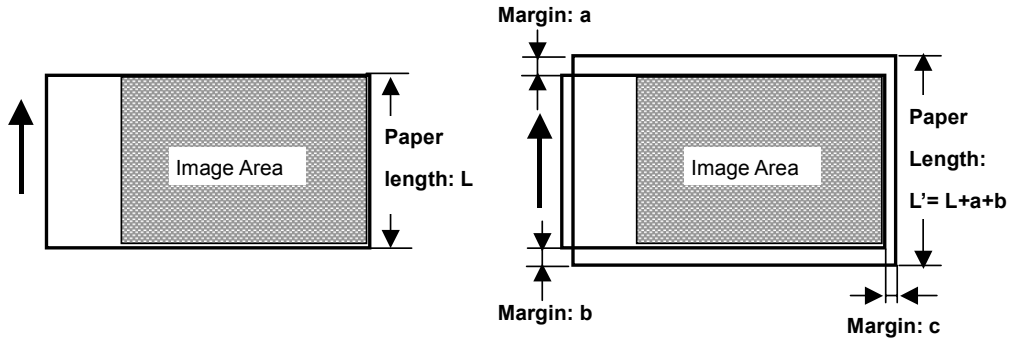
Version	Modified Points or Symptom Corrected
1.1.4a	<p>Other changes: Supports the use of the Synchro-cut feature with the HDI printer driver.</p> <p>Important: - To enable the use of this feature with the HDI driver, after installing this version, turn the Hard Clip setting OFF as follows:</p> <ol style="list-style-type: none"> 1. Press the "Menu" key. 2. Press [▲] or [▼] to select "Extended Features" and then press the [OK] key. 3. Check "GL2/ & TIFF" is selected, and then press the [OK] key. 4. Press [▲] or [▼] to select "GL/2 Print Settings", and then press the [OK] key. 5. Press [▲] or [▼] to select "Hard Clip", then press the [OK] key. 6. Press [▲] or [▼] to select "Off", and then press the [OK] key. <p>- After you do this, the Cut Method settings will not be applied. - To prevent the edges of the image from being overwritten by margins applied by the mainframe during image development, make sure to specify margins a, b, c in the printer driver (which are added to the edges without overwriting them) for the leading, trailing, and right edges.</p> <p style="text-align: center;">Added margins</p>
