Model: Neptune-C2	Date: 31-May-07	No.: RB286001b
--------------------------	-----------------	----------------

Subject: Firmware Release Note: Engine		Prepared by: F.Noguchi	
From: 2nd Tech. Support Sec. Service Support Dept.			
Classification:	<input type="checkbox"/> Troubleshooting	<input type="checkbox"/> Part information	<input type="checkbox"/> Action required
	<input type="checkbox"/> Mechanical	<input type="checkbox"/> Electrical	<input type="checkbox"/> Service manual revision
	<input type="checkbox"/> Paper path	<input type="checkbox"/> Transmit/receive	<input type="checkbox"/> Retrofit information
	<input checked="" type="checkbox"/> Other ()

This RTB has been issued to announce the firmware release information for the **Engine**.

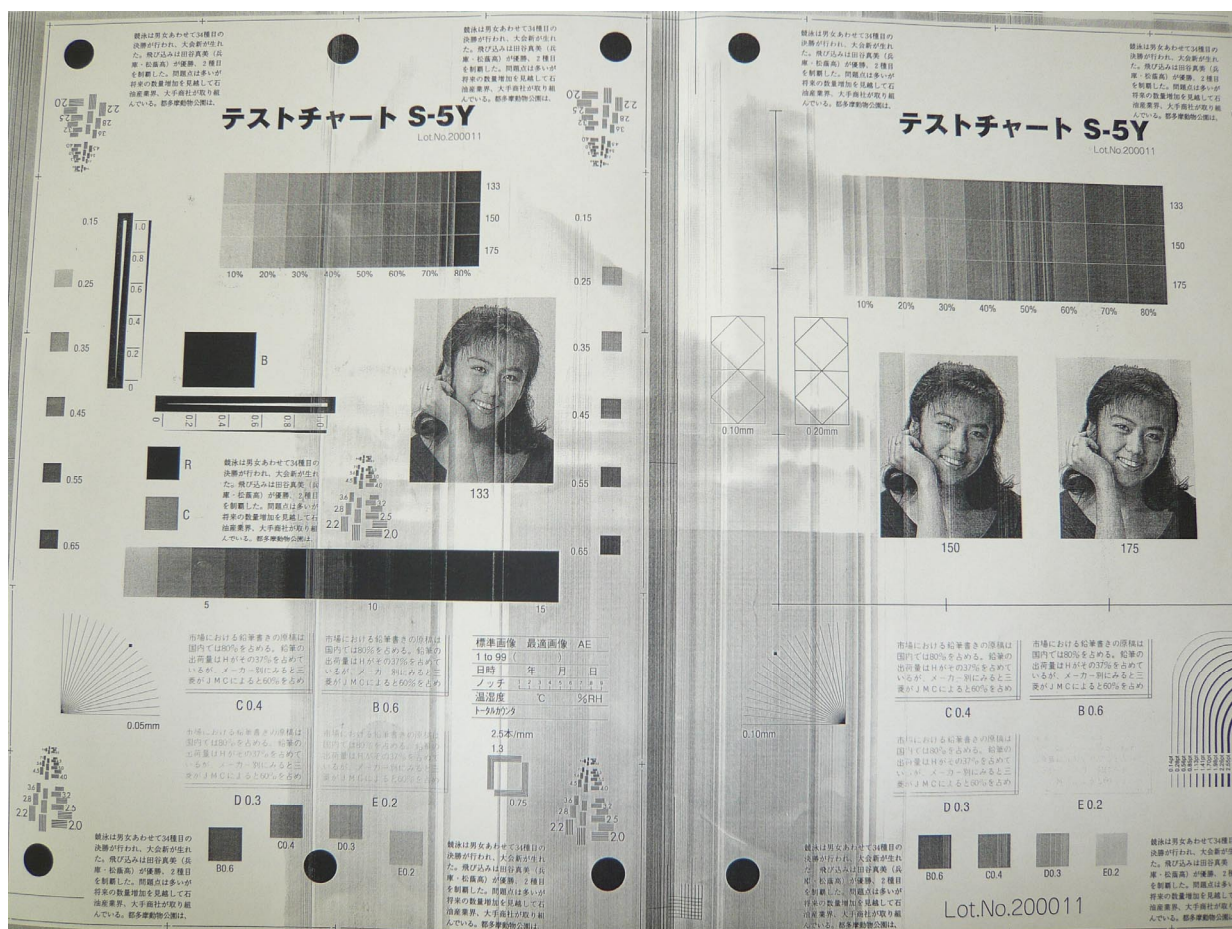
CAUSE

The machine is installed near a window, and direct sunlight gets into the CIS areas (inside the Scanner section).

1. Do the following procedure if the symptom occurs:
 - 1) Close the window blinds in the room, or cover the upper paper exit area with 4 to 6 sheets of paper (A) 840 mm in width.
 - Note:** This is to make sure that no sunlight gets into the scanner unit.
 - 2) Turn the main power switch ON.
 - 3) Make one copy of an original.

2. Keep the window blinds closed so that sunlight does not enter the scanner unit, **or** move the machine to an area away from all windows.

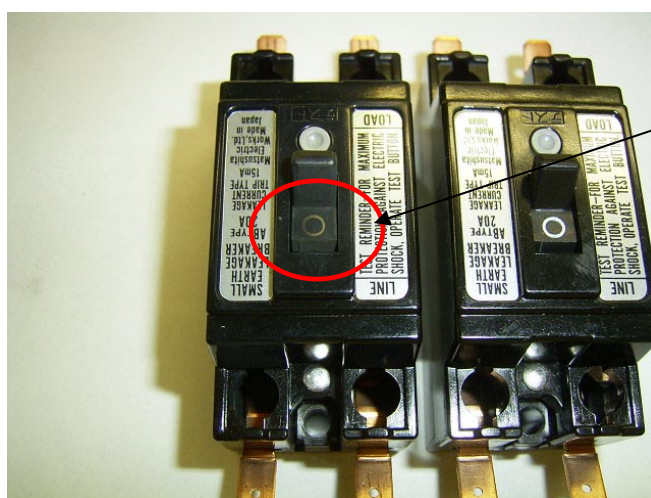
The machine does not power up when the main power switch is turned ON.

Damaged breaker

Normal breaker

CAUSE

The AC power source fluctuates to a level of 360V or higher, which damages the breaker.

Replace the breaker.

Important: Never continue using a damaged breaker. Always replace it. If a damaged breaker is used, spikes in the AC power source can damage the PSU.

Note: To prevent any damage to the breaker from fluctuations in the AC power source, it is recommended to install a constant-voltage transformer (voltage stabilizer).

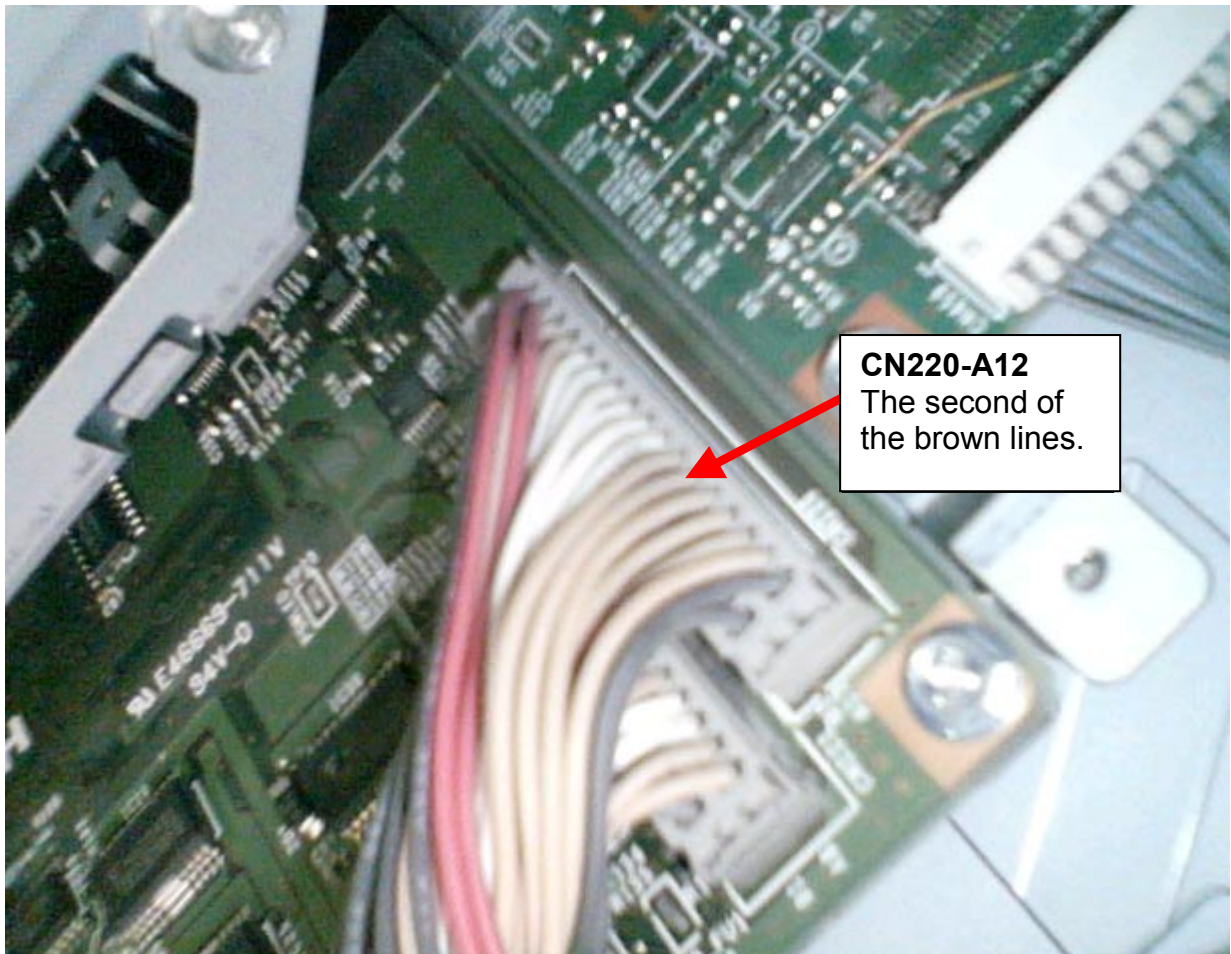
Photo: Before the modification (harness for 2-roll roll feeder).

- Replace the harness with one that supports the N-C1 and N-C2, OR
- Do the modification on the next page. This will make it possible to use the Type A Roll Feeder on the N-C2.

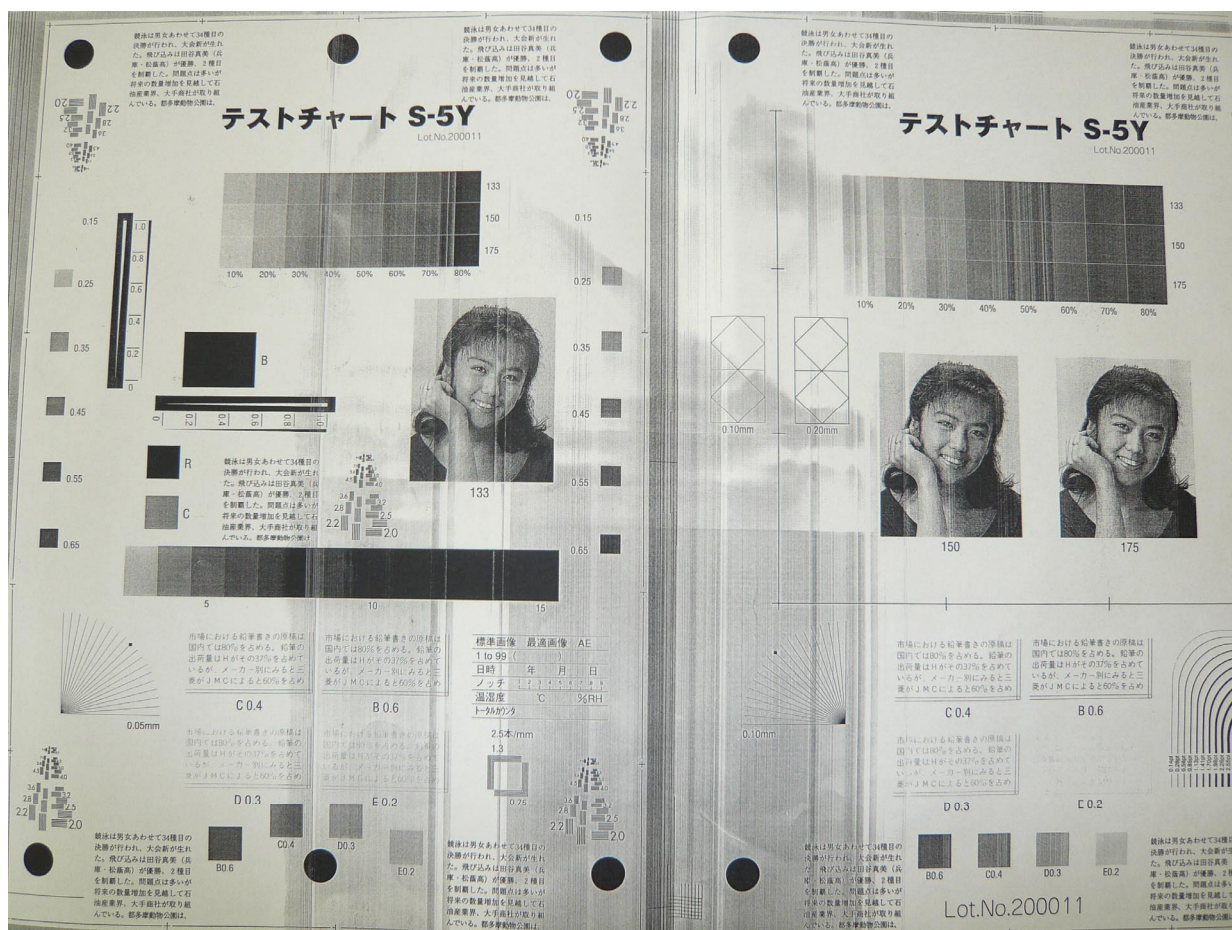
CAUSE

The machine is installed near a window, and the direct sunlight gets into the CIS areas (inside the Scanner section).

1. Do the following procedure if the symptom occurs:
 - 1) Close the window blinds in the room, or cover the upper paper exit area with 4-6 sheets of paper (A) that is 840mm in width.
Note: This is to make sure that no sunlight gets into the Scanner unit.
 - 2) Turn the main power switch ON.
 - 3) Make one copy of an original.

2. Keep the window blinds closed so that sunlight does not enter the Scanner unit, **or** move the machine to an area away from all windows.

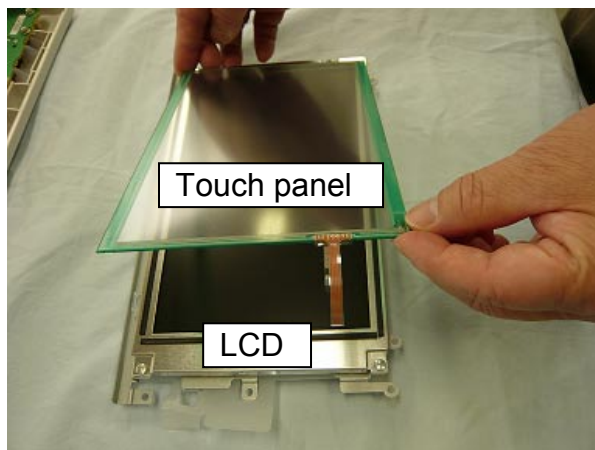
The adhesive that binds electrodes to the touch panel surface contains a polymer that tends to expand under normal office environmental conditions.

In the field: Replace the touch panel (**see the procedure below**).

4. Remove the old touch panel from the LCD.
