Model: N-C3		Date: 10-Dec-10	No.: RD093001
Subject: Service Manual Correction		Prepared by: F.Noguchi	
From: 2nd Overseas Tech Support Sec. 2nd PQM Dept			
Classification:	<input type="checkbox"/> Troubleshooting	<input type="checkbox"/> Part information	<input type="checkbox"/> Action required
	<input type="checkbox"/> Mechanical	<input type="checkbox"/> Electrical	<input checked="" type="checkbox"/> Service manual revision
	<input type="checkbox"/> Paper path	<input type="checkbox"/> Transmit/receive	<input type="checkbox"/> Retrofit information
	<input type="checkbox"/> Product Safety	<input type="checkbox"/> Other ()	<input type="checkbox"/> Tier 2

Revisions made to the N-C3 Field Service Manual (FSM) and Technical Training Package (TTP)

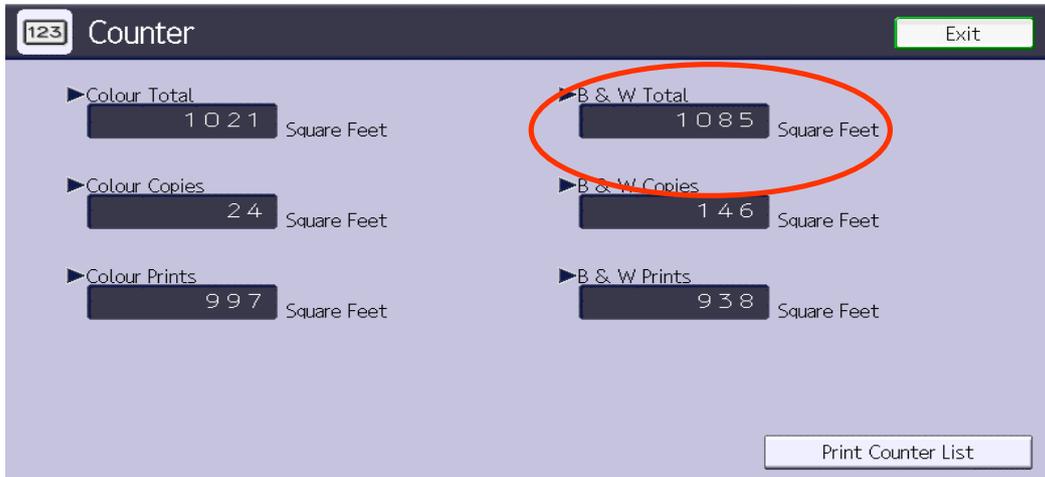
Correct status (before SP5045-002 is falsely rewritten in meters)

B&W Total counter indicates the total print volume of the month as 1085 square feet.

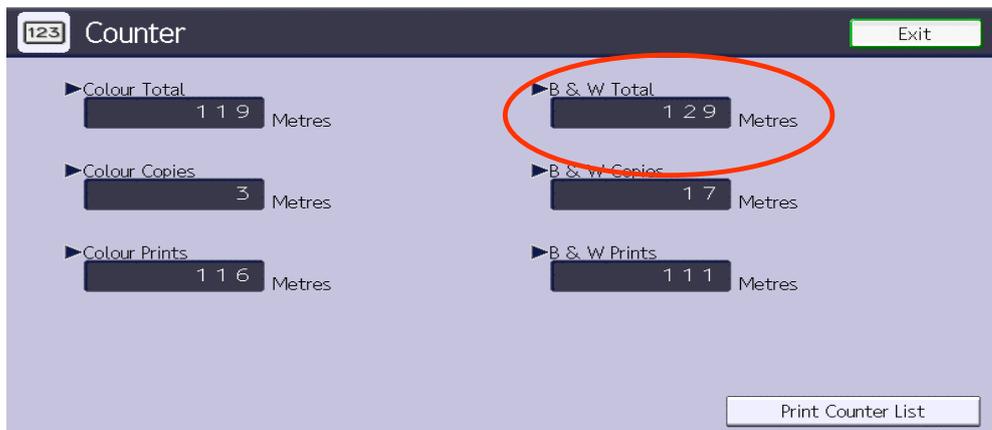
Incorrect status (after SP5045-002 is falsely rewritten in meters)

The B&W Total counter unit indicates the total print volume of the month as 129 meters.

Click worth 956 square feet (1085-129) is not charged to your customer. This is because data sent from @Remote disregards unit of measure.
