Model: Be-C1	Date: 19-Sep-08	No.: RD046002f
--------------	-----------------	----------------

Subject: Firmware Release Note: Engine		Prepared by: F.Noguchi	
From: 2nd PP Tech Service Sect., PP Tech Service Dept.			
Classification:	<input type="checkbox"/> Troubleshooting	<input type="checkbox"/> Part information	<input type="checkbox"/> Action required
	<input type="checkbox"/> Mechanical	<input type="checkbox"/> Electrical	<input type="checkbox"/> Service manual revision
	<input type="checkbox"/> Paper path	<input type="checkbox"/> Transmit/receive	<input type="checkbox"/> Retrofit information
	<input type="checkbox"/> Product Safety	<input checked="" type="checkbox"/> Other (Firmware)	<input checked="" type="checkbox"/> Tier 2

This RTB has been issued to announce the firmware release information for the **Engine**.

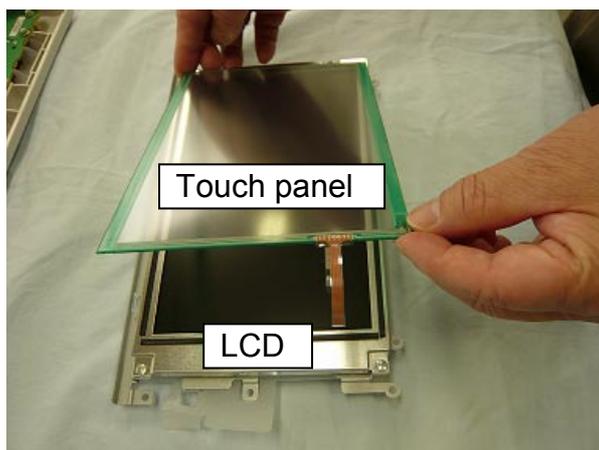
- Remove the old touch panel from the LCD.

In the field: Replace the touch panel (**see the procedure below**).

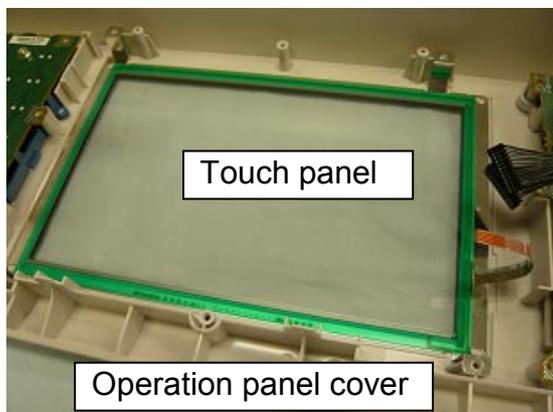
- Place the new touch panel (P/N **B2231484**) on the operation panel cover.
Important: Only replace the touch panel. Do not replace the LCD.

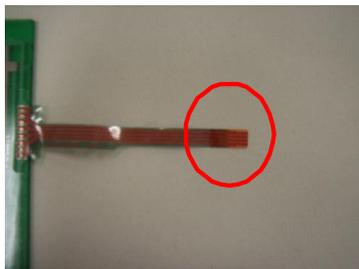
The adhesive that binds electrodes to the touch panel surface contains a polymer that tends to expand under normal office environmental conditions.

Old parts:
The tip of the electrode is **brown**.

Service parts: The adhesive was changed to one that will not expand under conditions of standard office environments.

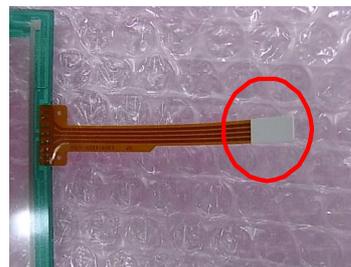
New parts:
The tip of the electrode is **white**.
