Model: V-C2/Be-C1.5	Date: 15-Nov-07	No.: RD014013a
---------------------	-----------------	----------------

Subject: Firmware Release Note: PS3 Font		Prepared by: T.Toriumi	
From: 1st Tech Service Sect., MFP/Printer Tech Service Dept.			
Classification:	<input type="checkbox"/> Troubleshooting	<input type="checkbox"/> Part information	<input type="checkbox"/> Action required
	<input type="checkbox"/> Mechanical	<input type="checkbox"/> Electrical	<input type="checkbox"/> Service manual revision
	<input type="checkbox"/> Paper path	<input type="checkbox"/> Transmit/receive	<input type="checkbox"/> Retrofit information
	<input type="checkbox"/> Product Safety	<input checked="" type="checkbox"/> Other (Firmware)	<input checked="" type="checkbox"/> Tier 2

Model: Mo-C1,Be-C1,Be-C1.5,N-C3		Date: 1-Aug-14	No.: RD154015
Subject: Accounting counter problem on @Remote embedded machines		Prepared by: Y.Kurohashi	
From: 2nd Tech Service sect, PP Tech Service Dept.			
Classification:	<input type="checkbox"/> Troubleshooting <input type="checkbox"/> Mechanical <input type="checkbox"/> Paper path <input type="checkbox"/> Product Safety	<input type="checkbox"/> Part information <input type="chec

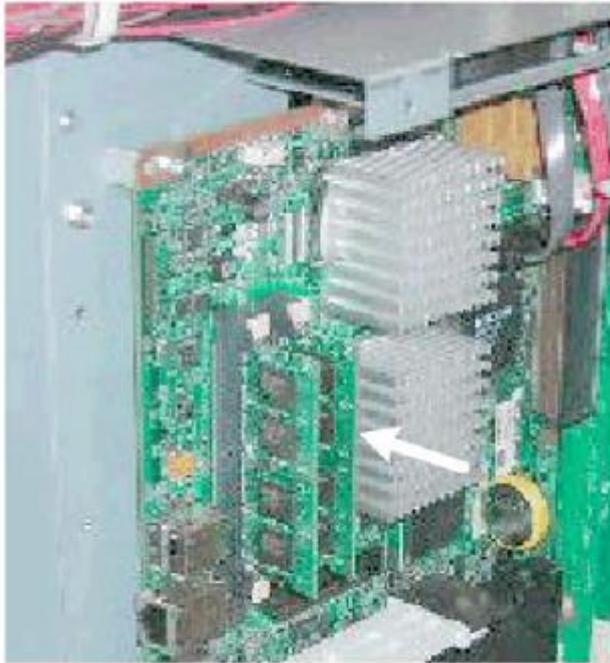
d397i002

6. Remove the controller box cover.

7. Insert the memory unit in the open slot on the controller board.

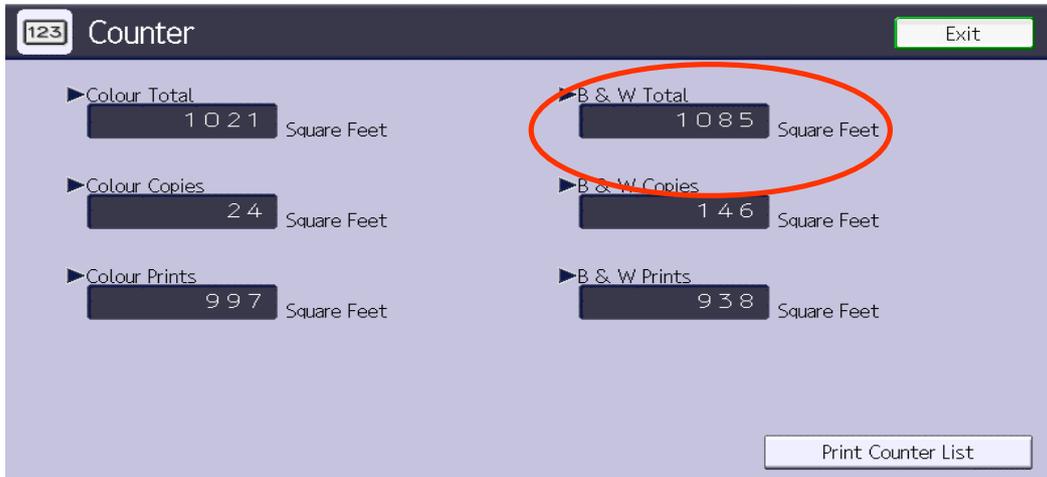
Correct status (before SP5045-002 is falsely rewritten in meters)

B&W Total counter indicates the total print volume of the month as 1085 square feet.

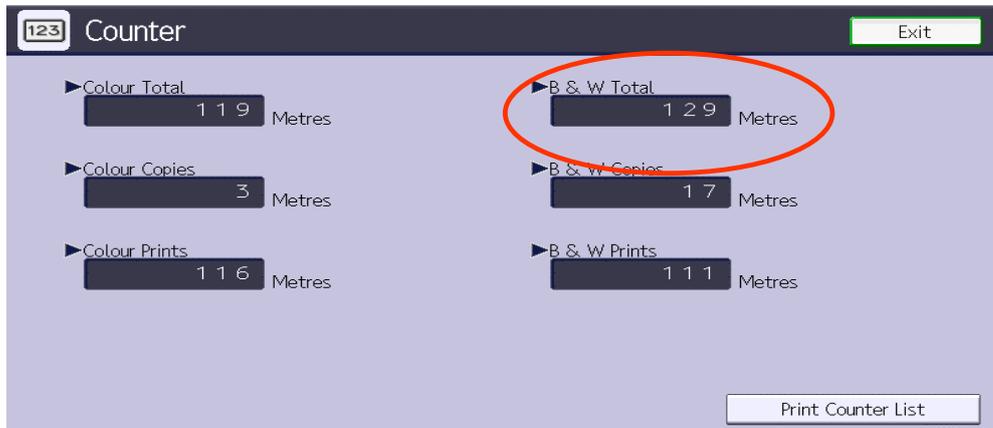
Incorrect status (after SP5045-002 is falsely rewritten in meters)

The B&W Total counter unit indicates the total print volume of the month as 129 meters.

Click worth 956 square feet (1085-129) is not charged to your customer. This is because data sent from @Remote disregards unit of measure.
