Model: <b>Be-C2</b>	Date: 01-Sep-15	No.: RD211005
---------------------	-----------------	---------------

Subject: Firmware Release Note: Web Uapl		Prepared by: Y. Kurohashi	
From: 1st PP Tech Service Sect., PP Tech Service Dept.			
Classification:	<input type="checkbox"/> Troubleshooting <input type="checkbox"/> Mechanical <input type="checkbox"/> Paper path <input type="checkbox"/> Product Safety	<input type="checkbox"/> Part information <input type="checkbox"/> Electrical <input type="checkbox"/> Transmit/receive <input checked="" type="checkbox"/> Other (Firmware)	<input type="checkbox"/> Action required <input type="checkbox"/> Service manual revision <input type="checkbox"/> Retrofit information <input checked="" type="checkbox"/> Tier 2

This RTB has been issued to announce the firmware release information for the **Web Uapl**.

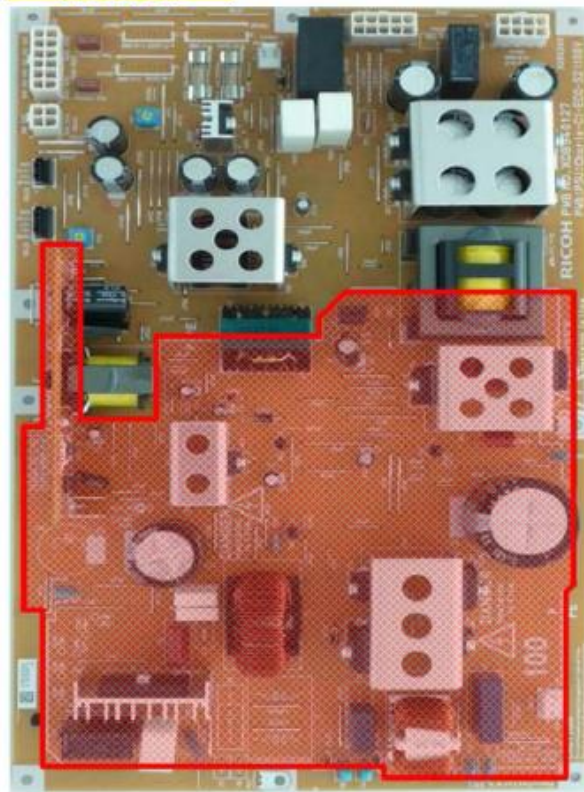
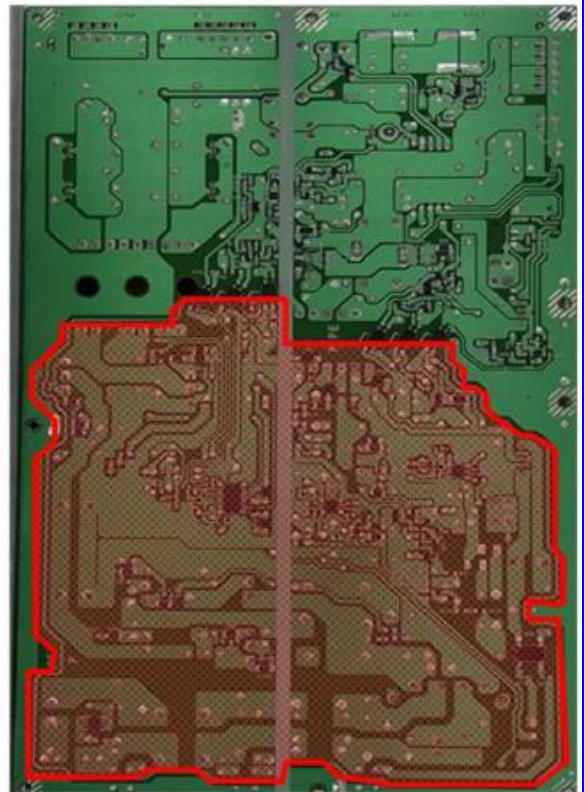
AZ240226

**NEVER touch** the areas outlined in red in the photos below to prevent electric shock caused by residual charge.

Residual charge of about 100V-400V remains in the AC circuits on the PSU board for several months even when the board has been removed from the machine after turning off the machine power and unplugging the power cord.

The procedure to discharge residual charge from the machine by unplugging the power cord from the AC wall outlet and pressing the main power switch works only for the DC circuits on this board. Residual charge remains in the AC circuits.

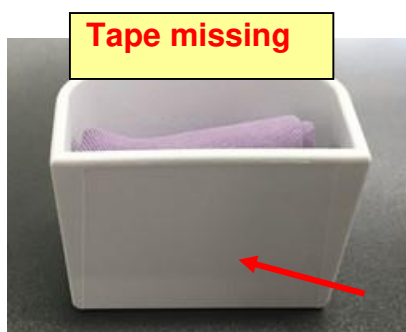
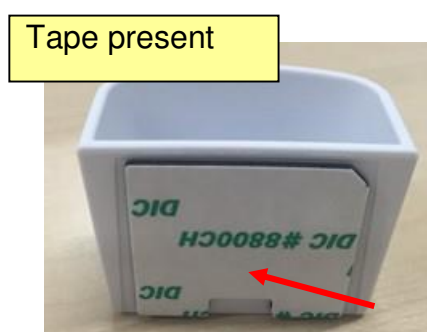
HOLDER:GLASS:CLEANER:ASS'Y     P/N: D1491317

The double-sided tape is missing from the following machine accessory.

Order a new assembly using the P/N mentioned above and replace it.

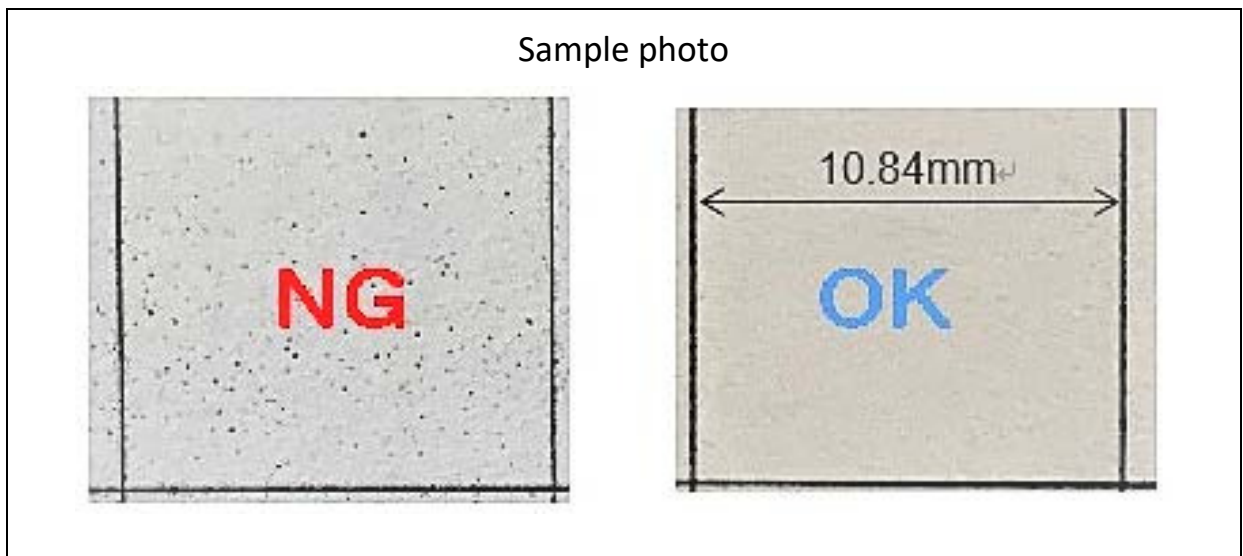
Dirty spots appear on a white background in rare cases due to the following cause.

Large toner particles were mixed in with the smaller (normal-sized) particles due to temporary issues with the toner manufacturing process.

If the symptom occurs, perform troubleshooting according to the page 929 of the Field Service Manual.

Nevertheless, if the problem persists, replace the toner cartridge (see **PROCEDURE** below).
