Model: Be-C2LT	Date: 11-Mar-16	No.: RD212006
-----------------------	-----------------	---------------

Subject: Firmware Release Note: Web Uapl		Prepared by: Y. Kurohashi	
From: 1st PP Tech Service Sect., PP Tech Service Dept.			
Classification:	<input type="checkbox"/> Troubleshooting	<input type="checkbox"/> Part information	<input type="checkbox"/> Action required
	<input type="checkbox"/> Mechanical	<input type="checkbox"/> Electrical	<input type="checkbox"/> Service manual revision
	<input type="checkbox"/> Paper path	<input type="checkbox"/> Transmit/receive	<input type="checkbox"/> Retrofit information
	<input type="checkbox"/> Product Safety	<input checked="" type="checkbox"/> Other (Firmware)	<input checked="" type="checkbox"/> Tier 2

Model: Be-C2LT		Date: 19-Jul-18	No.: RD212009
Subject: Image missing during reduced copying with Syncro Cut		Prepared by: Kanji Nakano	
From: PP CF/WF Sec., CIP Product Quality Management Dept			
Classification:	<input checked="" type="checkbox"/> Troubleshooting	<input type="checkbox"/> Part information	<input type="checkbox"/> Action required
	<input type="checkbox"/> Mechanical	<input type="checkbox"/> Electrical	<input type="checkbox"/>

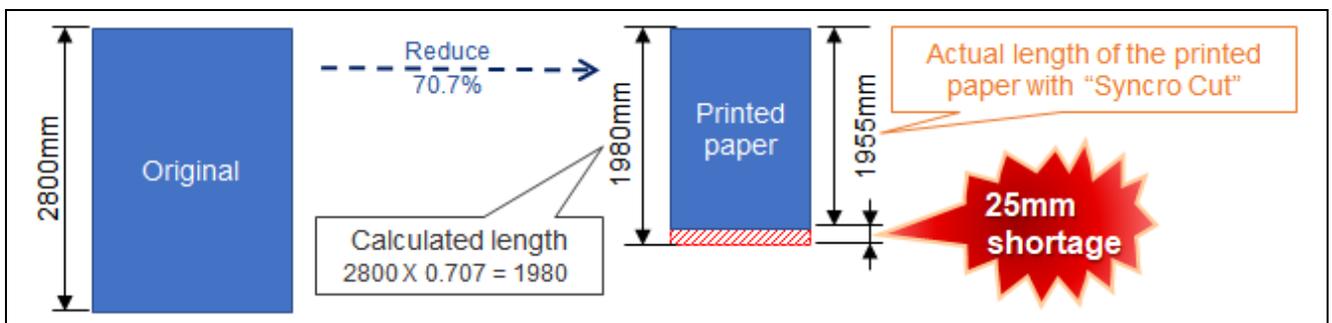
The image at the trailing edge is missing and the paper is shortened when printing at a 70.7% reduction with Syncro Cut.

- <Note>
- No problem occurs with "Variable Cut".
 - The system scans whole image normally.

Malfunction of the engine software.

The Engine firmware was modified as follows (Applied from April 2018 production).

Program No. D2125280D
Version **1.03:00**

Update to the modified firmware and then do the PROCEDURE below.

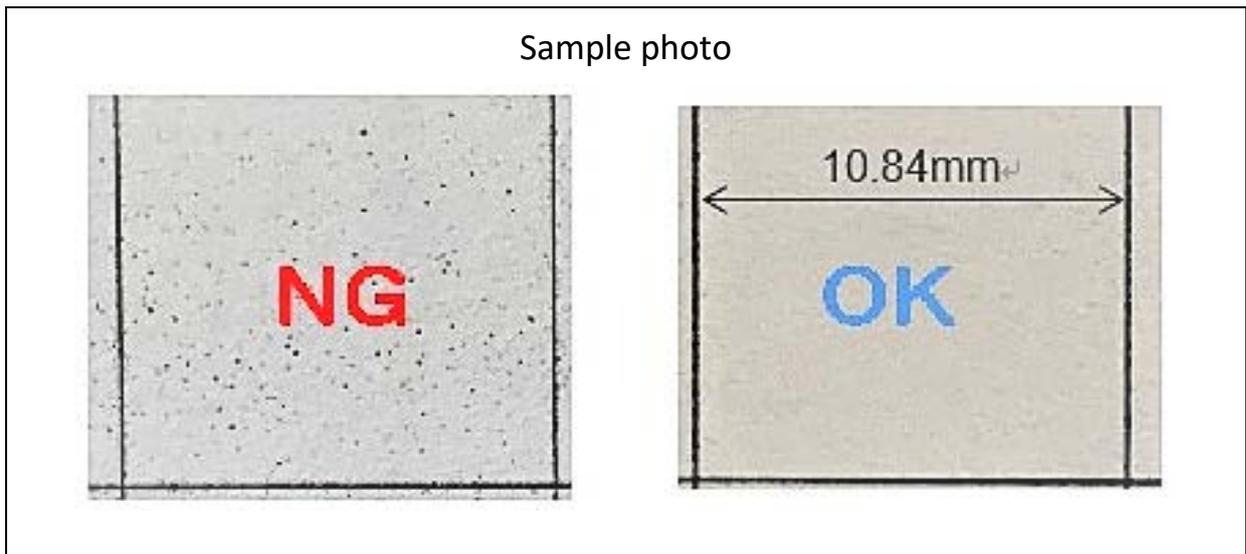
Dirty spots appear on a white background in rare cases due to the following cause.

Large toner particles were mixed in with the smaller (normal-sized) particles due to temporary issues with the toner manufacturing process.

If the symptom occurs, perform troubleshooting according to the page 483 of the Field Service Manual.

Nevertheless, if the problem persists, replace the toner cartridge (see **PROCEDURE** below).
