SUBJECT: Additional information to TD check

FROM: Copier Technical Support Section

PDC-1E

SUBJECT: Discolored spots on color background

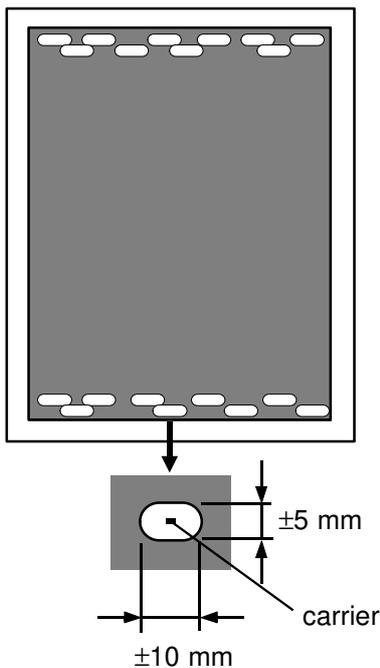
[Symptom]

- After the self check operation both in the morning and around noon, discolored spots are observed at the leading and the trailing parts of the copy image for about initial ten copies. After making ten copies, these spots will gradually disappear.
- When you touch these spots on the copy with your fingers, you can feel the carrier. Due to carrier particles, toner around the carrier particle can not be transferred from the OPC drum to the copy paper, resulting in discolored spots.

[Cause]

Due to a software error of the sequence control ROM, the "OFF" timing of development bias was a little early compared to that of drum charge during the self check run. This causes carrier to drop from the development unit onto the mylar of the cleaning unit.

To prevent discolored spots due to the carrier, install the following two ROM's as a set:

- One new ROM on the sequence control board (512K): P/N A0925507D (Check sum: E1E8)
- One new ROM on the process control board (256K): P/N A0925509C (Check sum: DF8F)

- The black plastic parts located just under the rear half of each development unit.
2. Clean each cleaning unit.
3. Replace two ROM's with the following new ones on both the sequence control board and the process control board.

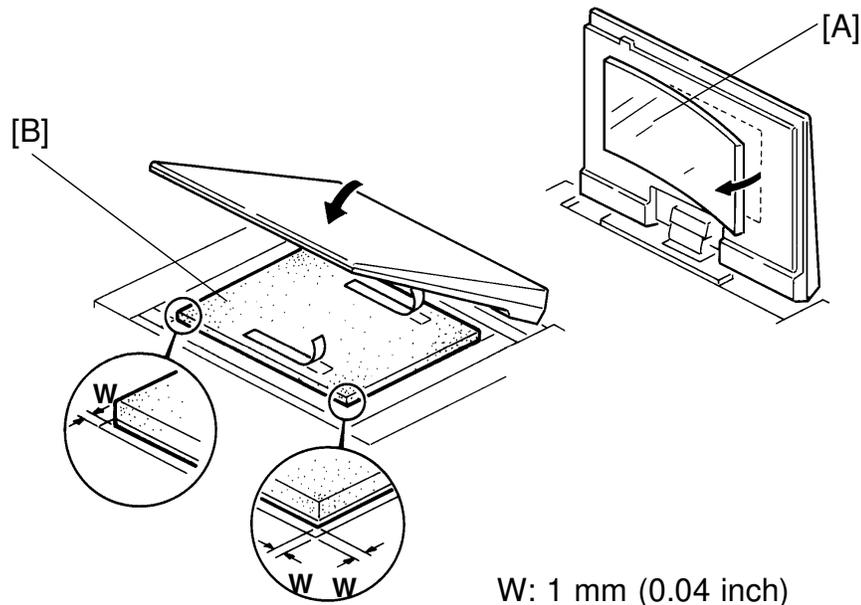
3-3. Modification procedure for the field machine

We do not recommend that you modify the editor board when it is not on the copier, it is very difficult to adjust the position for setting the pressure pad. You might have matching problems when the editor board is docked to the copier (e.g.. the pressure pad falls on the scale or the space between the edge of the pressure pad and the scale is much larger).

1. Remove the pressure pad [A] from the editor board.

NOTE: As some adhesive tape or sponge might remain on the editor board, make sure to check and remove everything.

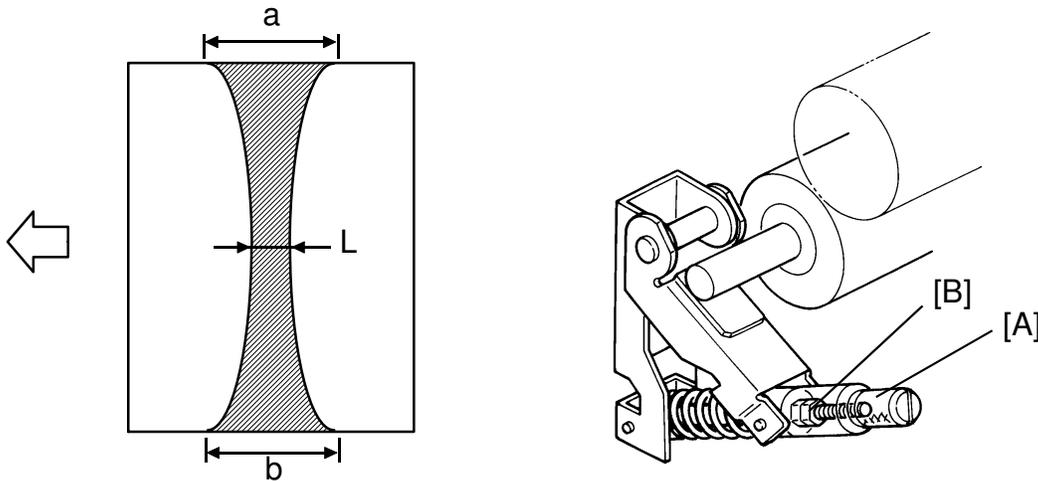
Adjustment Standard:

- 7.6 ± 0.4 mm (center of nip band width; L)
- Less than 0.2 mm (difference between a and b)

1. Prepare Folex OHP sheet Type 100.
2. Place a white paper (A3/11" x 17") on the exposure glass and perform free run (SP1) for 3 minutes.
3. As soon as the print key becomes green, pull out the transfer belt unit and open the fusing exit cover.

4. Insert an OHP sheet into the center of the fusing unit by turning the fusing knob manually and wait 15 seconds to make the nip band on the OHP sheet.

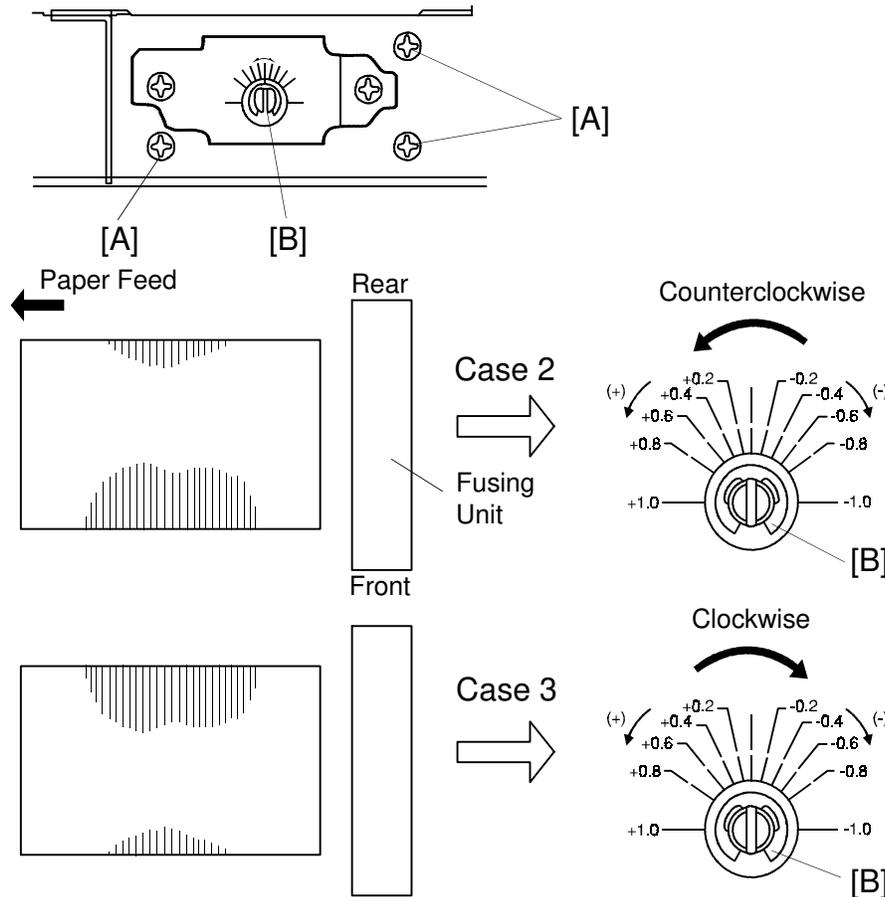
Case 1 The "Mimizu" pattern toward the front of the fusing unit is almost same size as that toward the rear.

- 1) Decrease the data of SPD#720 (Main motor speed) by 1.
- 2) Make 5 copies continuously.
- 3) Repeat step 1 until the "Mimizu" pattern on the copy image **just disappears**.

- 1) Loosen the screws [A].
- 2) Turn the adjustment cam [B] counterclockwise to equalize the "Mimizu" patterns toward the front and the rear.
- 3) Decrease the data of SPD#720 (Main Motor Speed) by 1.
- 4) Make 5 copies continuously.
- 5) Repeat step 3 until the "Mimizu" pattern on the copy image **just disappears**.

- Case 3** The "Mimizu" pattern toward the rear of the fusing unit is bigger than the "Mimizu" pattern toward the front.
- 1) Loosen the screws [A].
 - 2) Turn the adjustment cam [B] clockwise to equalize the "Mimizu" patterns toward the front and the rear.
 - 3) Decrease the data of SPD#720 (Main Motor Speed) by 1.
 - 4) Make 5 copies continuously.
 - 5) Repeat step 3 until the "Mimizu" patterns on the copy image **just disappears**.
