Model: Katana-P1 (Bellini-P1)	Date: 09-Feb-09	No.: RM002001g
-------------------------------	-----------------	----------------

Subject: Firmware Release Note: Engine		Prepared by: Y. Tanimoto	
From: 1st PP Tech Service Sect., PP Tech Service Dept.			
Classification:	<input type="checkbox"/> Troubleshooting <input type="checkbox"/> Mechanical <input type="checkbox"/> Paper path <input type="checkbox"/> Product Safety	<input type="checkbox"/> Part information <input type="checkbox"/> Electrical <input type="checkbox"/> Transmit/receive <input checked="" type="checkbox"/> Other ()	<input type="checkbox"/> Action required <input type="checkbox"/> Service manual revision <input type="checkbox"/> Retrofit information <input type="checkbox"/> Tier 2

This RTB has been issued to announce the firmware release information for the **Engine**.

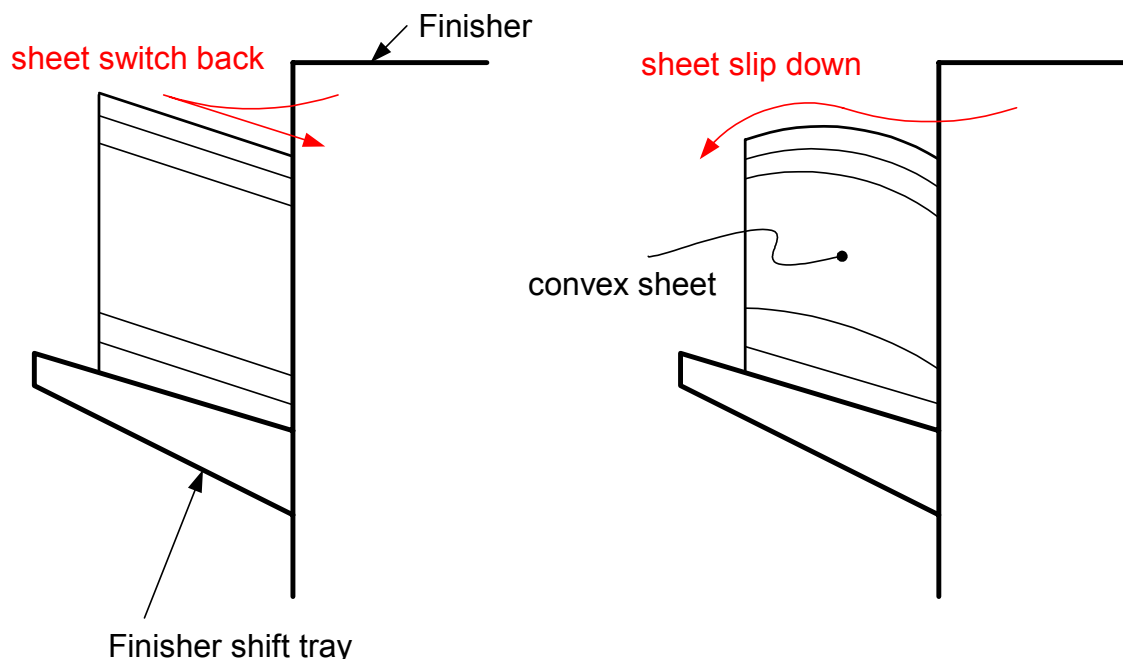
The exited sheets are switched back on the Finisher shift tray, which is at an angle. However, when the sheets have convex curl and are stacked in a large amount, the slope becomes flat at the top of the stack. The flat stack stops the exited sheets from switching back and causes them to slip over due to their momentum.

Set the de-curl roller unit upside down and adjust the value in the User Tools. Refer to the service manual and the operation manuals.

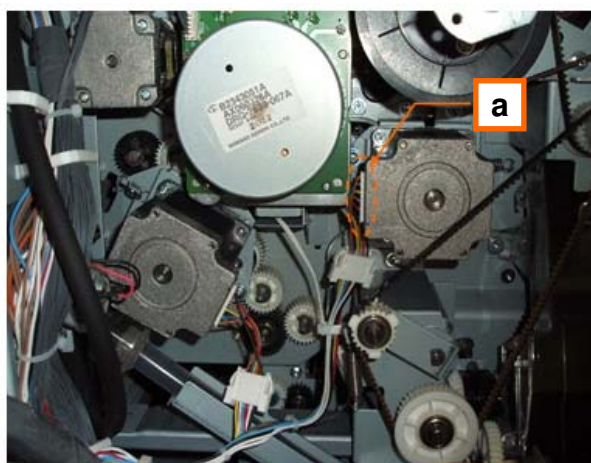
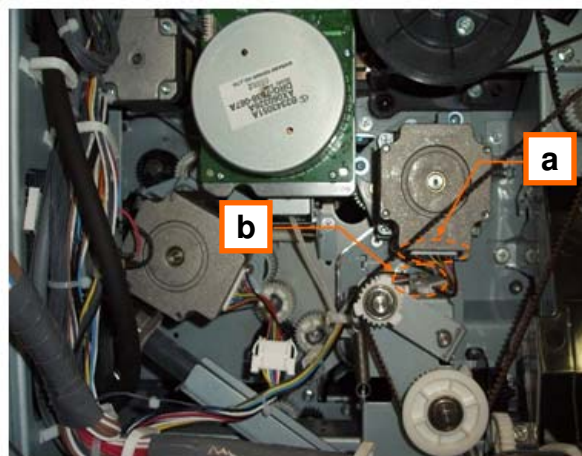
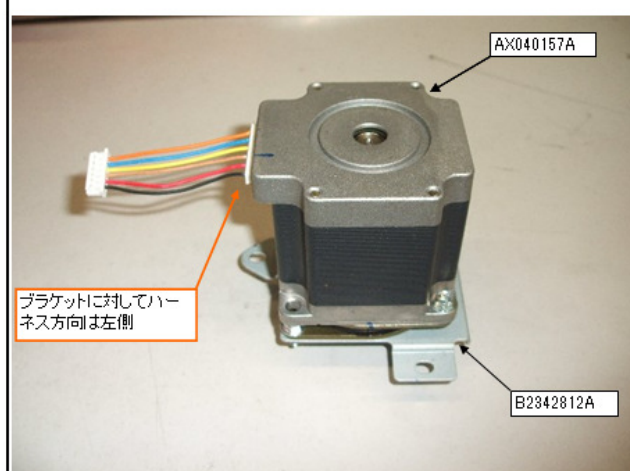
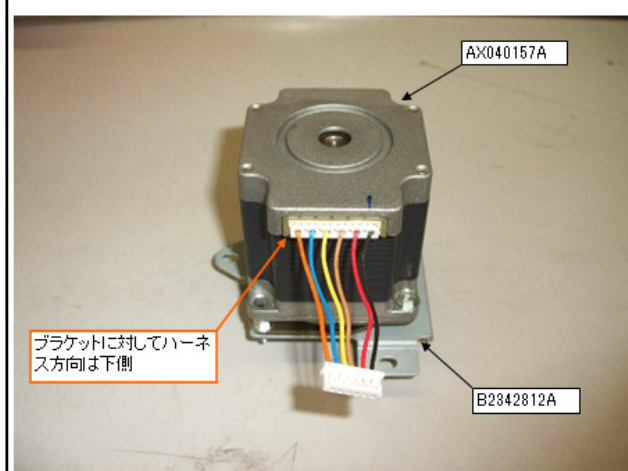
Change: a) Orientation of the DC Stepper Motor; 90 degrees counterclockwise
 b) Addition of a clamp (in accordance with the change in the motor orientation)

Reason: To prevent possible damage to the registration motor harnesses

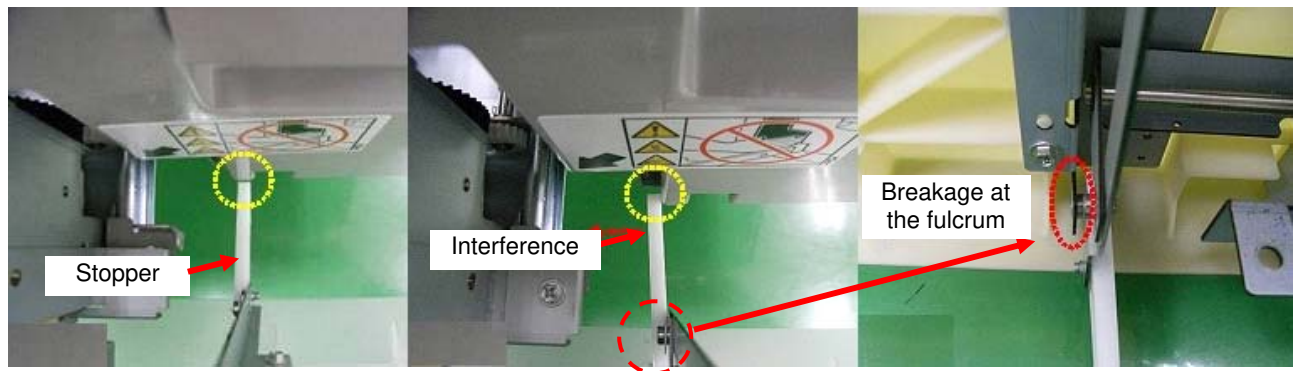
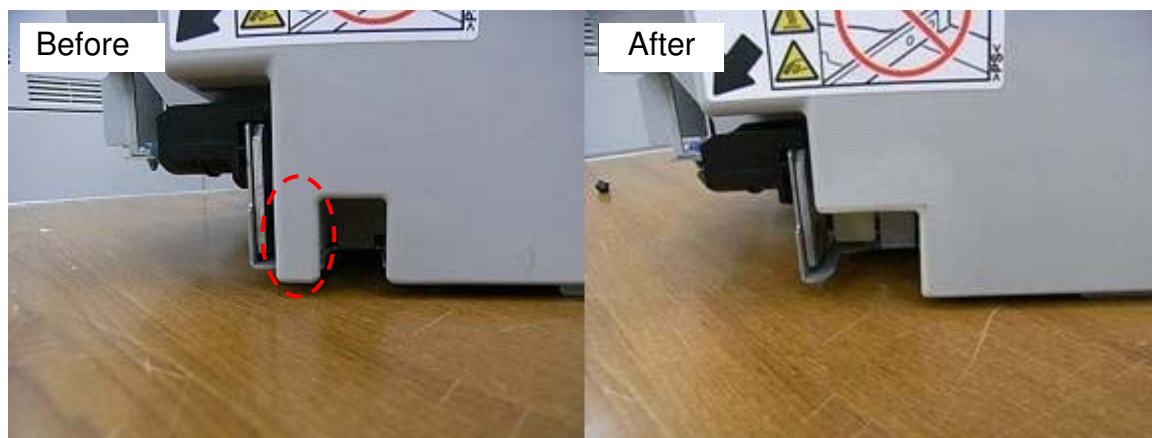
Reason: When closing the tray, the tip of the white plastic stopper (p/n: D0596702) could interfere with the tandem ray inner cover and damage the fulcrum of the stopper, disabling proper set of the tray.

The bottom corner of the INNER COVER: TANDEM LCT (indicated with a red circle in the photo below) was cut out to prevent the stopper from interfering.

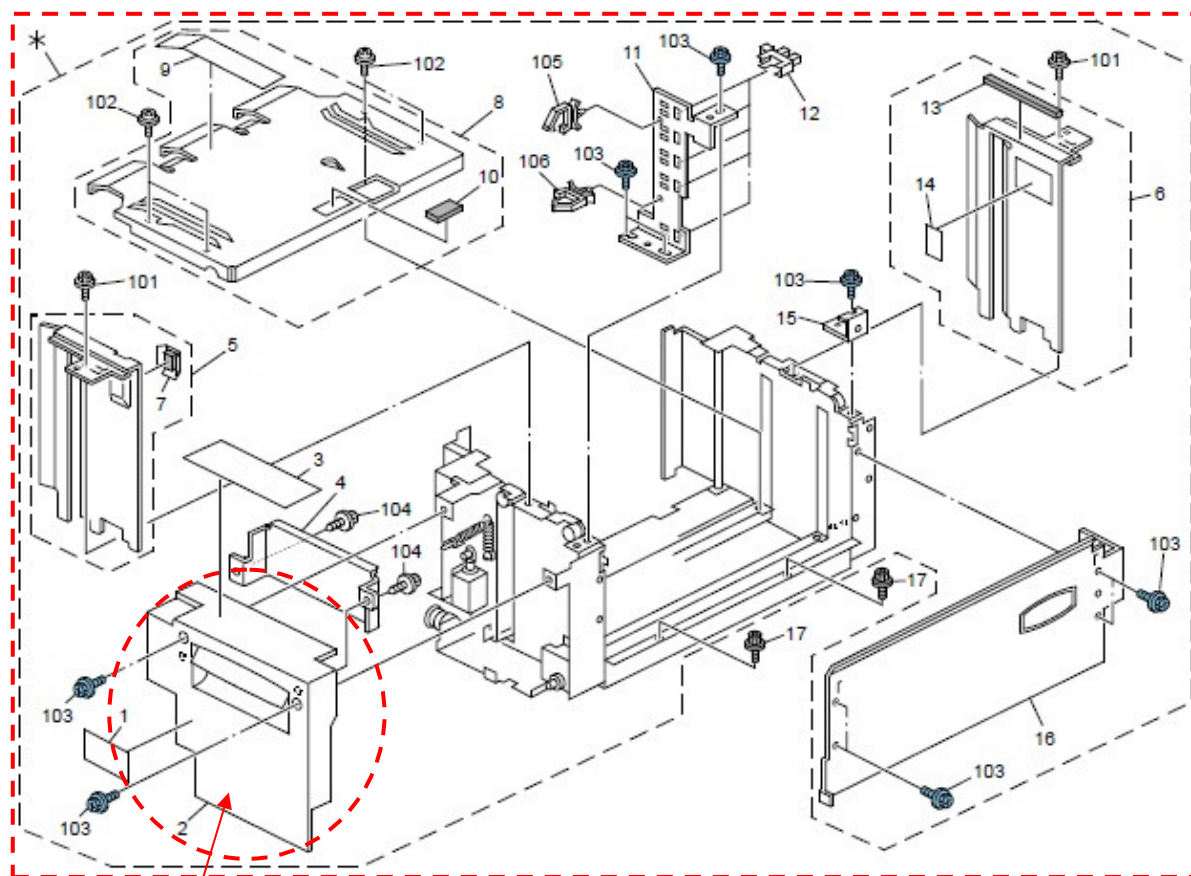
12. Tandem Tray 2 (M002/M003/M004)

D0596698 → **D0596712** (Change)
INNER COVER: TANDEM LCT

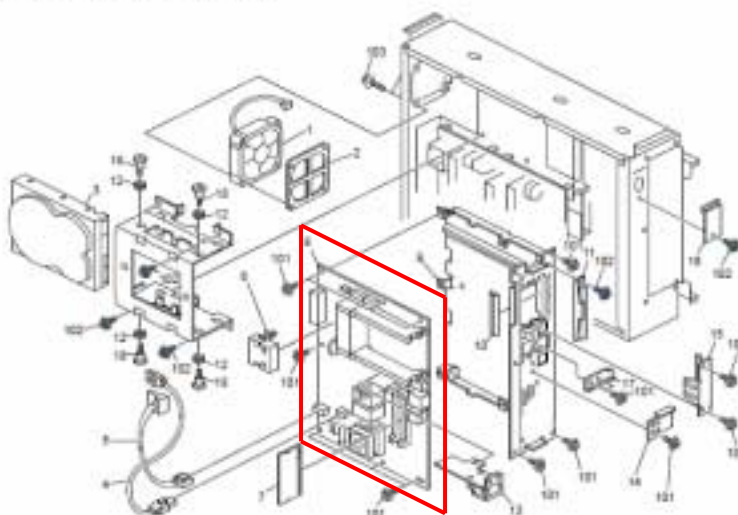
62.Electrical Section 4 (M002/M003/M004)

Reason: The PCB Controller Board was modified to resolve the failure in activating the printer.

Use M0025507/M0035507/M0045507 for GW controllers assigned with the Mac address 00:00:74:XX:XX:XX.
