Model: B-C4	Date: 04-Feb-09	No.: RD059002h
-------------	-----------------	----------------

Subject: Firmware Release Note: Printer		Prepared by: J.Ohno	
From: 1st PP Tech Service Sect., PP Tech Service Dept.			
Classification:	<input type="checkbox"/> Troubleshooting <input type="checkbox"/> Mechanical <input type="checkbox"/> Paper path <input type="checkbox"/> Product Safety	<input type="checkbox"/> Part information <input type="checkbox"/> Electrical <input type="checkbox"/> Transmit/receive <input checked="" type="checkbox"/> Other (     )	<input type="checkbox"/> Action required <input type="checkbox"/> Service manual revision <input type="checkbox"/> Retrofit information <input type="checkbox"/> Tier 2

This RTB has been issued to announce the firmware release information for the **Printer**.

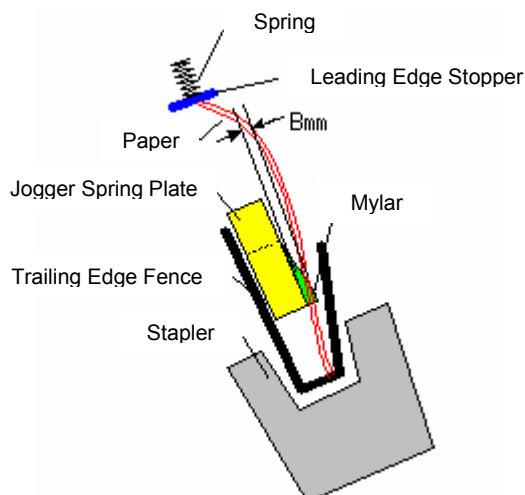
Misaligned stapling is caused by the shifting of the stacked paper when the stapler clinches. A portion of the trailing edge of the stack of paper is caught by the Jogger Spring Plate as it is bent when jogged by the Spring, which causes the shift.

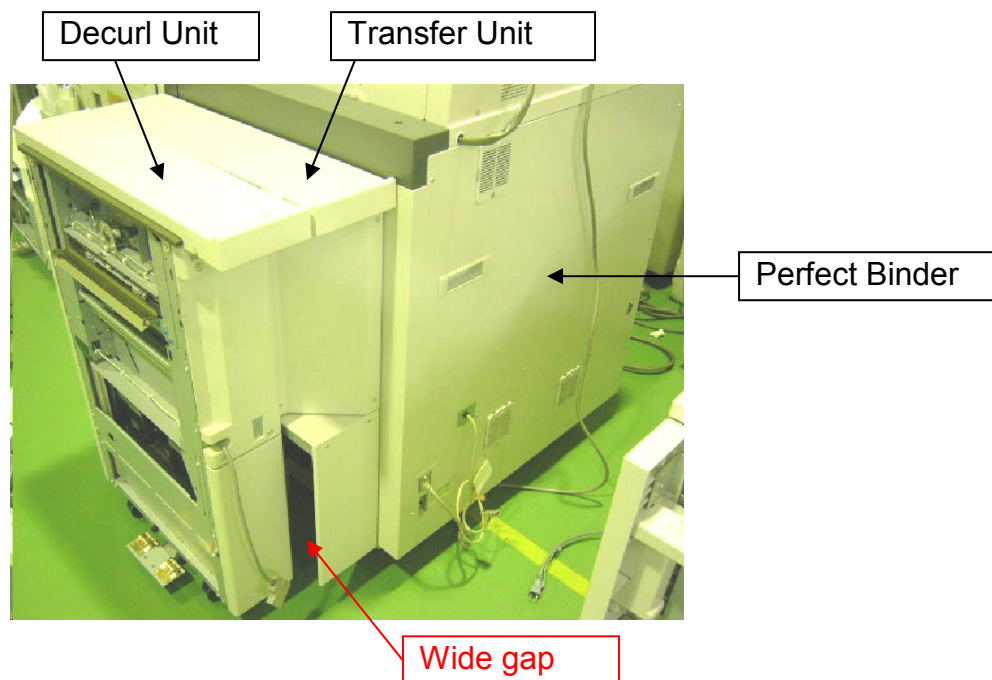
When connecting the Perfect Binder GB5000 and the Decurl Unit DU5000, the transfer unit of the Perfect Binder GB5000 makes a wide gap.  
 This is not safe for customers because their hands could mistakenly get inside the gap.

This is only seen when connecting both the Perfect Binder GB5000 and the Decurl Unit DU5000

Design modification. Cover:Rear Lower (D3914506) will be changed to close the gap. Later we will inform you of details.

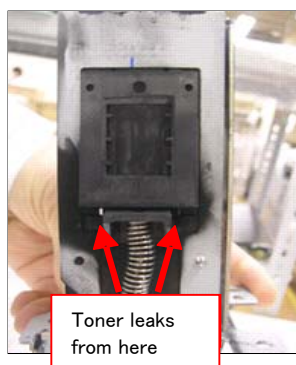
A) Gap in the toner pump shutter (\*)

Charge leak originating in toner leaks from the toner pump.

\*Deflection of the spring causes the shutter to slant, leaving a gap causing toner leakage

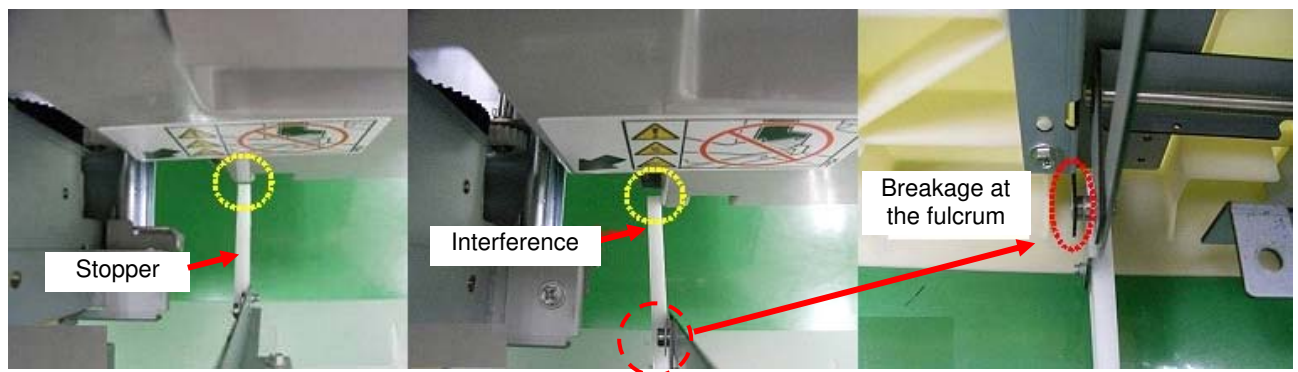
**Reason:** When closing the tray, the tip of the white plastic stopper (p/n: D0596702) could interfere with the tandem ray inner cover and damage the fulcrum of the stopper, disabling proper setting of the tray.
