Model: BR-C1 (D179)		Date: 20-Aug-13	No.: RD179001
Subject: FSM Correction (Notes on main power switch status check / ITB unit removal procedure)		Prepared by: Kazuya Tsutsui	
From: 1st PP Tech Service Sec., PP Tech Service Dept.,			
Classification:	<input type="checkbox"/> Troubleshooting <input type="checkbox"/> Mechanical <input type="checkbox"/> Paper path <input type="checkbox"/> Product Safety	<input type="checkbox"/> Part information <input type="checkbox"/> Electrical <input type="checkbox"/> Transmit/receive <input type="checkbox"/> Other ()	<input type="checkbox"/> Action required <input checked="" type="checkbox"/> Service manual revision <input type="checkbox"/> Retrofit information <input type="checkbox"/> Tier 2

Subject: Firmware Release Note: NetworkDocBox		Prepared by: J.Ohno	
From: 1st PP Tech Service Sect., PP Tech Service Dept.			
Classification:	<input type="checkbox"/> Troubleshooting <input type="checkbox"/> Mechanical <input type="checkbox"/> Paper path <input type="checkbox"/> Product Safety	<input type="checkbox"/> Part information <input type="checkbox"/> Electrical <input type="checkbox"/> Transmit/receive <input checked="" type="checkbox"/> Other (Firmw

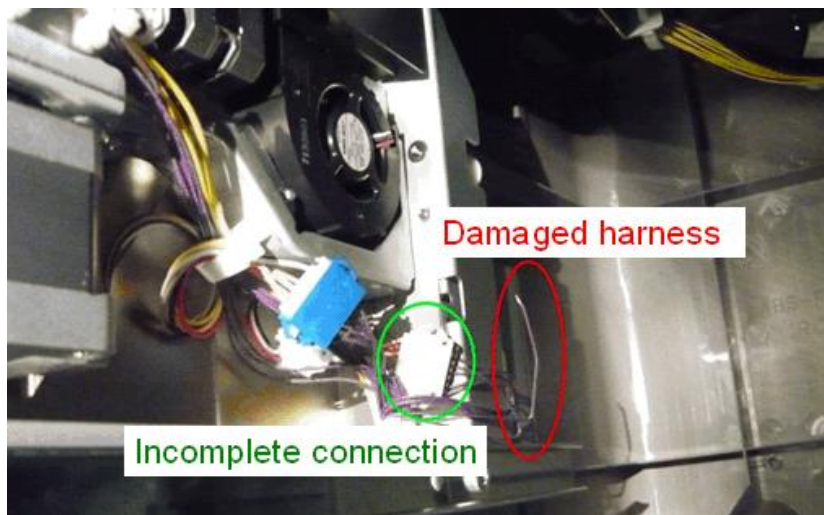
The bundle of purple harnesses behind the drag roller unit, which are supposed to be to the left of the slide rail in the open space, are falsely positioned above the slide rail. The harnesses are caught when pulling out and pushing in the stapler unit, resulting in loose connection or damage.

Photo showing the purple harnesses positioned incorrectly above the slide rail, instead of to the left of the slide rail in the open space.

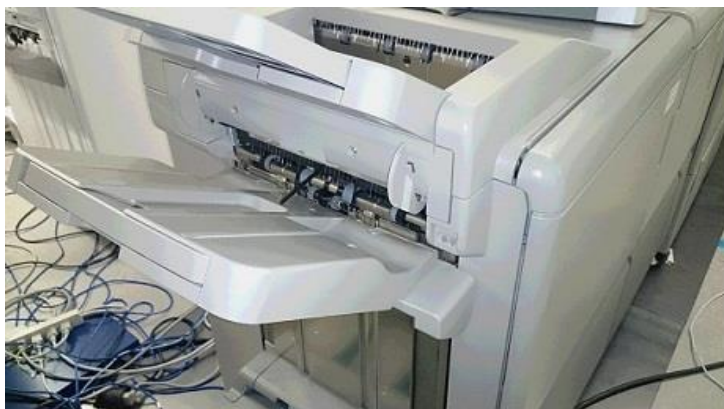
This slight arch prevents the cam from stopping at its home position and causes the TE (trailing edge) press-down levers and the cam to contact in the wrong position.

As a result, the TE press-down levers do not function properly and the sheets are fed on top of the levers instead of below the levers, generating Jam122 followed by SC720-75.

- If the unit is of June production, make another visit and set DIP SW2-1 (far left) on the main board to "OFF" and replace the Drag Roller Unit.
(Work time: approx 40 min)

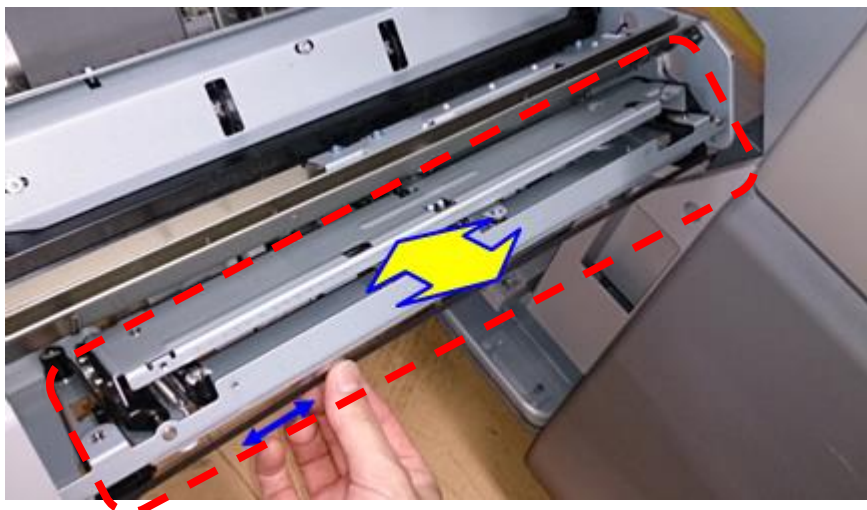
The corner stapler unit does not move properly and/or smoothly.

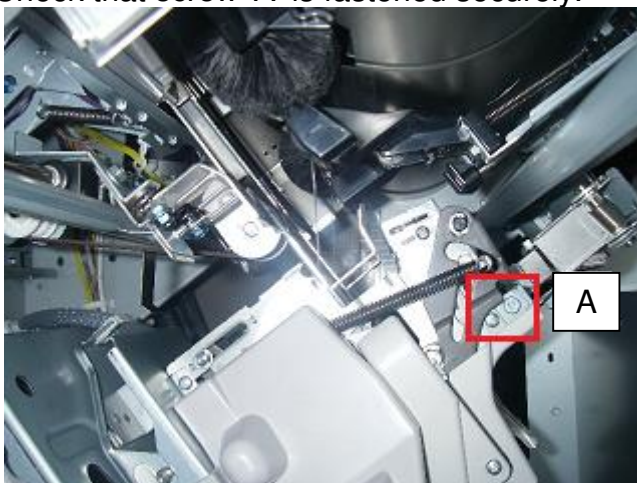
2. Check that screw 'A' is fastened securely.

If the screw is loose, or lost, **tighten it with an M3 x 6 screw.**

Note: Screws originally attached are fastened with an anti-loosening agent, **so change the screw to M3 x 6 and tighten it** when it is loosened, since the fastening force has decreased.

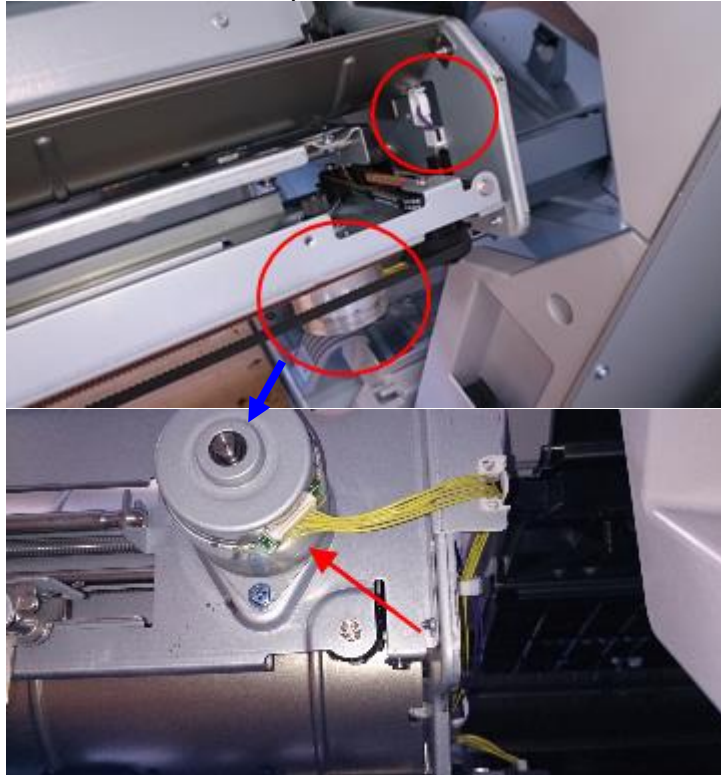
Incomplete connection or damaged cables will cause Jam126 and SC720-35.

1. Check for secure connection of the cables connected to the corner stapler stack unit motor and the home position sensor.

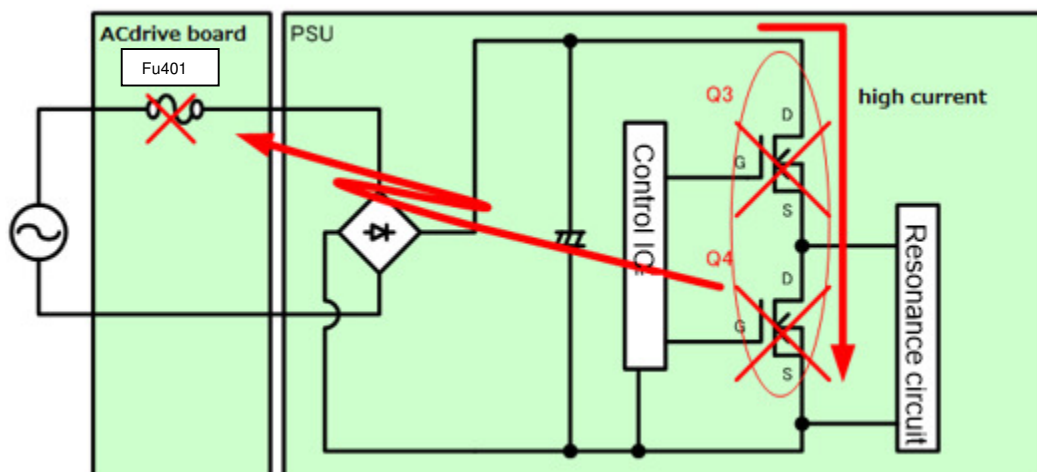
Machine power does not turn on as a result of a damaged PSU-A (PSU-ECO) and a blown fuse FU401 on the AC drive board.

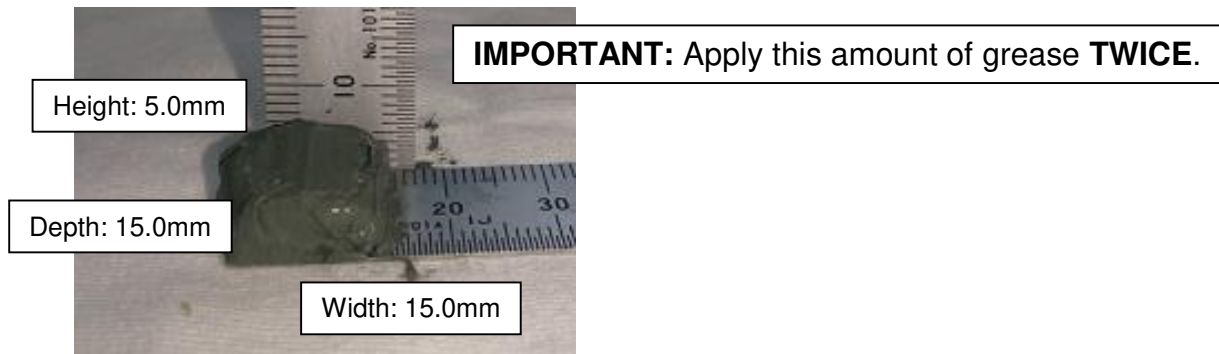
If the teeth of the gear are severely worn, replace with a new gear (p/n: AB014285). Similarly, clean with a dry cloth before applying grease when installing the new gear.

Rotate the gears as you apply the grease so that the grease covers the entire surface of the gears thoroughly and evenly.

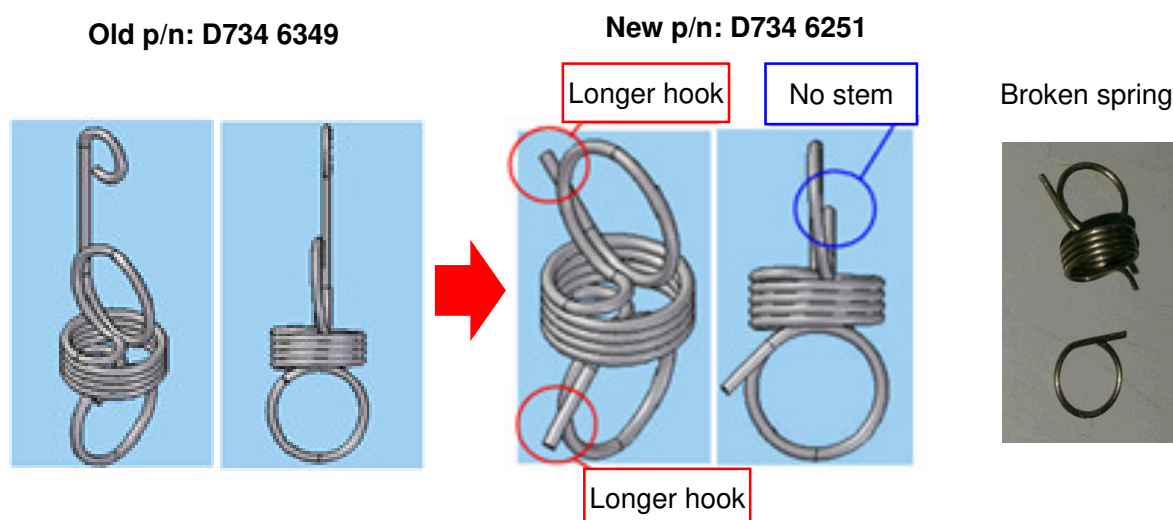
Since the modification of the spring in Apr 2014 (p/n: D734 6349 → p/n: D734 6251), a biased load is put on the spring, depending on the direction in which the spring is attached to the TE press-down lever, and eventually causes the breakage.

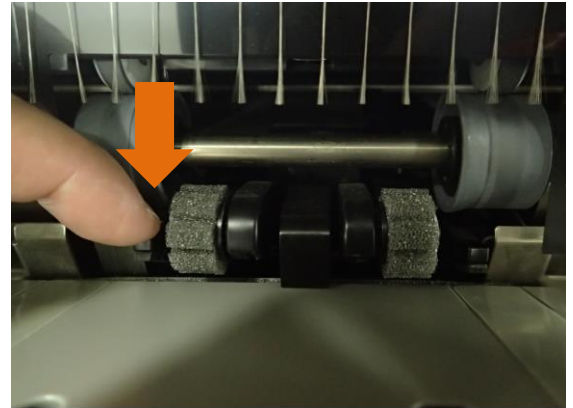
1. Power cycle or open and close the front door of the finisher to run the initialization process.
2. Press the rear TE press-down lever with your finger with moderate pressure. The lever should not move on a properly working unit. However, if the lever sinks and touches the shift tray, the unit is defective.
3. Run 2 copies of a 2-sheet booklet; 2 center staples on A4/LT paper. The job should result in SC720-70, if the unit is defected.
4. Repeat Step 2.

5. If the lever sinks and touches the shift tray in Steps 2 and 4, replace with a new drag roller unit (p/n: D179 9003).

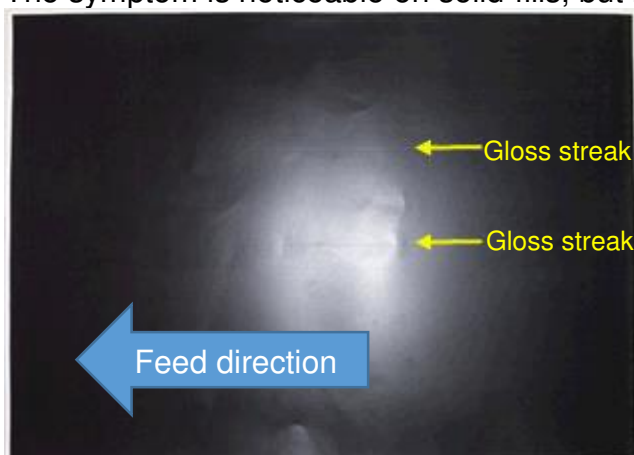
Glossy streaks appear along the paper feed direction.
The symptom is noticeable on solid-fills, but hard to notice on pages printed only with text.

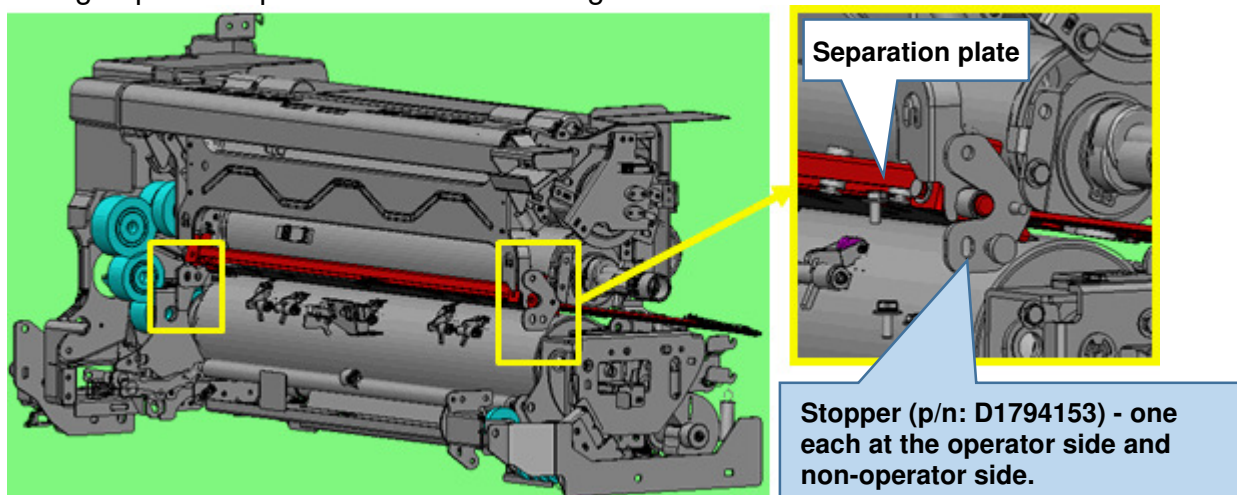
The 2 stoppers (p/n: D1794153) that are supposed to be attached to the fusing separation plate are missing due to incorrect assembly at the factory. Without these stoppers, the fusing separation plate contacts the fusing belt and scratches the belt.

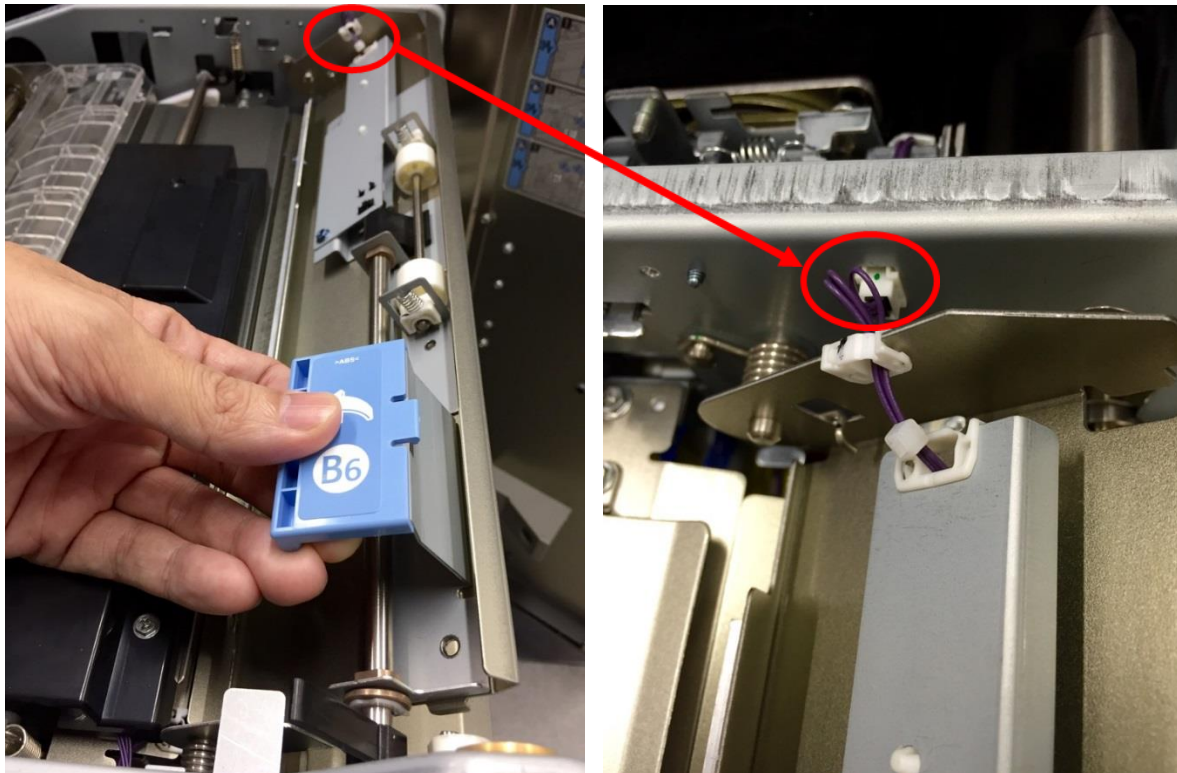
Repeatedly opening and closing the B6 guide plate eventually breaks the LCT sensor harness.

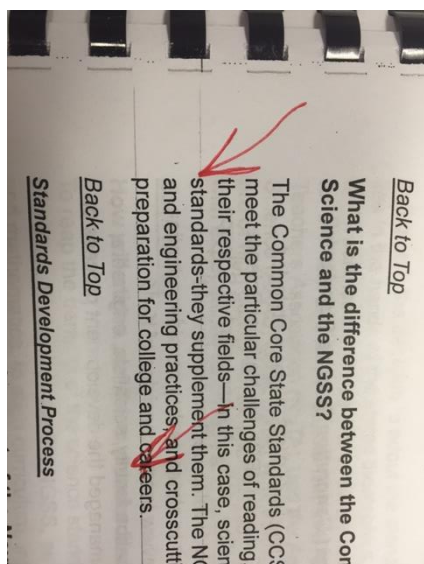
Example picture

When using the ADF, some black streaks occur.
