Model: BR-P1	Date: 27-May-15	No.: RM263005a
--------------	-----------------	----------------

Subject: Firmware Release Note: PDF		Prepared by: J. Ohno	
From: 1st PP Tech Service Sect., PP Tech Service Dept.			
Classification:	<input type="checkbox"/> Troubleshooting <input type="checkbox"/> Mechanical <input type="checkbox"/> Paper path <input type="checkbox"/> Product Safety	<input type="checkbox"/> Part information <input type="checkbox"/> Electrical <input type="checkbox"/> Transmit/receive <input checked="" type="checkbox"/> Other (Firmware)	<input type="checkbox"/> Action required <input type="checkbox"/> Service manual revision <input type="checkbox"/> Retrofit information <input checked="" type="checkbox"/> Tier 2

Model: BR-C1/Leo-C1/Leo-P1/Andromeda-P1/ BR-P1	Date: 23-Aug-13	No.: RD179017k
---	-----------------	----------------

Model:BR-P1		Date: 16-Oct-17	No.: RM263029
Subject: Parts information - Development Unit		Prepared by: Rie Shohda	
From: Sales Strategy Sect., 1st CP Business Dept.			
Classification:	<input type="checkbox"/> Troubleshooting <input type="checkbox"/> Mechanical <input type="checkbox"/> Paper path <input type="checkbox"/> Product Safety	<input chec

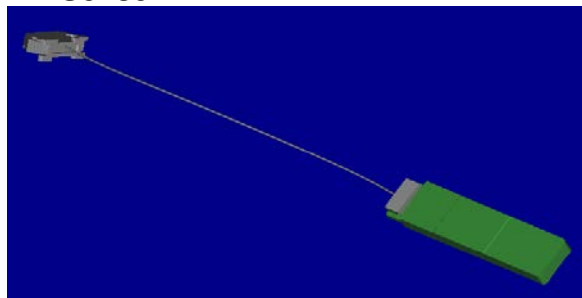
TD Sensor

If the sensor is not in the correct position, the distance between the sensor and the developer contained in the development unit will fluctuate and hinder proper toner density detection, which may cause problems like toner scattering.

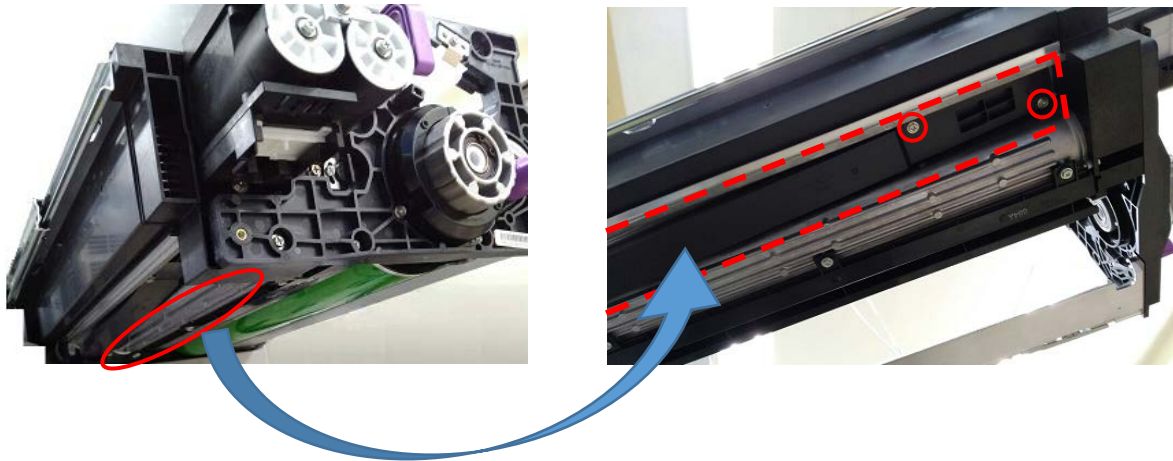
NOTE: The screwhead of the two screws used for the TD sensor cover tend to strip rather easily. Work with care when removing and reattaching these screws.

2. Remove the cover of the TD sensor. (Screw x2)

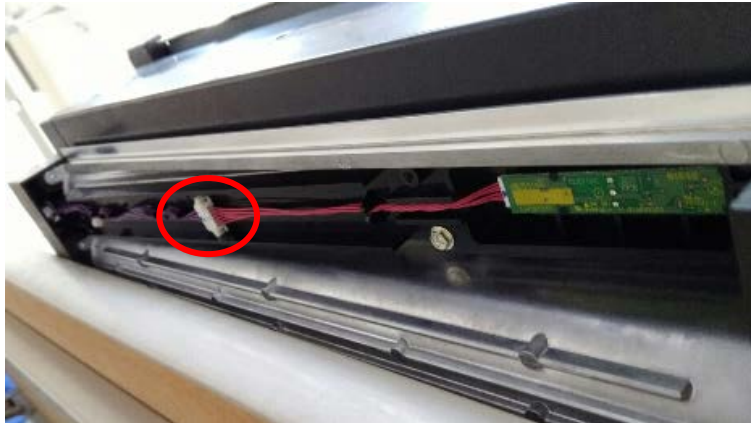
NOTE: The TD sensor harness is thin. Work carefully not to catch it when putting back the cover.

7. Connect the TD sensor harness to the development unit and put back the sensor cover.

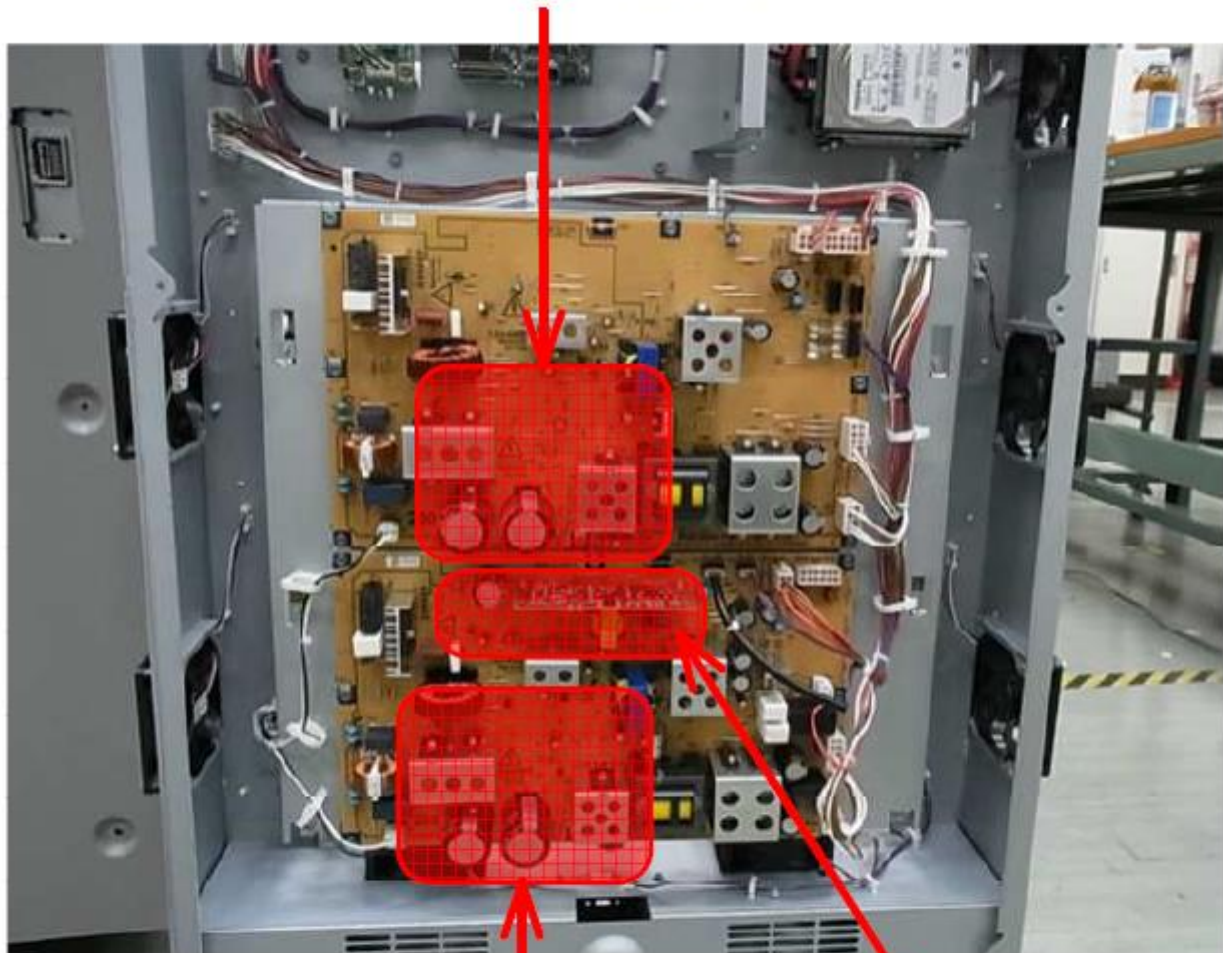
AZ240232
PSU-B C9,C75

NEVER touch the areas outlined in red in the photos below, to prevent electric shock caused by residual charge.

The procedure to discharge residual charge from the machine by unplugging the power cord from the AC wall outlet and pressing the main power switch works only for the DC circuits on this board. Residual charge remains in the AC circuits.

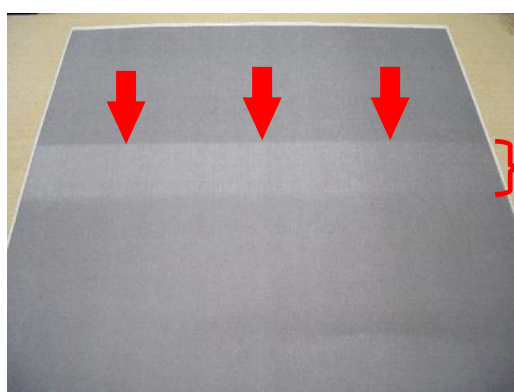
Halftone and text images appear low in density or blurred. The symptom is observed across the width of the drum charge unit at intervals corresponding to the drum circumference.

Low density

NOx (nitrogen oxides) generated in the drum charging process combine with the lubricant powder (zinc stearate) and this absorbs moisture, which adheres to the drum surface, if the machine is left unused for an extended period, causing poor drum charge in the affected area.

Do the following SP modification and part replacements.

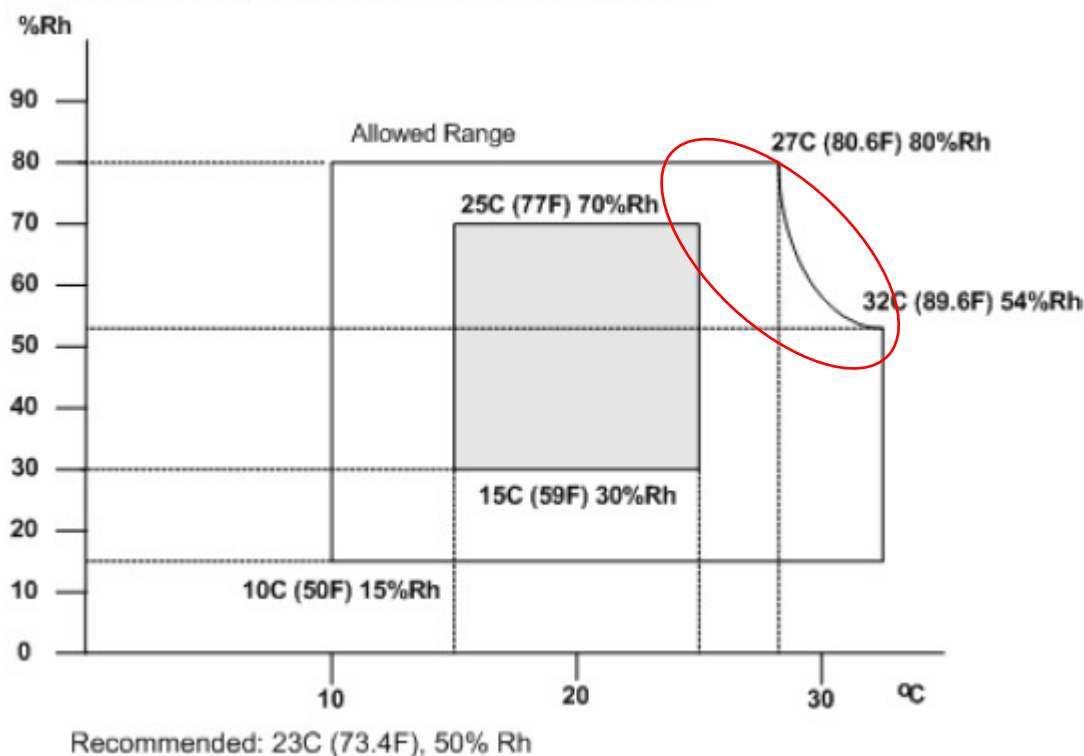
Recommended Temperature/Humidity Range for Operation

For machines installed in an environment close to the upper limit (circled in red in the diagram below), do the procedure below in addition the procedure on the previous pages.

Make the following SP settings, which will increase the airflow around the charge unit and further remove ozone.

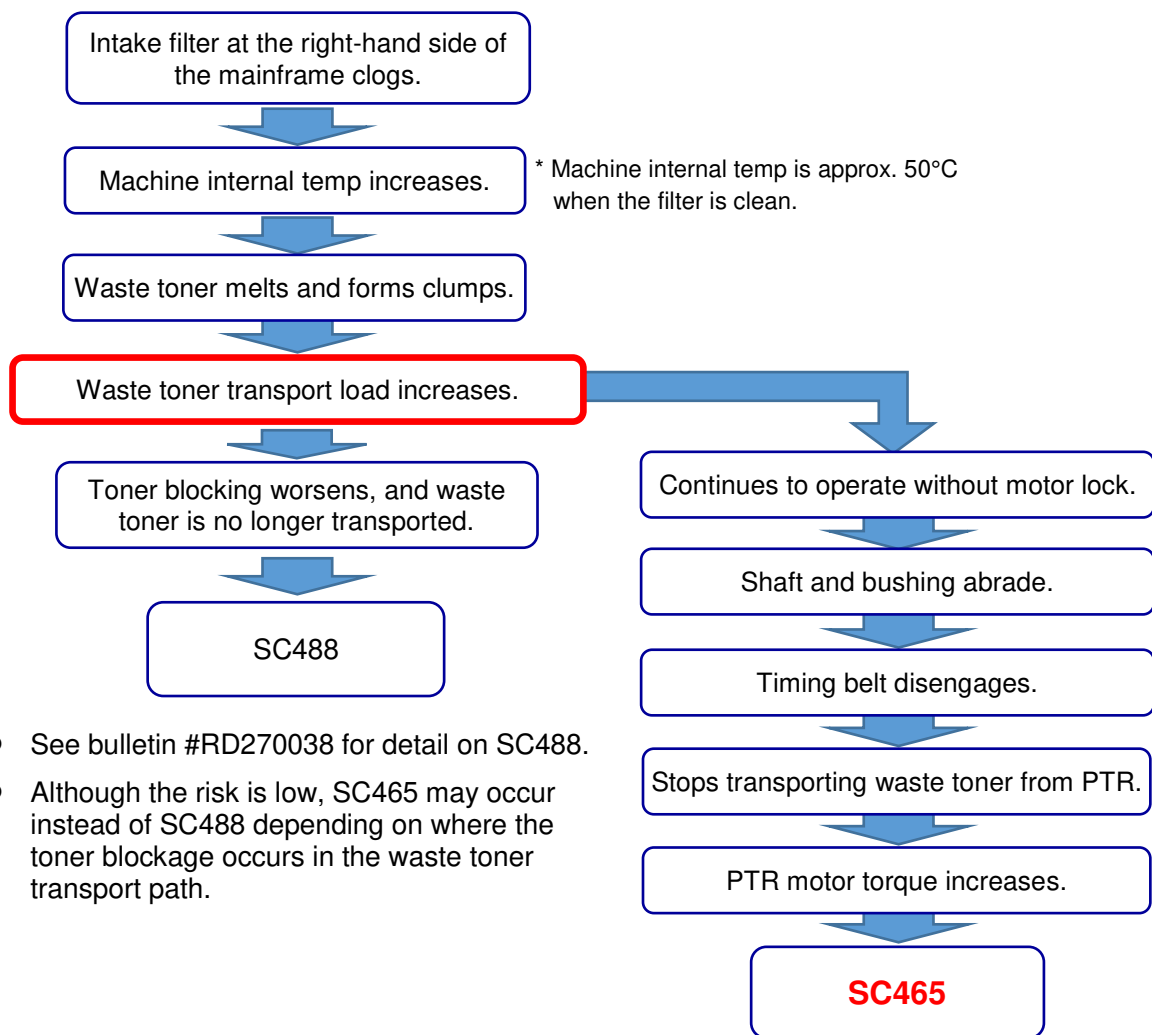
SC465 (PTR motor error)

- See bulletin #RD270038 for detail on SC488.
- Although the risk is low, SC465 may occur instead of SC488 depending on where the toner blockage occurs in the waste toner transport path.

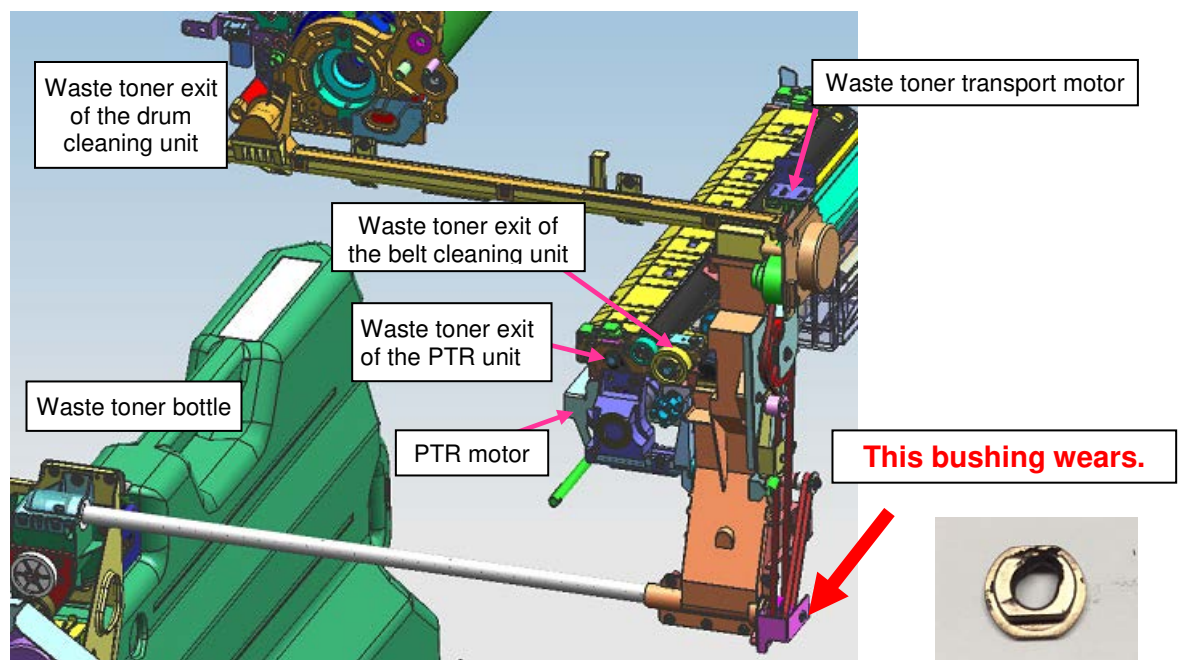
- High room temperature
- The machine is installed close to the wall with hardly any or no space at all.
- The machine generates high print volume.
- Intake filter at the right-hand side of the mainframe is clogged.
- The machine experienced SC488 in the past. The waste toner transport unit and bushing were not replaced at that time.

- Check the above bushing (p/n: B1202063). If it is abraded and requires replacement, replace it together with the waste toner unit (p/n: D1796528).

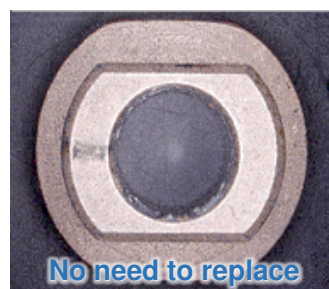
After approx. 20,000k
(normal transport load)

No need to replace
