Model: <b>BR-C2</b>	Date: 10-Nov-16	No.: RD270004
---------------------	-----------------	---------------

Subject: Firmware Release Note: PowerSaving Sys		Prepared by: J.Ohno	
From: 1st PP Tech Service Sect., PP Tech Service Dept.			
Classification:	<input type="checkbox"/> Troubleshooting	<input type="checkbox"/> Part information	<input type="checkbox"/> Action required
	<input type="checkbox"/> Mechanical	<input type="checkbox"/> Electrical	<input type="checkbox"/> Service manual revision
	<input type="checkbox"/> Paper path	<input type="checkbox"/> Transmit/receive	<input type="checkbox"/> Retrofit information
	<input type="checkbox"/> Product Safety	<input checked="" type="checkbox"/> Other (Firmware)	<input checked="" type="checkbox"/> Tier 2

Model: BR-C2		Date: 8-Nov-16	No.: RD270011
Subject: Request for Firmware Update at new site install (Baron-C2)		Prepared by: J. Ohno	
From: 1st PP Tech Service Sec., PP Tech Service Dept.,			
Classification:	<input type="checkbox"/> Troubleshooting	<input type="checkbox"/> Part information	<input checked="" type="checkbox"/> Action required
	<input type="checkbox"/> Mechanical	<input type="checkbox"/> Electrical	<input type="checkbox"/>

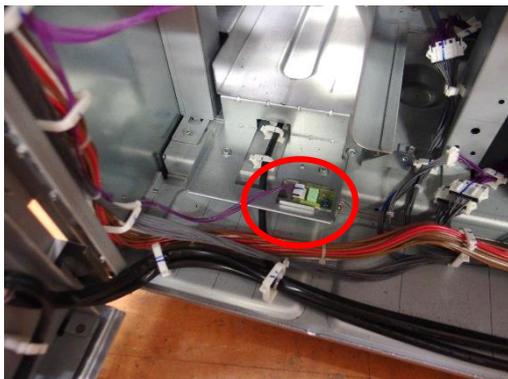
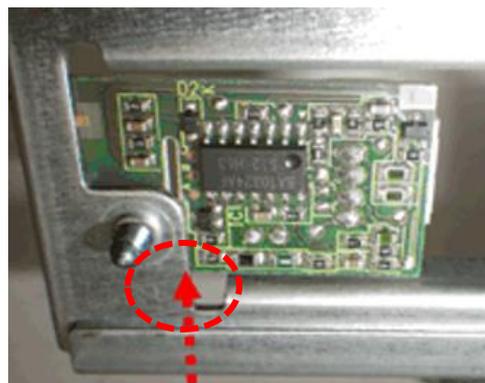
Temperature/Humidity detection sensor  
(View with the waste toner bottle removed)

The PCB that mounts the temperature/humidity detection sensor is touching the metal plate (near the waste toner bottle), causing a short circuit.

Short circuit is caused by contact between the PCB and metal plate at this point.

- 4. Loosen the screw fixing the sensor PCB and pull the white connector together with the cables toward the direction shown with the arrow.

- 5. Verify that there is a gap between the screw and the outline of the imprint "54AG" and refasten the screw. With this gap secured, the PCB should not touch the metal plate.

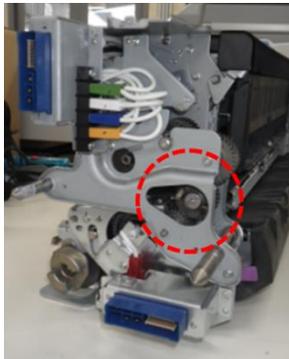
Damaged drive gear

The drive gear in the Fuser Unit is broken and jams at the PTB Unit occur because the fuser rollers cannot rotate.

Fuser unit and red circle indicates the position of the drive gear

The 2 joints of the drive gear do not have enough mechanical strength and might be broken during printing.

Replace the affected drive gear with a new one and apply the required grease to it. Please see the following replacement procedure.

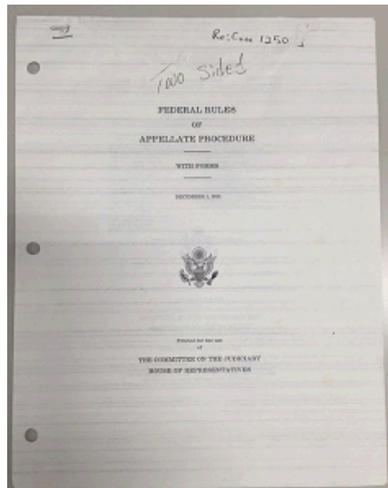
**Note 1:** Black streaks disappear after a few sheets have been printed.

Under the conditions described below, the surface layer of the pressure roller rubs against the web and is scraped. And the abrasive powder passes through the web, accumulates on the pressure roller, and is transferred to the sheet.

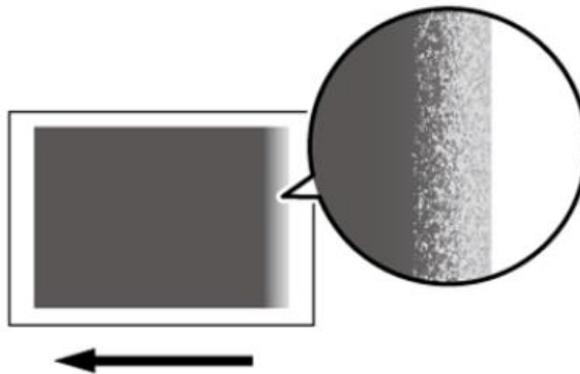
**SYMPTOM:** The image printed within 15mm (approx. 5/8 inch) from the trailing edge is faint.

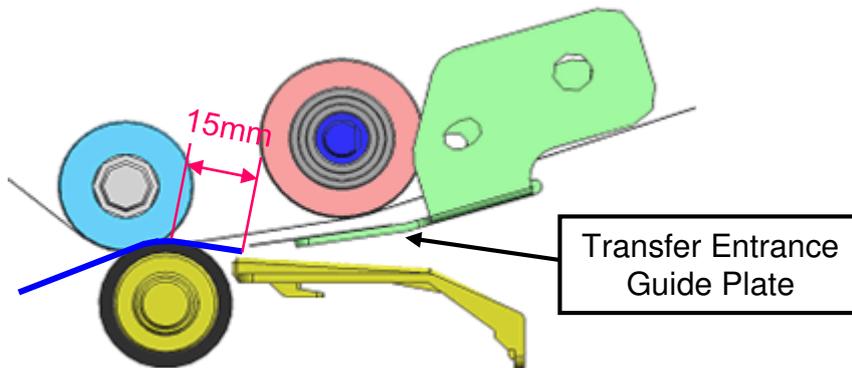
**CAUSE:** Toner on the ITB scatters when the trailing edge approaches the PTR. This happens because the trailing edge flicks the belt immediately after it passes the guide plate before entering the PTR nip.

**SOLUTION:** Two new transfer entrance guide plates were registered as service parts.

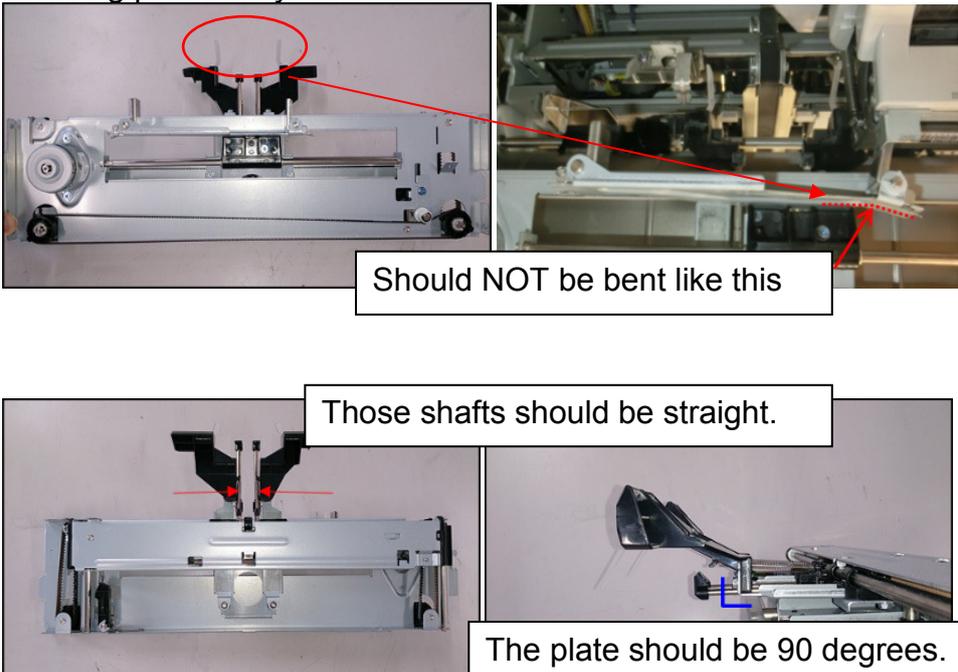
<p>Bent Plate check</p>	<p>Check the following to ensure no plate is bent.</p> <p>Vibrating plate Ass'y</p>

<p>Should NOT be bent like this</p> <p>Those shafts should be straight.</p> <p>The plate should be 90 degrees.</p>

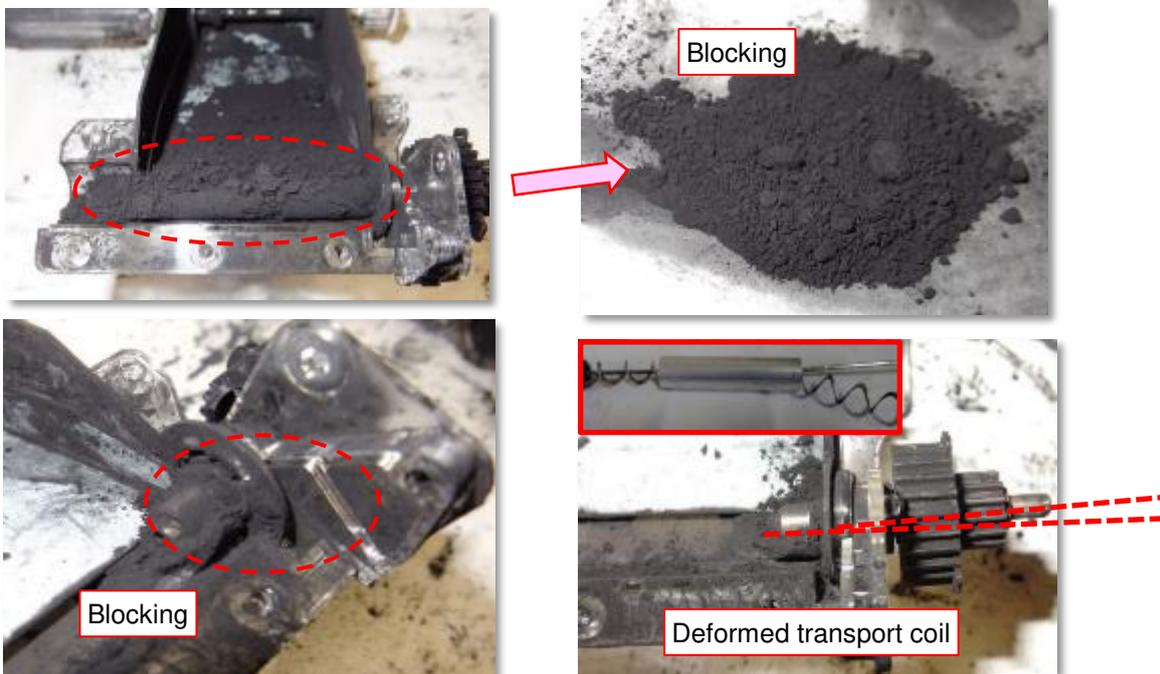
SC488 (used toner transport blockage) and broken waste toner transport coil

The right cover air intake filters of the main frame are clogged with dust / paper dust and increases the internal temperature of the ITB cleaning unit. This causes waste toner collected from the ITB to melt and eventually clog the waste toner path.

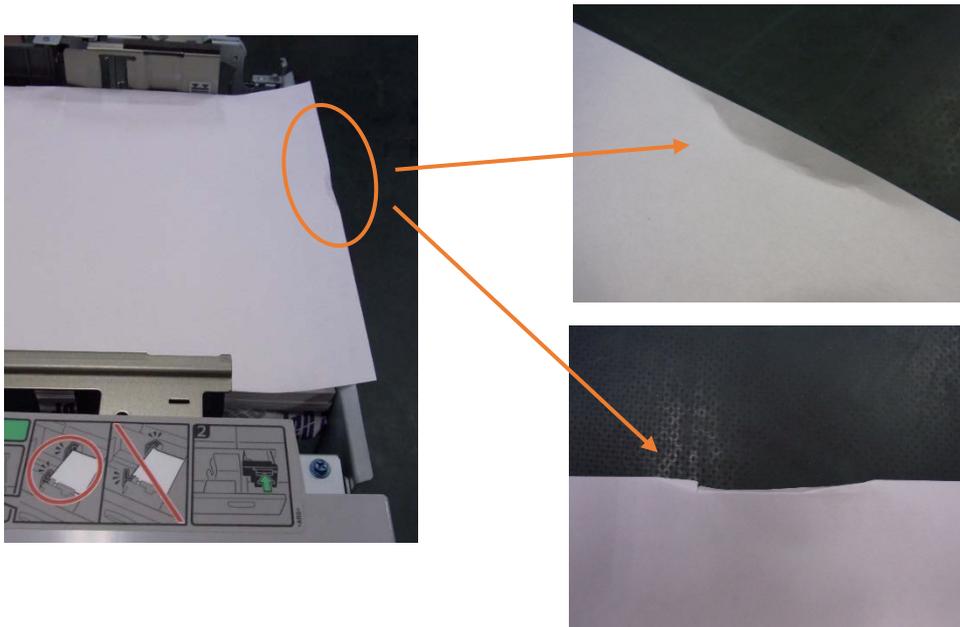
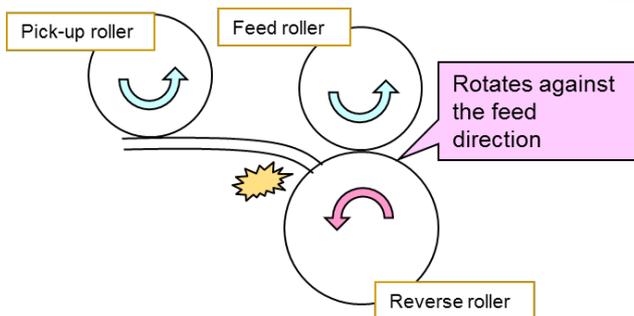
- No-feed jams start to occur at approximately 50K.
- The rollers are not abraded and have not reached life.
- Paper dust is powder-like, not grainy.
- Damages to the leading edge of paper as shown in photos below

Torque limiter in the reverse roller does not function because the rollers are slippery with paper dust. This causes the reverse roller to rotate against the feed direction and the leading edge of the paper to hit the reverse roller.

If the paper in use by your customer is high in ash content and the machine is experiencing frequent no-feed jams, replace the existing spring in PFU of LCT with this service part below.

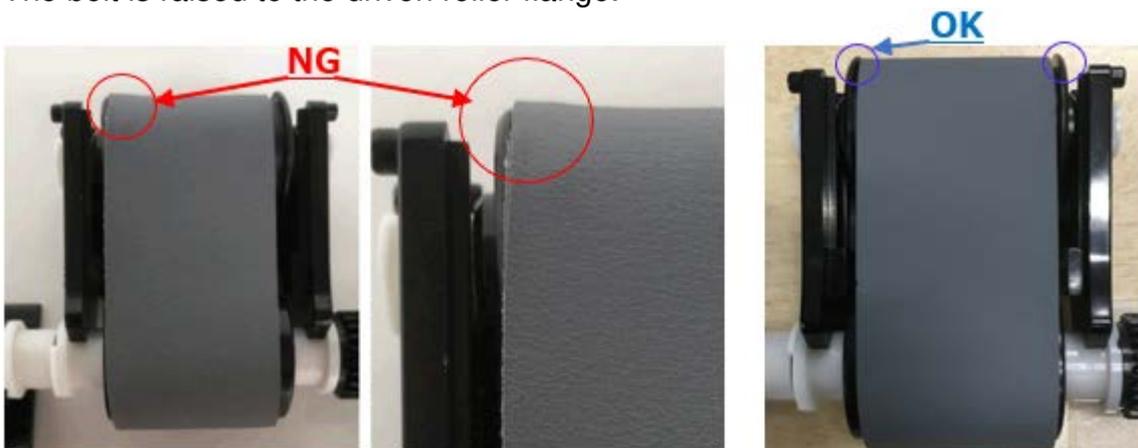
- 1) The belt is raised to the driven roller flange.

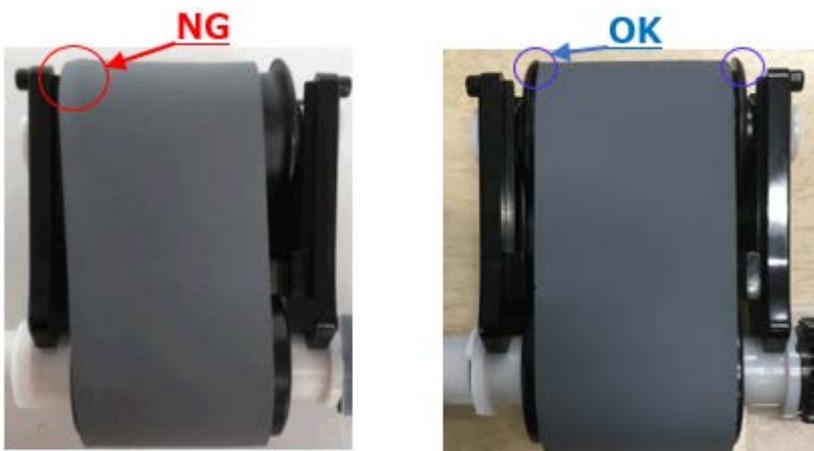
- 2) The belt is running on the driven roller flange.
