Model: BR-P2	Date: 10-Nov-16	No.: RM0AA002
---------------------	-----------------	---------------

Subject: Firmware Release Note: Network Support		Prepared by: J. Ohno	
From: 1st PP Tech Service Sect., PP Tech Service Dept.			
Classification:	<input type="checkbox"/> Troubleshooting <input type="checkbox"/> Mechanical <input type="checkbox"/> Paper path <input type="checkbox"/> Product Safety	<input type="checkbox"/> Part information <input type="checkbox"/> Electrical <input type="checkbox"/> Transmit/receive <input checked="" type="checkbox"/> Other (Firmware)	<input type="checkbox"/> Action required <input type="checkbox"/> Service manual revision <input type="checkbox"/> Retrofit information <input checked="" type="checkbox"/> Tier 2

Model: BR-P2		Date: 23-Oct-17	No.: RM0AA019
Subject: Troubleshooting of Black streaks after long leave with unprinted		Prepared by: Youngsoo Lim	
From: Sales Strategy Sect., 1st CP Business Dept.			
Classification:	<input checked="" type="checkbox"/> Troubleshooting <input checked="" type="checkbox"/> Mechanical <input type="checkbox"/> Paper path <input type="checkbox"/> Product Safety	<input type="checkbox"/> Part information <input type="chec

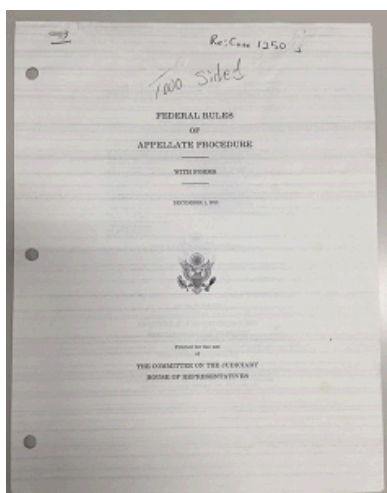
Black streaks on paper feed direction.

Black streaks appears on a couple of pages when it resumes the jobs after long leave without printing.

Note 1: Black streaks disappear after a few sheets have been printed.

1. Set the Low Power Mode Timer to a value of less than 60 minutes.

Default setting (= **15** minutes) is recommended.

2. Set the SP values as follows, if solution #1 does not resolve the Black streaks.
 - 1) SP1-902-031 (Standby: Web Operation Time) :99999 (Default) to **30** [sec]
 - 2) SP1-902-032 (Standby: Web Rotation times) : 1(Default) to **9** [times]

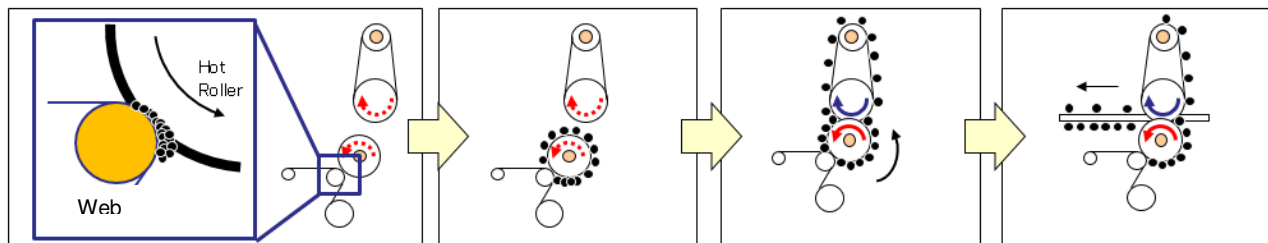
Note 2: While the machine is in the Ready (stand-by) condition, the web roller is stationary while the pressure roller is rotated. A certain amount of shavings from the pressure roller are transferred to the web roller, but this is normally not visible.

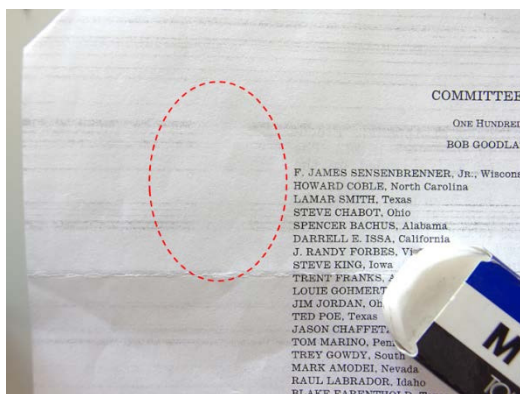
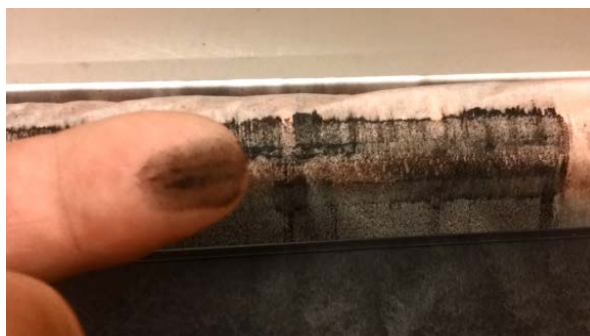
Note 3: If the streaks can be wiped off easily with an eraser, they are caused by the CAUSE explained above (as the streaks are not toner). The roller shavings will also rub off easily onto your finger. If not, the cause is different.

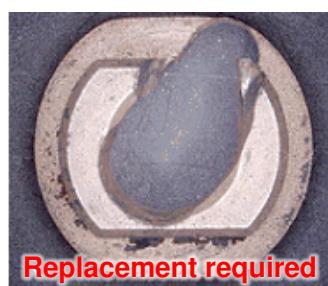
After approx. 30,000k
(SC465 confirmed)

- Check the above bushing (p/n: B1202063). If it is abraded and requires replacement, replace it together with the waste toner unit (p/n: D1796528).
