Model: Baron-P3/C3	Date: 22-Mar-19	No.: RD0BX001a
--------------------	-----------------	----------------

Subject: Production delay of the Feed Rollers		Prepared by: S. Katoh	
From: Sales Strategy Section, 1st CP Business Dep.			
Classification:	<input type="checkbox"/> Troubleshooting	<input checked="" type="checkbox"/> Part information	<input type="checkbox"/> Action required
	<input type="checkbox"/> Mechanical	<input type="checkbox"/> Electrical	<input type="checkbox"/> Service manual revision
	<input type="checkbox"/> Paper path	<input type="checkbox"/> Transmit/receive	<input type="checkbox"/> Retrofit information
	<input type="checkbox"/> Product Safety	<input type="checkbox"/> Other ( )	<input checked="" type="checkbox"/> Tier 2

**Notice Regarding the New Paper Feed Roller**

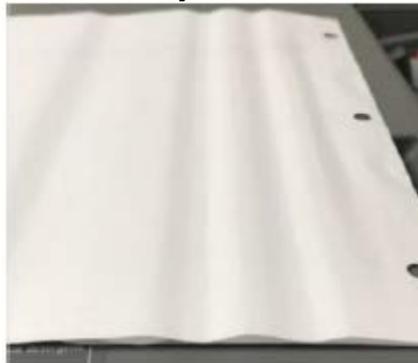
Fig.1 Wavy wrinkle

- 1) Wavy wrinkles occur on the second and subsequent sheets.
- 2) "Paper JAM staying at the entrance" may occur due to the wavy wrinkles.

Firmware change to ensure the margin of 29 m sec (12.5 mm) against the condition where 15 m sec (6.5 mm) control can not be made in time. As a result, the same productivity (90.5 ppm) as shift tray punch mode.

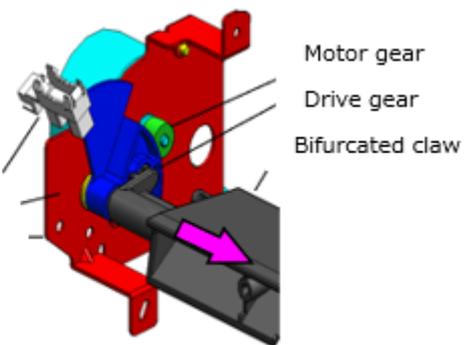
Fig.2 Bifurcated Claw

Inadequate "amount of hooked bearings" due to design error and Parts failure.

Replace with the Bearing that has sufficient amount of "hooked bearings".

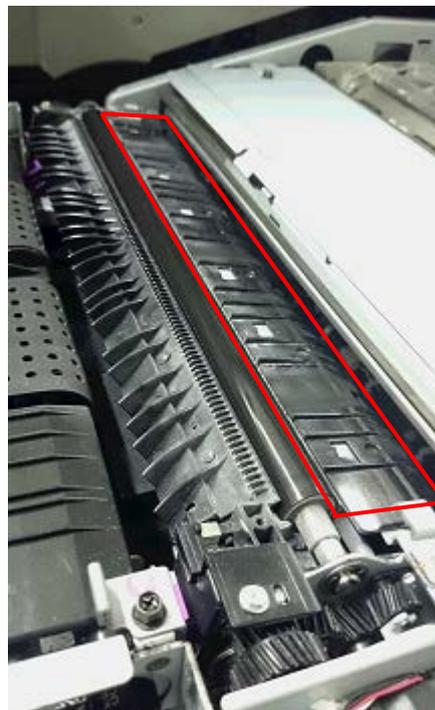
Pressure applied by the paper feed/transport rollers causes the chemical substance contained in the carbonless copy paper to seep to the surface and adhere to the PTR, which offsets to the back side of the page and appear as black roller marks.

Advise the operator to clean the ribs of the PTR unit every day before running the first job. (Cleaning is recommended every 20K pages.)

Clean the following location:

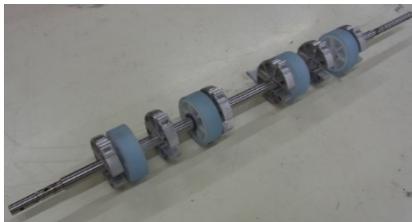
The registration gate roller swells and then falls off from its metal core after printing more than 3000K of carbonless copy paper, causing paper jams.

Replace with the modified roller.

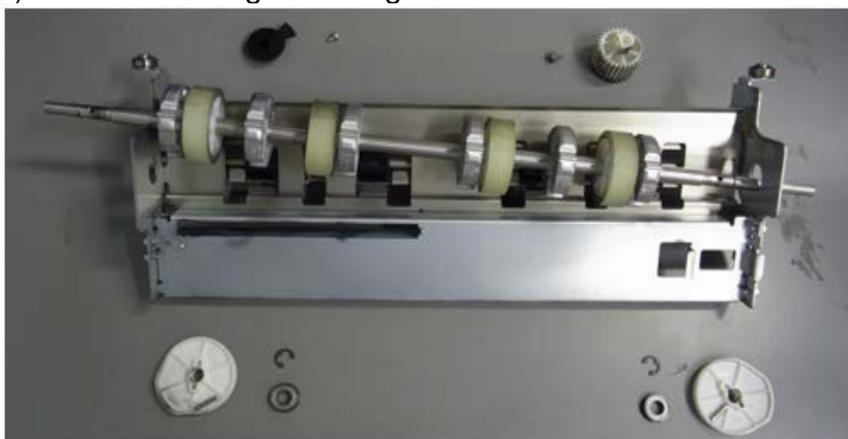
NOTE: When swollen the rollers may appear whitish as in above.

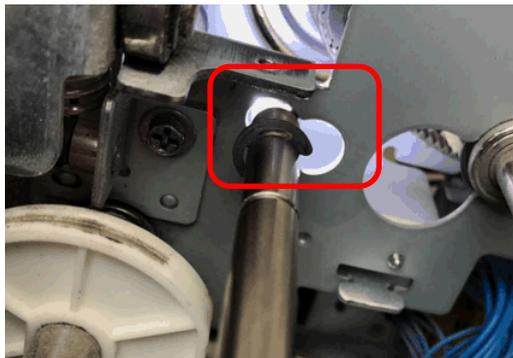
The gap between the registration timing roller and its idle roller is too small for the leading edge of the paper to pass through. This happens because the radial load generated by the registration timing roller wears the keyhole-shaped slot on the side plate to which the roller is fixed, causing a loose shaft. The wear occurs over time at approximately 50,000K.

Worn keyhole-shaped slot on the side plate
