Model: Taurus-C1a/C1b	Date: 20-Jun-11	No.: RD074001d
-----------------------	-----------------	----------------

Subject: Firmware Release Note: OpePanel.EXP		Prepared by: S. Sasaki	
From: 1st PP Tech Service Sect., PP Tech Service Dept.			
Classification:	<input type="checkbox"/> Troubleshooting	<input type="checkbox"/> Part information	<input type="checkbox"/> Action required
	<input type="checkbox"/> Mechanical	<input type="checkbox"/> Electrical	<input type="checkbox"/> Service manual revision
	<input type="checkbox"/> Paper path	<input type="checkbox"/> Transmit/receive	<input type="checkbox"/> Retrofit information
	<input type="checkbox"/> Product Safety	<input checked="" type="checkbox"/> Other (Firmware)	<input checked="" type="checkbox"/> Tier 2

This RTB has been issued to announce the firmware release information for the **OpePanel.EXP**.

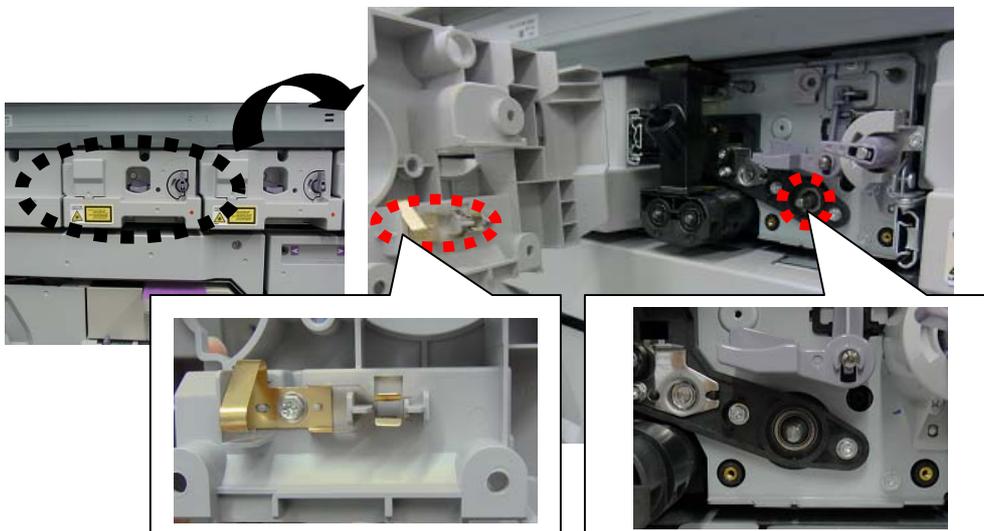
Cause

Friction between the drum shaft and the spring plate located behind the PCDU cover

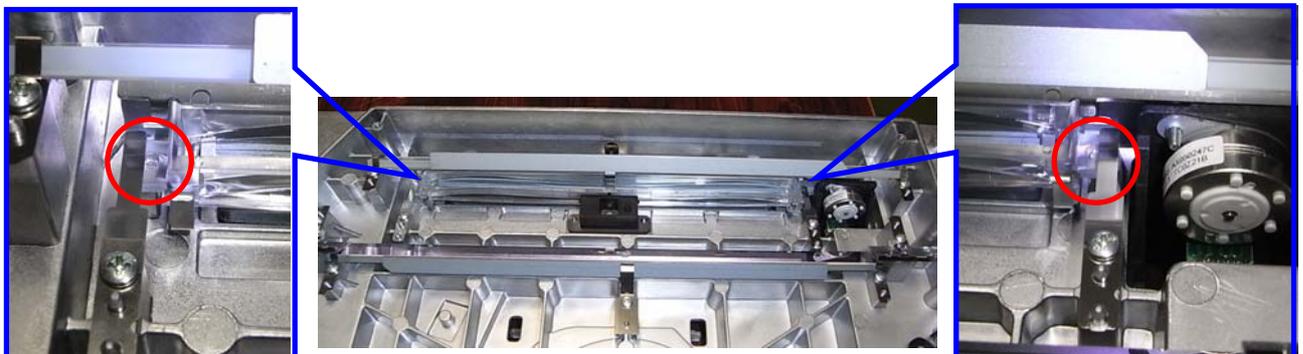
Cause

Lens assembly unit is slightly off-position, possibly because of shock generated during transportation.

The laser unit will be modified to prevent the lens assembly unit from becoming loose. The modification is scheduled to complete in late November 2011. An additional announcement will follow when completed.

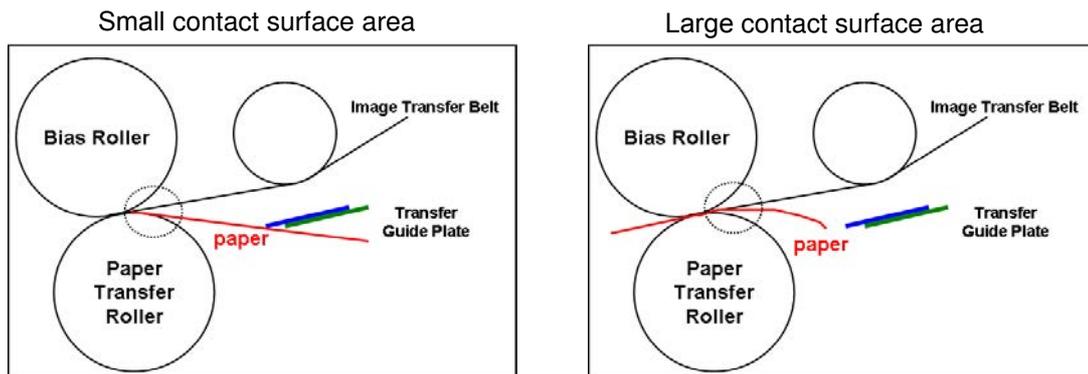
The side effects a) and b) are caused by the difference in the “contact surface area” between the paper and the ITB. As shown in the diagrams below, the contact surface area is small when the leading edge enters the PTR nip, whereas the contact surface area is large when the trailing edge passes the transfer guide plate.

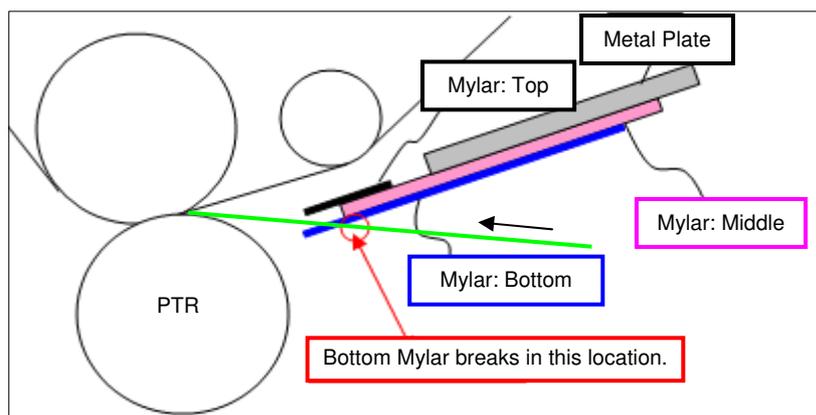
Among the 3 Mylars attached to the PTR entrance guide plate, the bottom Mylar wears over time. The leading edge of the paper interferes with the damaged area of this bottom Mylar, resulting in paper jams. (Please see the following page for details.)

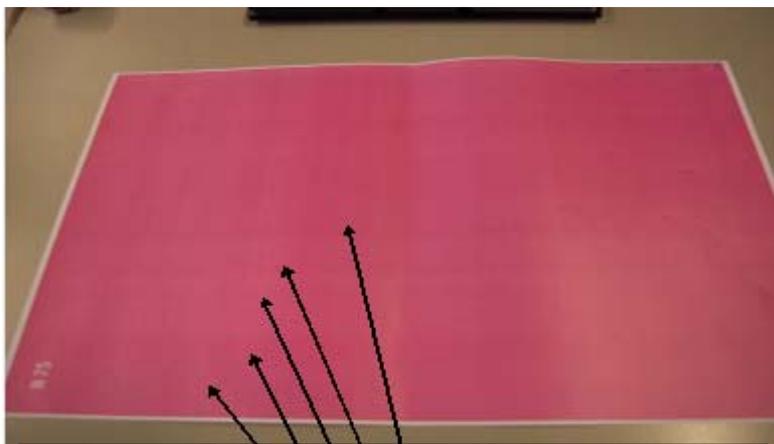
Vertical dark lines [A] appear on the output when printing solid images in single color mode.

Dark lines appear along the feed direction.

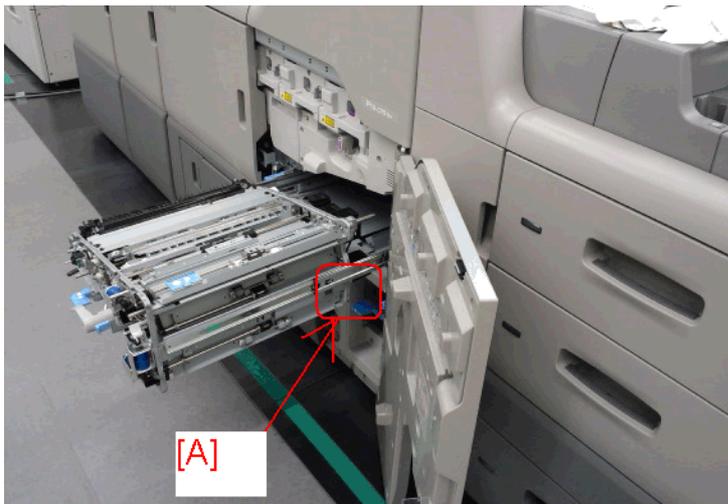
Opening and closing the Right Drawer Unit with the couplings incorrectly engaged will eventually break the molded coupling [C].

Molded coupling [C] is on the back side of area [A]

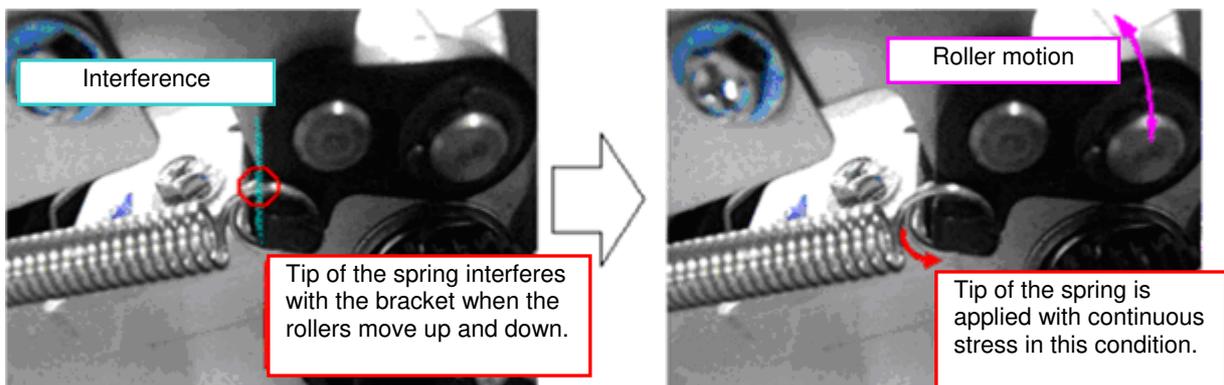
If the tip of these springs is positioned to the top, the contact/retract motion of the rollers causes the tip to interfere with the plastic bracket and applies excess contortion to the tip, which could result in breakage of the springs over time.

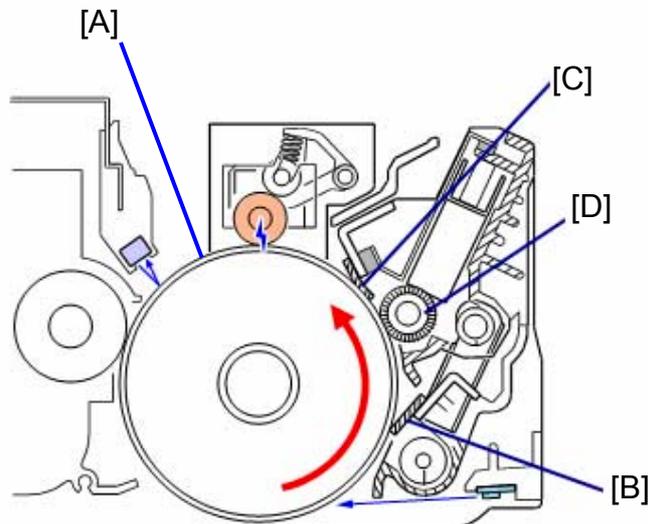
[A] Drum, [B] Cleaning Blade, [C] Lubrication Blade, [D] Lubrication Brush Roller

Excess friction between the Drum [A] and the Cleaning Blade [B] causes a heavy load on the drum motor, resulting in a Drum Motor Error.

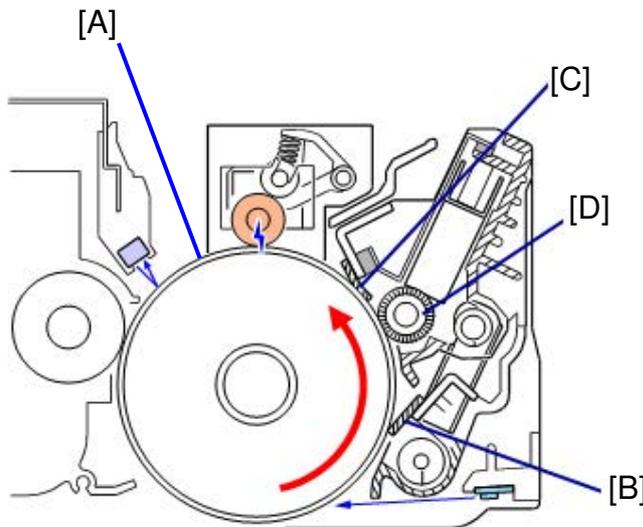
[A] Drum, [B] Cleaning Blade, [C] Lubrication Blade, [D] Lubrication Brush Roller

Excess friction between the Drum [A] and the Cleaning Blade [B] causes heavy load on the drum motor, resulting in Drum Motor Error and damaging or peeling off the development roller seal due to the abnormal rotation of the drum.

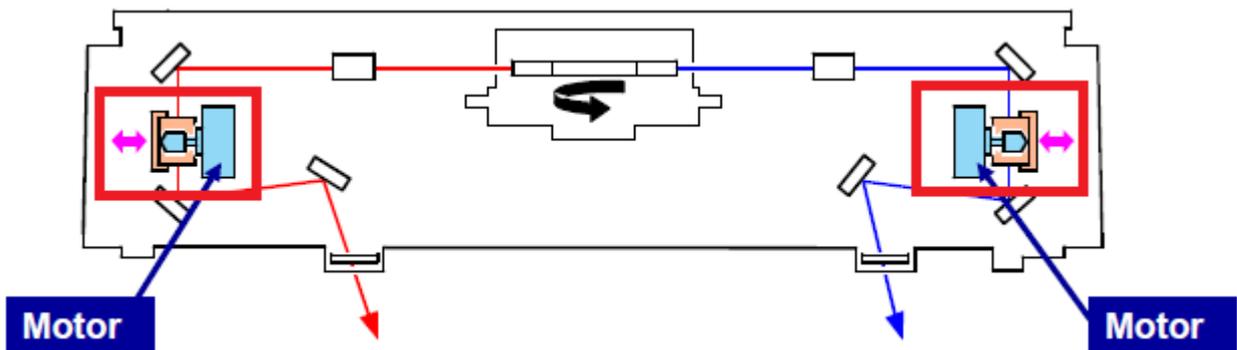
Defective skew motor

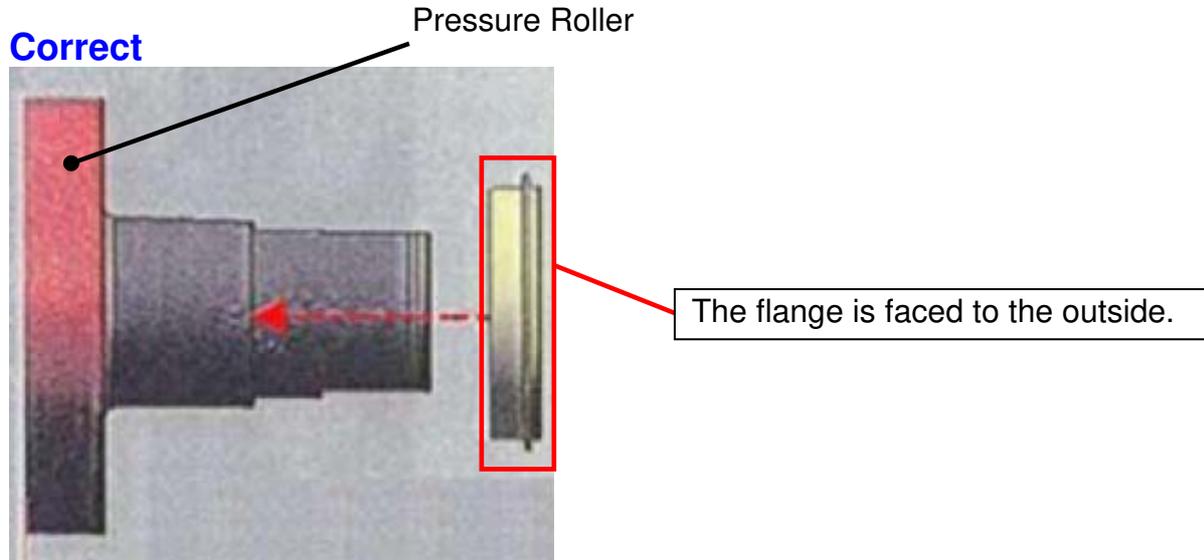
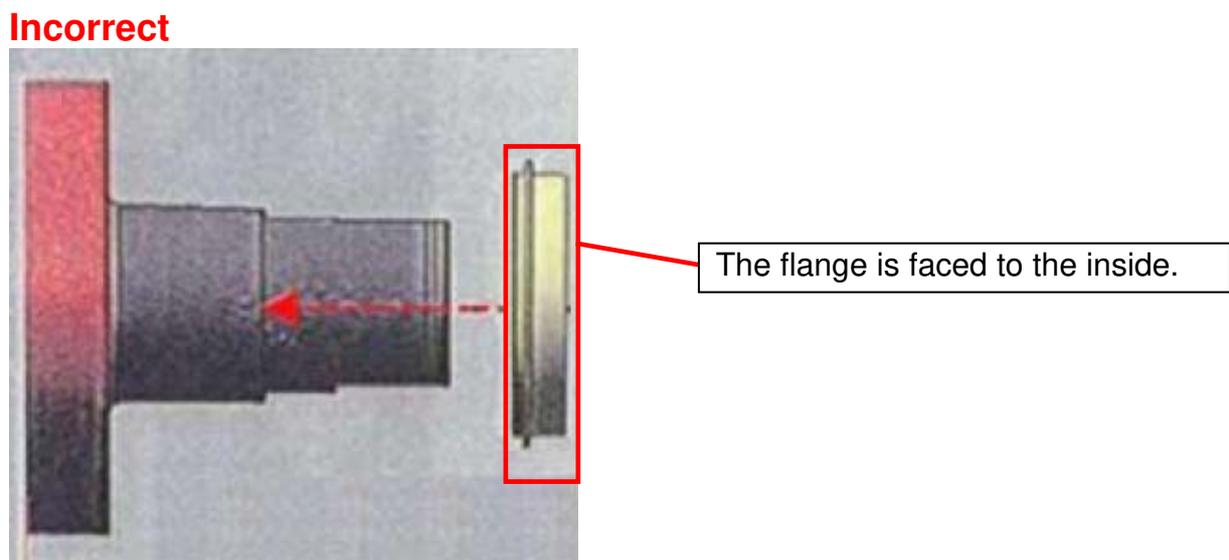
This RTB has been issued to announce the following note regarding proper installation of the bearing for the pressure roller in the fusing unit. Make sure the pressure roller bearing is installed correctly. (See the diagrams below.) Incorrect installation of the bearing could result in errors such as SC569 (Pressure Roller Lift Error).
