Model: AGL-C1	Date: 15-Jan-10	No.: RD097001d
---------------	-----------------	----------------

Subject: Firmware Release Note: Engine		Prepared by: H.kawamura	
From: PPBG Service Planning Dept.			
Classification:	<input type="checkbox"/> Troubleshooting <input type="checkbox"/> Mechanical <input type="checkbox"/> Paper path <input type="checkbox"/> Product Safety	<input type="checkbox"/> Part information <input type="checkbox"/> Electrical <input type="checkbox"/> Transmit/receive <input checked="" type="checkbox"/> Other (Firmware)	<input type="checkbox"/> Action required <input type="checkbox"/> Service manual revision <input type="checkbox"/> Retrofit information <input type="checkbox"/> Tier 2

Model: AGL-P1/C1		Date: 21-Jan-10	No.: RM078003
Subject: Notice of exclusive parts for AGL-P1/C1		Prepared by: N.iida	
From: PPBG Service Planning Dept.			
Classification:	<input type="checkbox"/> Troubleshooting <input type="checkbox"/> Mechanical <input type="checkbox"/> Paper path <input type="checkbox"/> Product Safety	<input checked="" type="checkbox"/> Part information <input type="checkbox"/> Electrical <input type="checkbox"/> Transmit/receive <input type="checkbox"/> Other ()

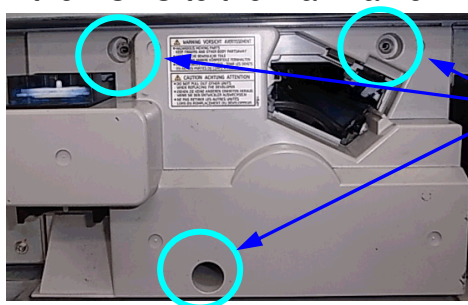
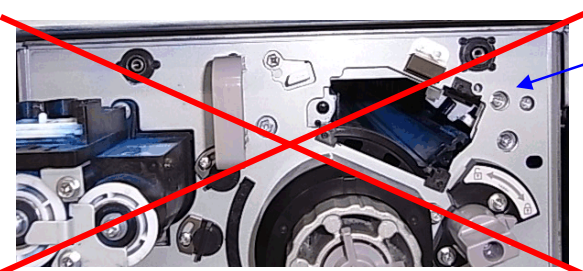
1-1. Confirming Attachment of the Inner Cover

The Inner Cover must always be fastened with the 3 screws circled in blue in the photo below when in operation. Note that these screws not only function to hold the cover but fix the PCDU to the mainframe.

Confirm complete fastening of the 3 screws.

Never operate the machine without the Inner Cover or the screws.

The development unit will be positioned incorrectly when operated without the Inner Cover and the screws, causing scratches on the drum surface and uneven image density.

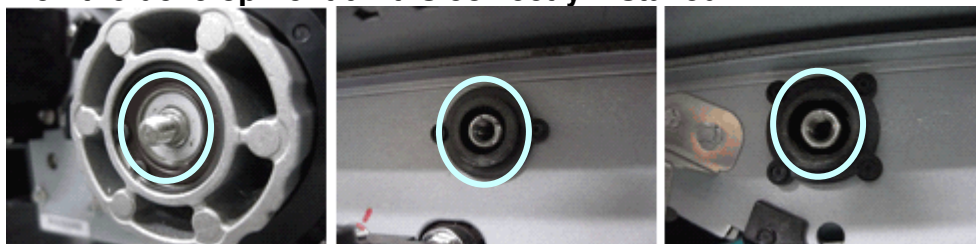
When the development unit is correctly installed...

The surface of the knob and the adjacent area (black-colored) is almost flush, as shown in the left photo. Also, the screw holes for attaching the inner cover should be clearly visible as shown in the center and right photos.

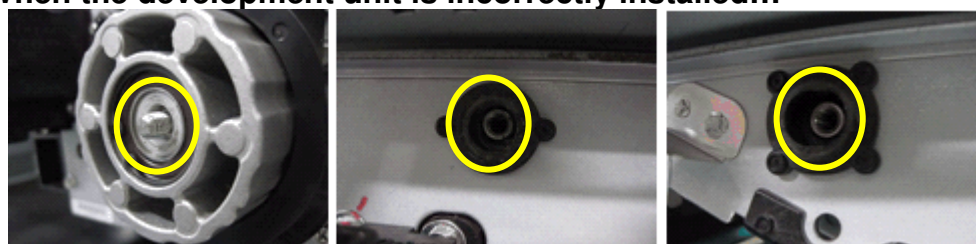
When the development unit is incorrectly installed...

The surface of the knob is clearly protruding against the adjacent area (black-colored) and the screw holes are sunk in and are not clearly visible, as shown in the photos above. In this case, the unit is bounced back towards the front side because the drum internal and drum drive external gears are not properly engaged as shown below.

If the development unit is not correctly installed, pull out the PCDU and slightly reposition the drum so that the internal and external gears are engaged properly.

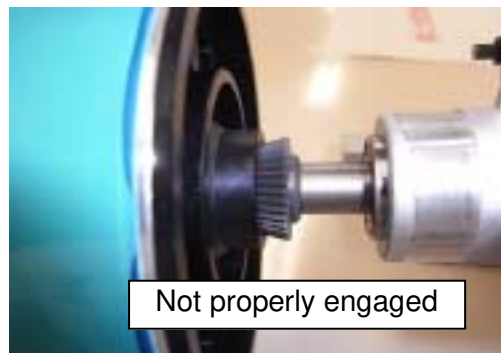
Not properly engaged

When the gears are not engaged properly, the drum cleaning unit pushes the drum towards the direction in which the PG is narrowed. Printing in this condition will cause toner to adhere to the development rollers and generate scratches on the drum surface.

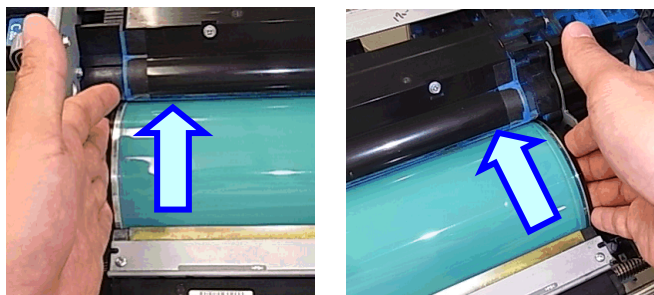
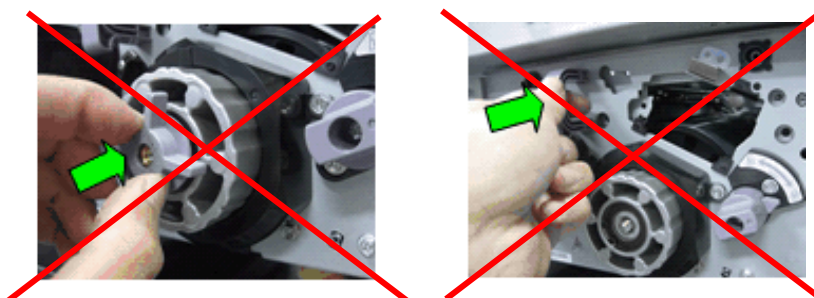
Do not attempt to forcefully fasten the (cross-shaped) drawer stop knob by shoving in the unit. Doing so will NOT help install the unit completely but will only damage the teeth of the internal gear.

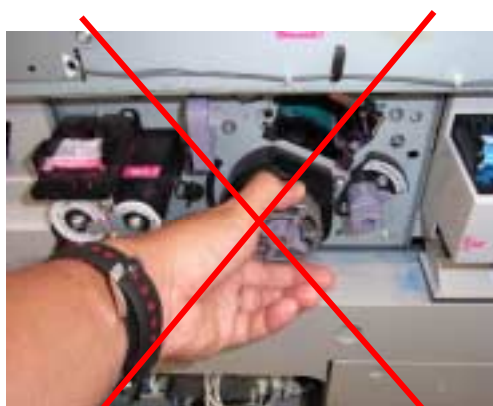
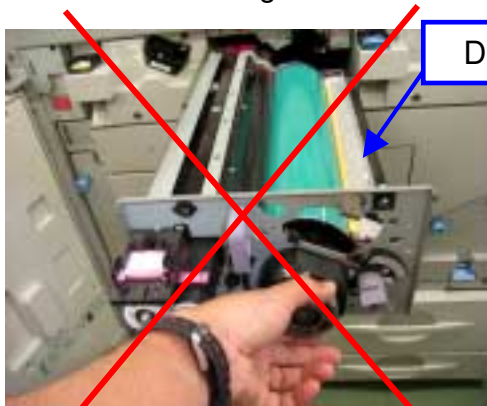
Do NOT fasten the drum knob when the development unit is installed.
Do NOT fasten the drum knob when the drum cleaning unit is installed.

Fastening the drum knob with the drum cleaning unit installed will cause the drum cleaning unit to apply pressure to the drum and narrow the PG at the front side.

If the drum knob is loosened with the drum cleaning unit installed, make sure to remove the drum cleaning unit, and then fasten the knob.

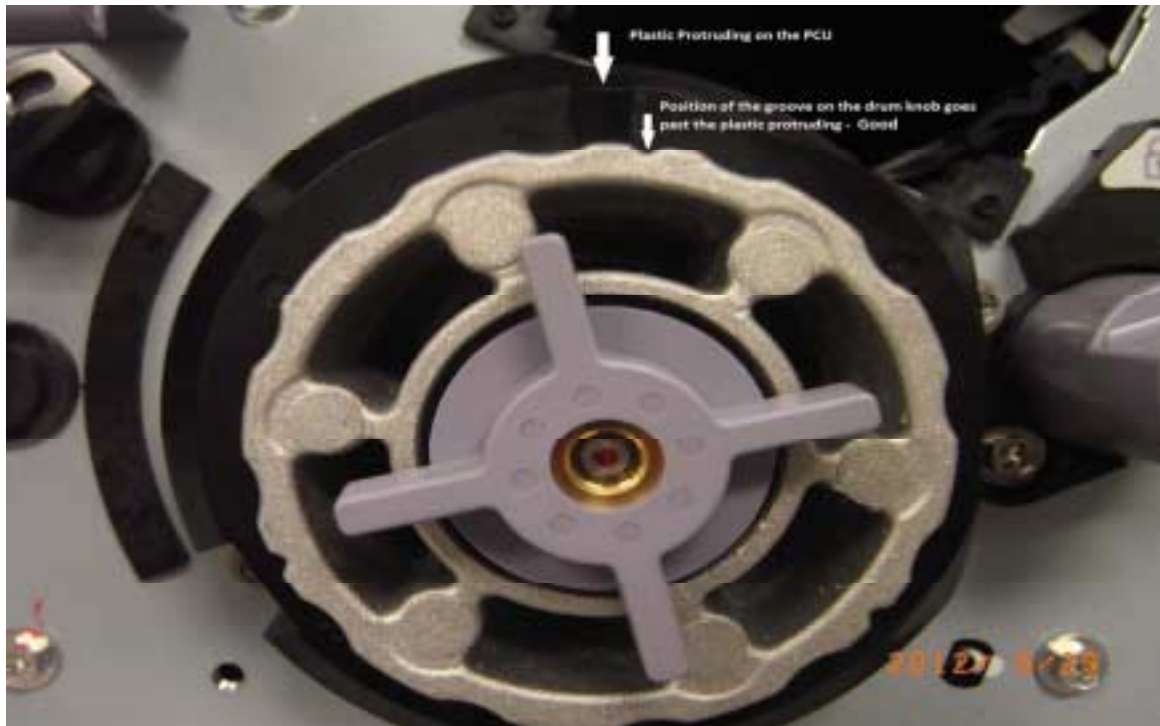
Correct Drum Knob Position

Tighten the Drum Knob so that the groove on the Drum Knob goes past the plastic protrusion on the PCDU as shown in the photo below.

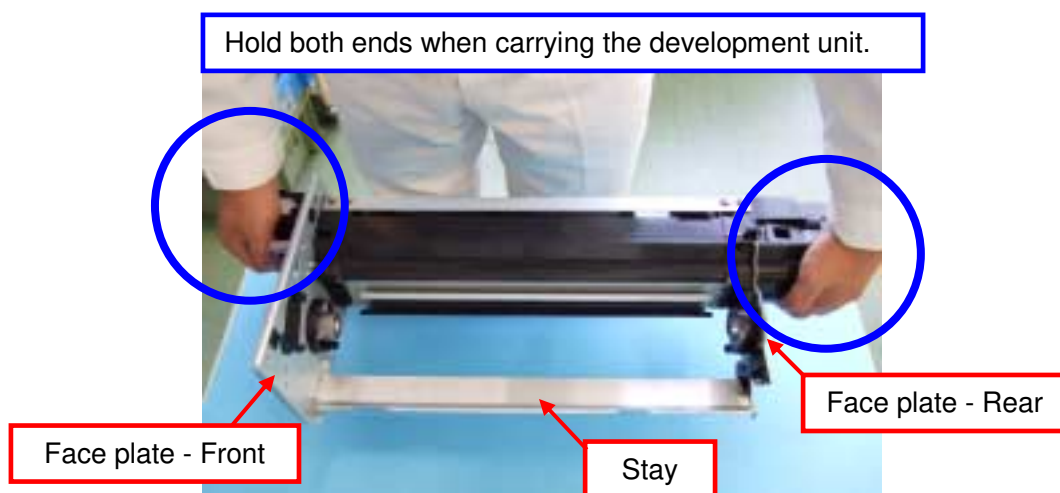
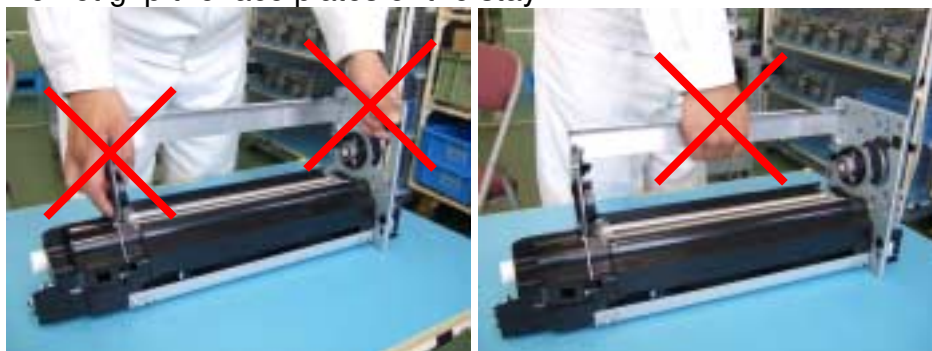
Do not grip the face plates or the stay.

Applying external pressure will deform the front and rear plates in vertical and horizontal directions, resulting in fluctuation of the PG.

- Always hold the prescribed locations when handling the development unit.
- Never apply external pressure to the front and rear plates and the stay.

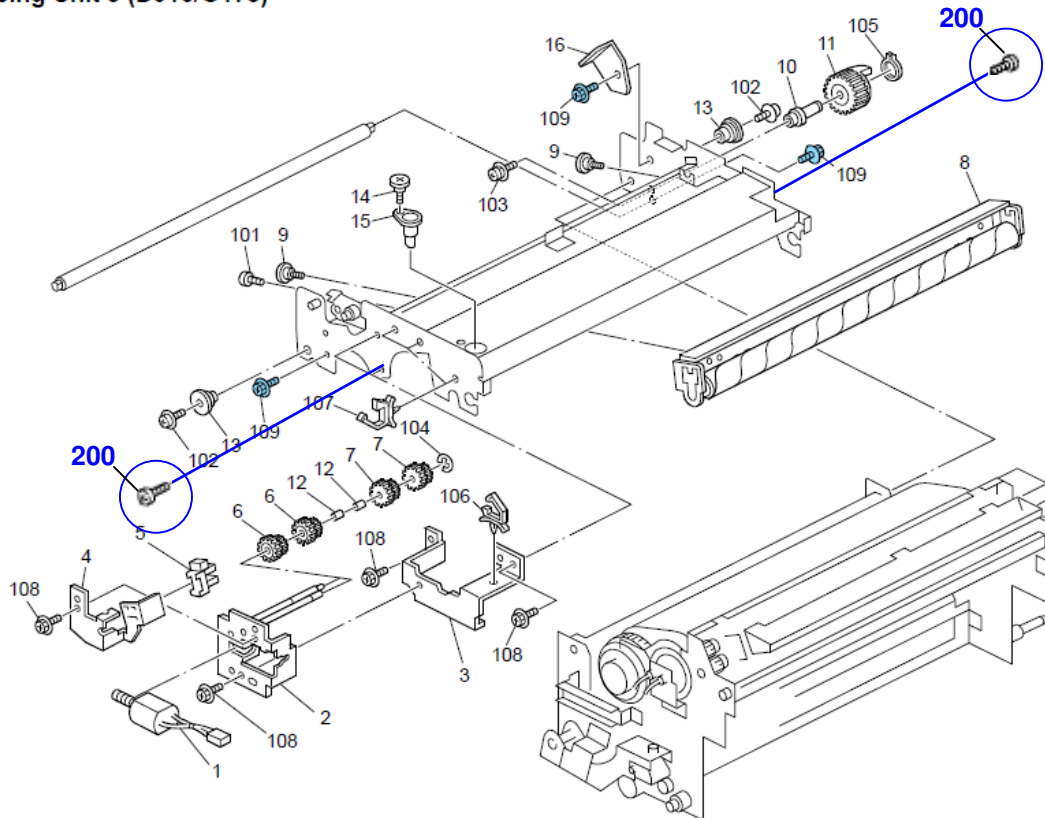
54.Fusing Unit 3 (D016/G178)

*2) The screws indexed 200 have been added to the locations shown in the diagram below in the modified fusing unit.

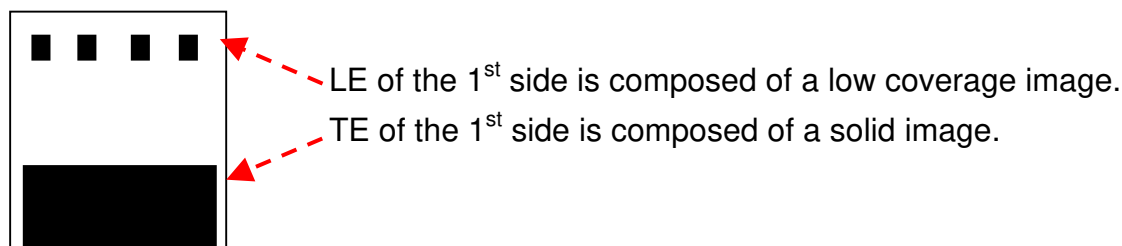
Issues	Cause	Solutions and Workarounds
4	<p>Gloss Residues: Pressure Roller</p> <p>If the LE on the 1st side contains a low coverage image and the TE on the 1st side contains a solid image (high coverage), the low coverage image on the LE could overlay on the TE while fusing the 2nd side (1st side is in contact with the pressure roller) under these conditions:</p> <ul style="list-style-type: none"> * Coated paper * 1 original fed in automatic duplex, or 1-3 original fed in manual duplex <p>The overlaid (residual) image will gradually become less noticeable over time.</p> <p><i>See additional explanation on the following page.</i></p> <p>LE: Leading edge TE: Trailing edge</p>	<ul style="list-style-type: none"> * Due to the elimination of the oil application components, oil is applied to the pressure roller via the fusing belt. Therefore, the first sheet fed attracts the largest amount of oil from the pressure roller while the amount of oil transferred to the following sheets gradually decreases. * When fusing the 2nd side, oil on the surface of the pressure roller is absorbed by the low coverage image on the LE of the 1st side resulting in a residual image being created on the pressure roller, which is then overlaid onto the TE consisting of a solid image. Uneven oil on the pressure roller surface is essentially caused by the elimination of the pressure roller blade. 	<p>When observed with 1-3 original manual duplex:</p> <ul style="list-style-type: none"> * Switch to automatic duplex * Feed a test sheet to absorb (erase) the overlaid image * Switch the LE and TE so that the solid image is on the LE <p>When observed with 1 original automatic duplex:</p> <ul style="list-style-type: none"> * Feed a test sheet to absorb (erase) the overlaid image * Switch the LE and TE so that the solid image is on the LE <p>Note</p> <p>The same problem will occur with standard units if the oil application components are eliminated.</p>

The following is an example of a 1st side image likely to cause the side effect.

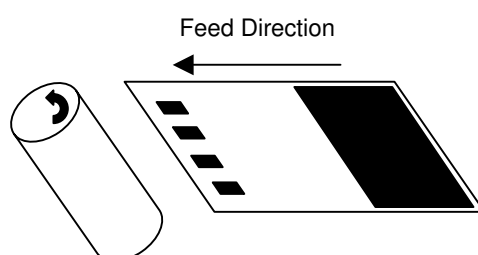
The following is a view of the pressure roller from below and explains how the side effect is generated when fusing the 2nd side in a duplex print job.

1. The surface of the pressure roller is applied with sufficient amount of oil via the fusing belt until the sheet enters the nip to fuse the 2nd side. While fusing the 2nd side, the pressure roller is in contact with the 1st side.

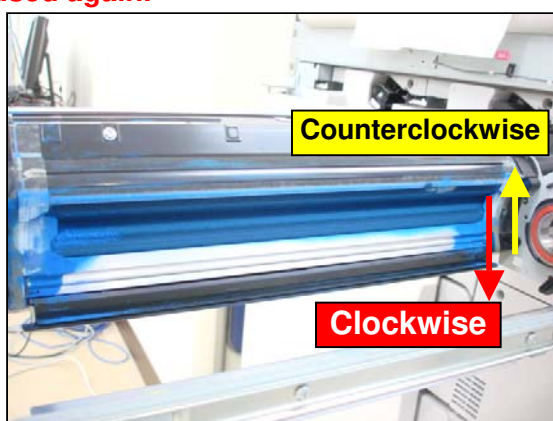
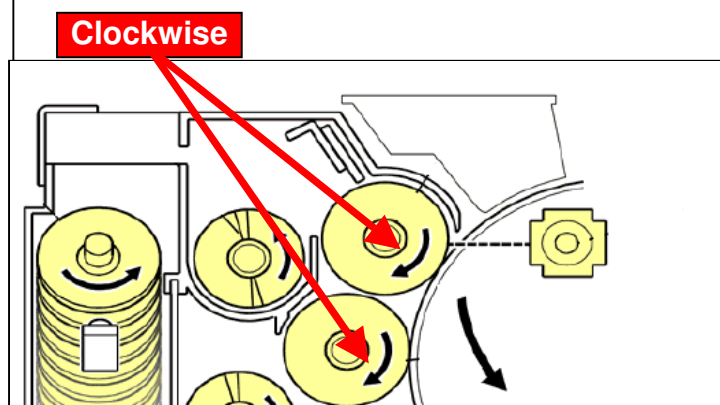
Rotating the development rollers counterclockwise with the developer installed will cause toner to adhere to the development rollers (see Reference below), resulting in higher chances of damaging the drums. Make sure to clear out the developer from the unit in advance when rotating the developer rollers counterclockwise.

Also, please do NOT clear the PM counter if the developer removed is to be re-installed and used again.

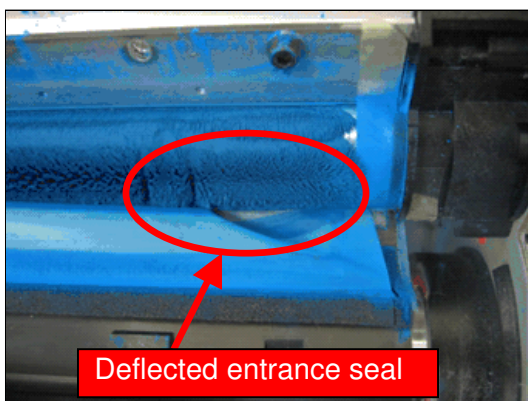
Reference

Rotating the development rollers counterclockwise with the developer installed will cause the entrance seal to deflect (especially at the edge).

The photo on the left shows the developer unit with its upper cover removed. Note that deflection of the entrance seal is not visible from the outside.
