Model: AGL-P1	Date: 15-Jan-10	No.: RM078001d
---------------	-----------------	----------------

Subject: Firmware Release Note: Engine		Prepared by: H.kawamura	
From: PPBG Service Planning Dept.			
Classification:	<input type="checkbox"/> Troubleshooting	<input type="checkbox"/> Part information	<input type="checkbox"/> Action required
	<input type="checkbox"/> Mechanical	<input type="checkbox"/> Electrical	<input type="checkbox"/> Service manual revision
	<input type="checkbox"/> Paper path	<input type="checkbox"/> Transmit/receive	<input type="checkbox"/> Retrofit information
	<input type="checkbox"/> Product Safety	<input checked="" type="checkbox"/> Other (Firmware)	<input type="checkbox"/> Tier 2

Model: AGL-P1/C1		Date: 21-Jan-10	No.: RM078003
Subject: Notice of exclusive parts for AGL-P1/C1		Prepared by: N.iida	
From: PPBG Service Planning Dept.			
Classification:	<input type="checkbox"/> Troubleshooting	<input checked="" type="checkbox"/> Part information	<input type="checkbox"/> Action required
	<input type="checkbox"/> Mechanical	<input type="checkbox"/> Electrical	<input type="checkbox"/> Service manual revision
	<input type="checkbox"/> Paper path	<input type="checkbox

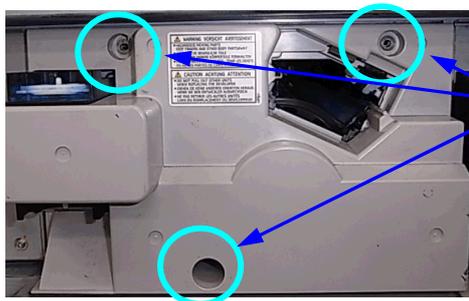
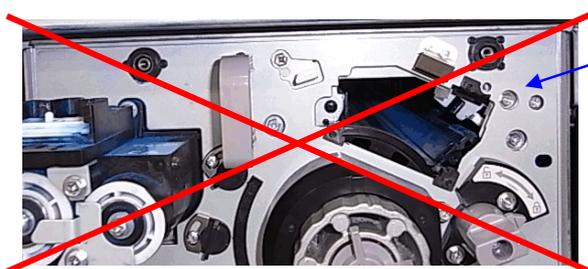
The Inner Cover must always be fastened with the 3 screws circled in blue in the photo below when in operation. Note that these screws not only function to hold the cover but fix the PCDU to the mainframe.

Confirm complete fastening of the 3 screws.

Never operate the machine without the Inner Cover or the screws.

The development unit will be positioned incorrectly when operated without the Inner Cover and the screws, causing scratches on the drum surface and uneven image density.

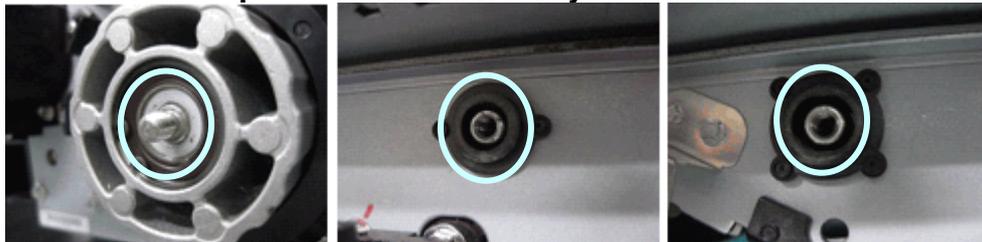
When the development unit is correctly installed...

The surface of the knob and the adjacent area (black-colored) is almost flush, as shown in the left photo. Also, the screw holes for attaching the inner cover should be clearly visible as shown in the center and right photos.

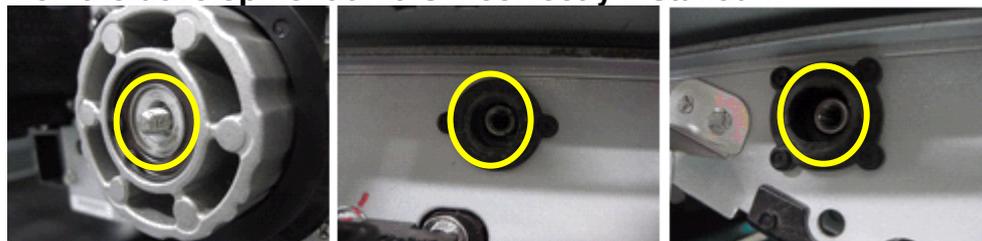
When the development unit is incorrectly installed...

The surface of the knob is clearly protruding against the adjacent area (black-colored) and the screw holes are sunk in and are not clearly visible, as shown in the photos above. In this case, the unit is bounced back towards the front side because the drum internal and drum drive external gears are not properly engaged as shown below.

If the development unit is not correctly installed, pull out the PCDU and slightly reposition the drum so that the internal and external gears are engaged properly.

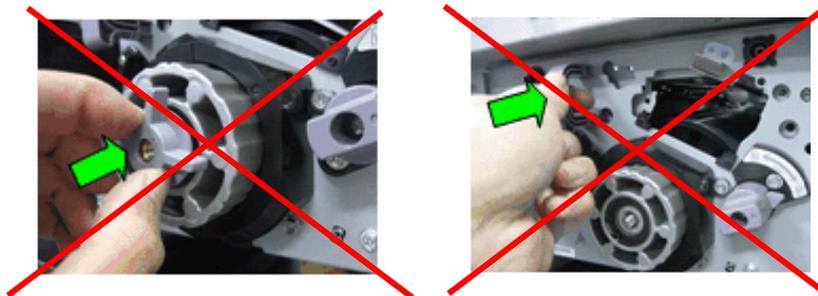
Do not attempt to forcefully fasten the (cross-shaped) drawer stop knob by shoving in the unit. Doing so will NOT help install the unit completely but will only damage the teeth of the internal gear.

When the gears are not engaged properly, the drum cleaning unit pushes the drum towards the direction in which the PG is narrowed. Printing in this condition will cause toner to adhere to the development rollers and generate scratches on the drum surface.

If the above SC occurs and heavy scratches are observed on the drum surface, replace the drum with a new one.

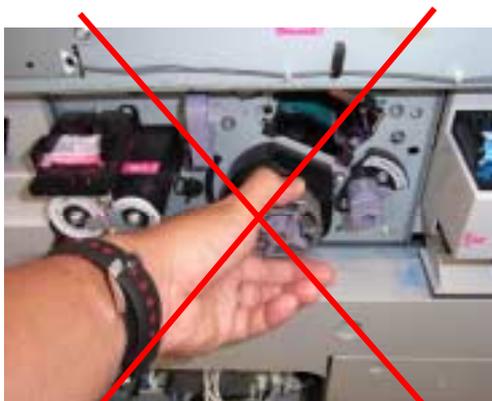
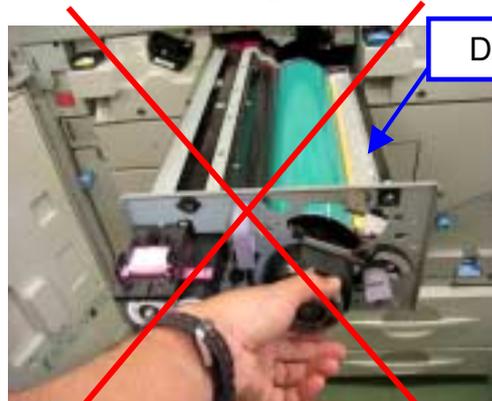
Do NOT fasten the drum knob when the development unit is installed.
Do NOT fasten the drum knob when the drum cleaning unit is installed.

Fastening the drum knob with the drum cleaning unit installed will cause the drum cleaning unit to apply pressure to the drum and narrow the PG at the front side.

If the drum knob is loosened with the drum cleaning unit installed, make sure to remove the drum cleaning unit, and then fasten the knob.

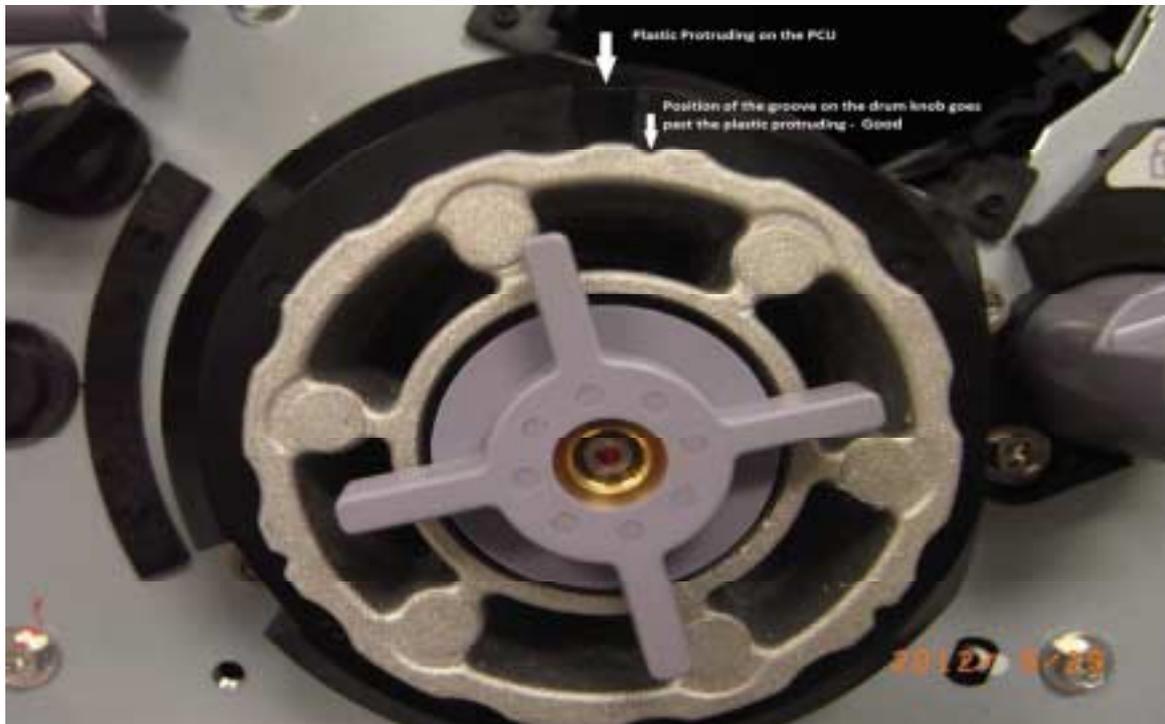
Correct Drum Knob Position

Tighten the Drum Knob so that the groove on the Drum Knob goes past the plastic protrusion on the PCDU as shown in the photo below.

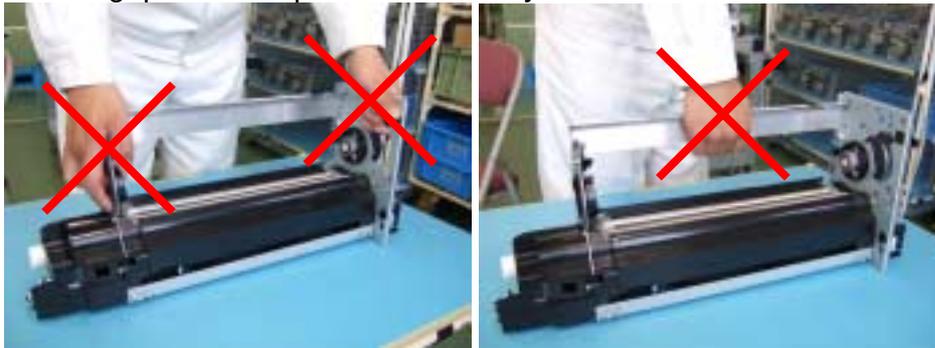
Do not grip the face plates or the stay.

Applying external pressure will deform the front and rear plates in vertical and horizontal directions, resulting in fluctuation of the PG.

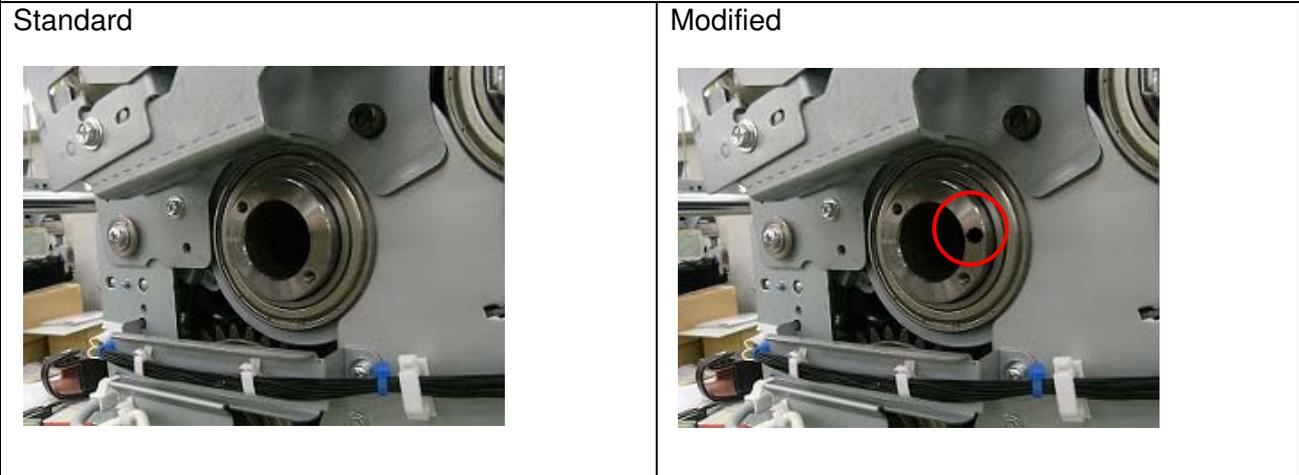
2. Hot Roller

The modified fusing unit is marked with a blue sticker on the outer ring of the hot roller, which becomes visible by removing the fusing knob.

* Do NOT attempt to install the hardened hot roller in a standard fusing unit, and vice versa. Nip width and relative properties will not meet their target values and could result in jams, SCs, and image problems.

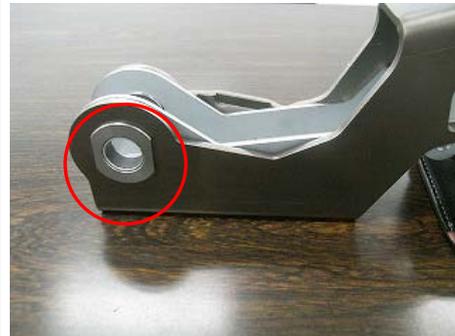
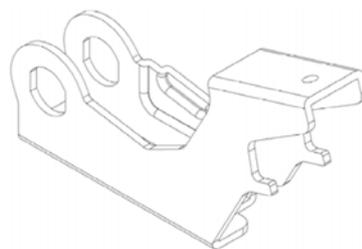
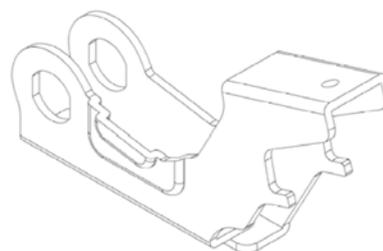
Modified

The arm for the standard unit is not durable enough to operate the modified unit and will cause the shaft to wear. The arm for the modified unit made of thicker plate is installed with a bushing to prevent wear and also has a different shape.

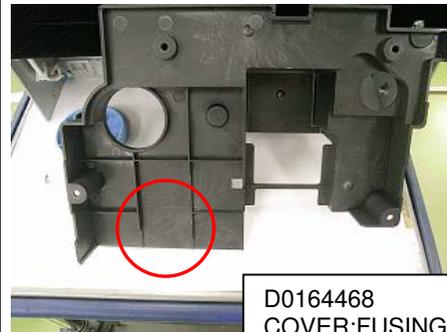
D0164468
COVER:FUSING UNIT:REAR

To avoid contact between the ribs on the cover and the pressure arm caused by the shape change of the pressure arm, the ribs on the cover have been partially removed.

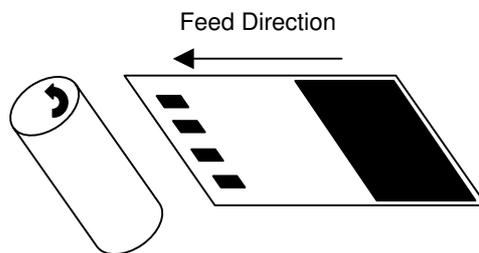
The following is a view of the pressure roller from below and explains how the side effect is generated when fusing the 2nd side in a duplex print job.

1. The surface of the pressure roller is applied with sufficient amount of oil via the fusing belt until the sheet enters the nip to fuse the 2nd side. While fusing the 2nd side, the pressure roller is in contact with the 1st side.

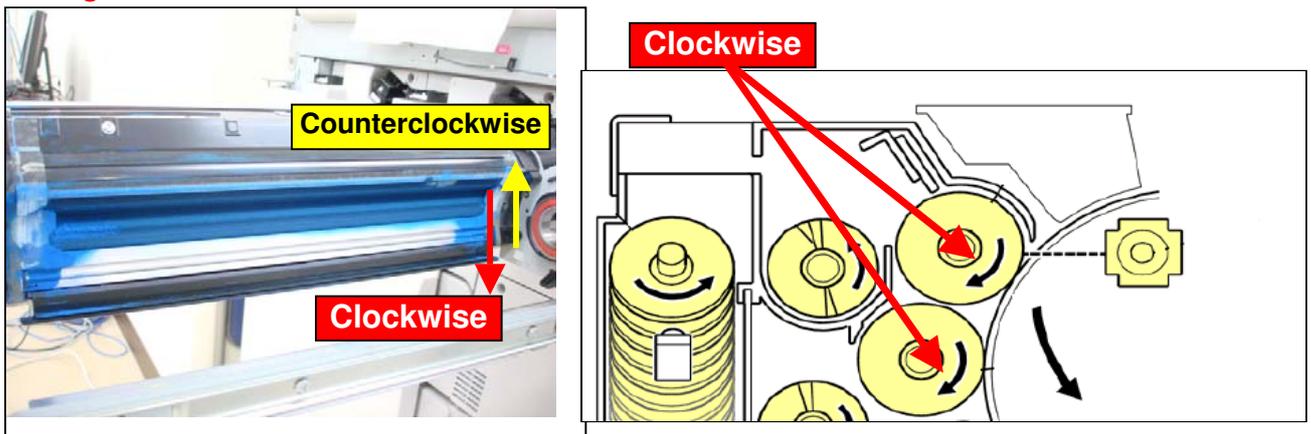
Rotating the development rollers counterclockwise with the developer installed will cause toner to adhere to the development rollers (see Reference below), resulting in higher chances of damaging the drums. Make sure to clear out the developer from the unit in advance when rotating the developer rollers counterclockwise.

Also, please do NOT clear the PM counter if the developer removed is to be re-installed and used again.

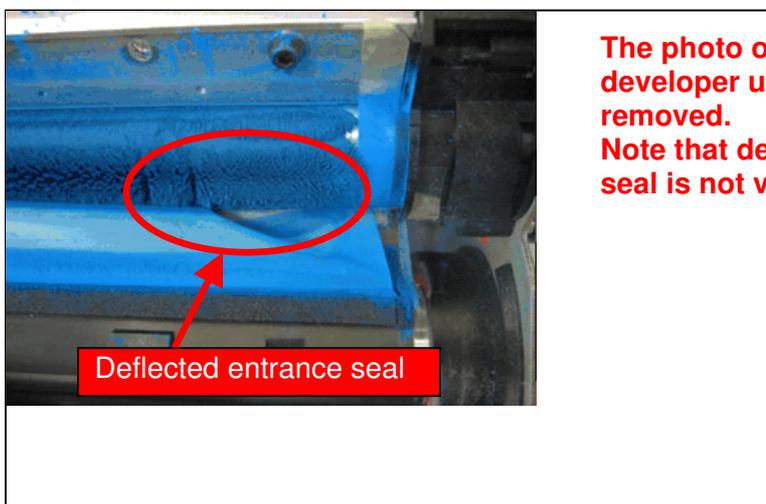
Reference

Rotating the development rollers counterclockwise with the developer installed will cause the entrance seal to deflect (especially at the edge).
