Model: Aries-C1.5	Date: 04-Oct-10	No.: RD095001h
-------------------	-----------------	----------------

Subject: Firmware Release Note: Engine		Prepared by: T. Miyamoto	
From: 1st PP Tech Service Sect., PP Tech Service Dept.			
Classification:	<input type="checkbox"/> Troubleshooting	<input type="checkbox"/> Part information	<input type="checkbox"/> Action required
	<input type="checkbox"/> Mechanical	<input type="checkbox"/> Electrical	<input type="checkbox"/> Service manual revision
	<input type="checkbox"/> Paper path	<input type="checkbox"/> Transmit/receive	<input type="checkbox"/> Retrofit information
	<input type="checkbox"/> Product Safety	<input checked="" type="checkbox"/> Other (Firmware)	<input checked="" type="checkbox"/> Tier 2

This RTB has been issued to announce the firmware release information for the **Engine**.

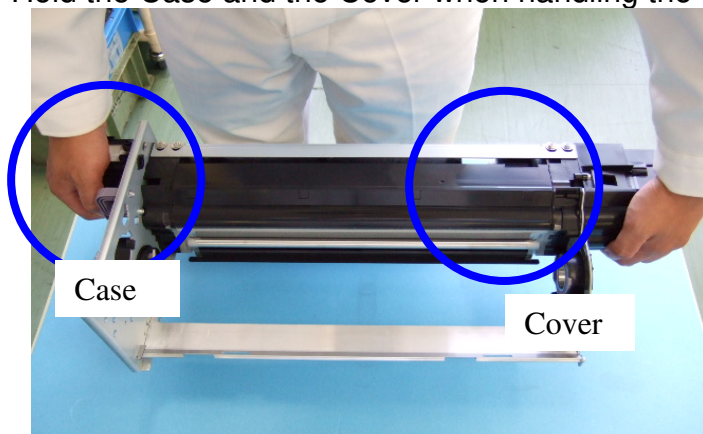
Hold the Case and the Cover when handling the developer unit.

- Always hold the prescribed locations when handling the developer unit.
- Never apply external pressure to the front and rear plates and the stay.

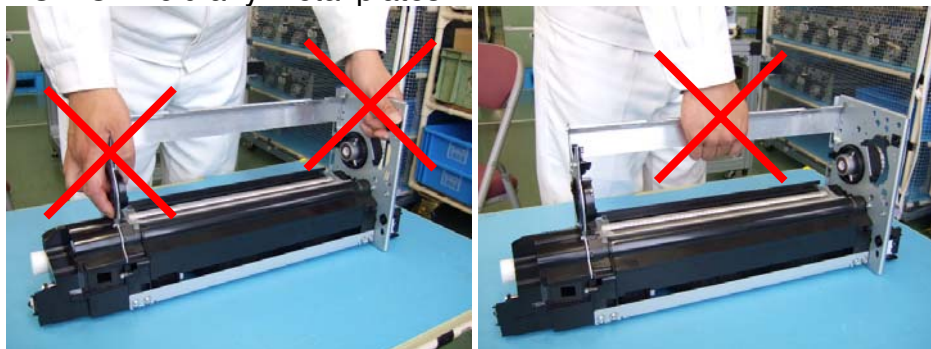
DO NOT hold any metal plates

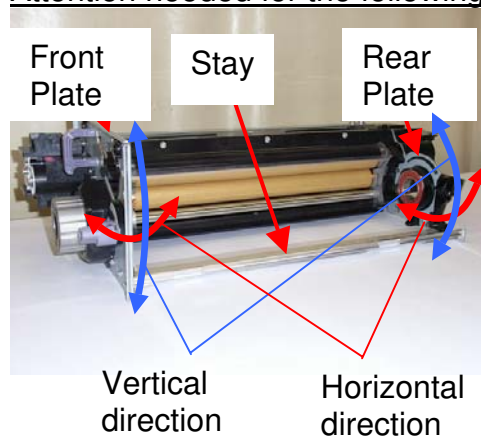
Attention needed for the following parts

Applying external pressure will deform the front and rear plates in vertical and horizontal directions, resulting in fluctuation of the PG.

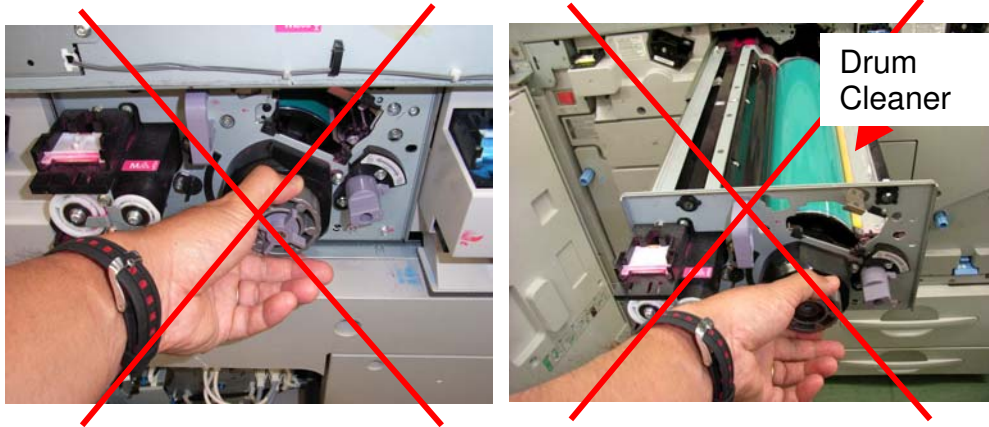
Do NOT fasten the drum knob when the developer unit is installed.

Do NOT fasten the drum knob when the drum cleaner is installed.

If the drum knob is loosened while the drum cleaner is installed, make sure to remove the drum cleaner before fastening the drum knob.

Never fasten the drum knob when the drum cleaner is installed.

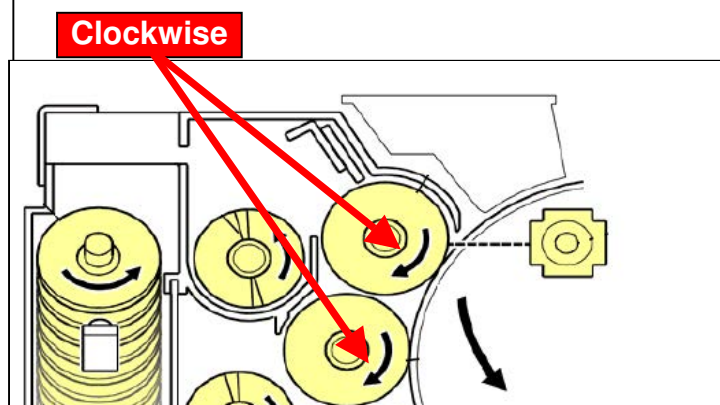
Rotating the development rollers counterclockwise with the developer installed will cause toner to adhere to the development rollers (see Reference below), resulting in higher chances of damaging the drums. Make sure to clear out the developer from the unit in advance when rotating the developer rollers counterclockwise.

Also, please do NOT clear the PM counter if the developer removed is to be re-installed and used again.

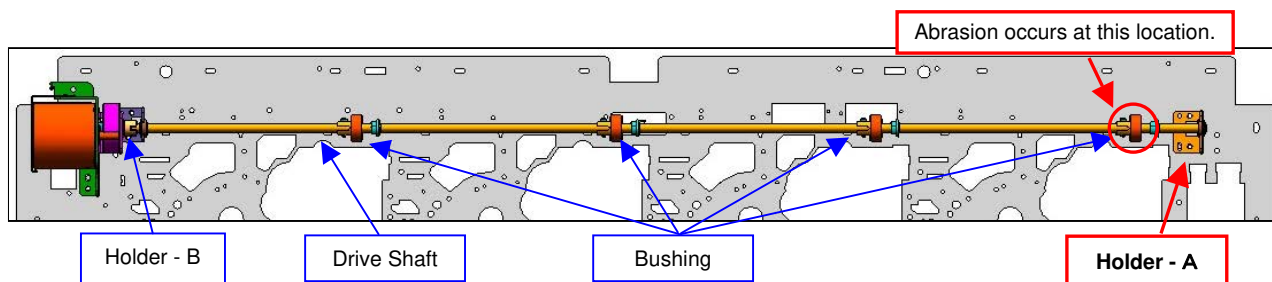
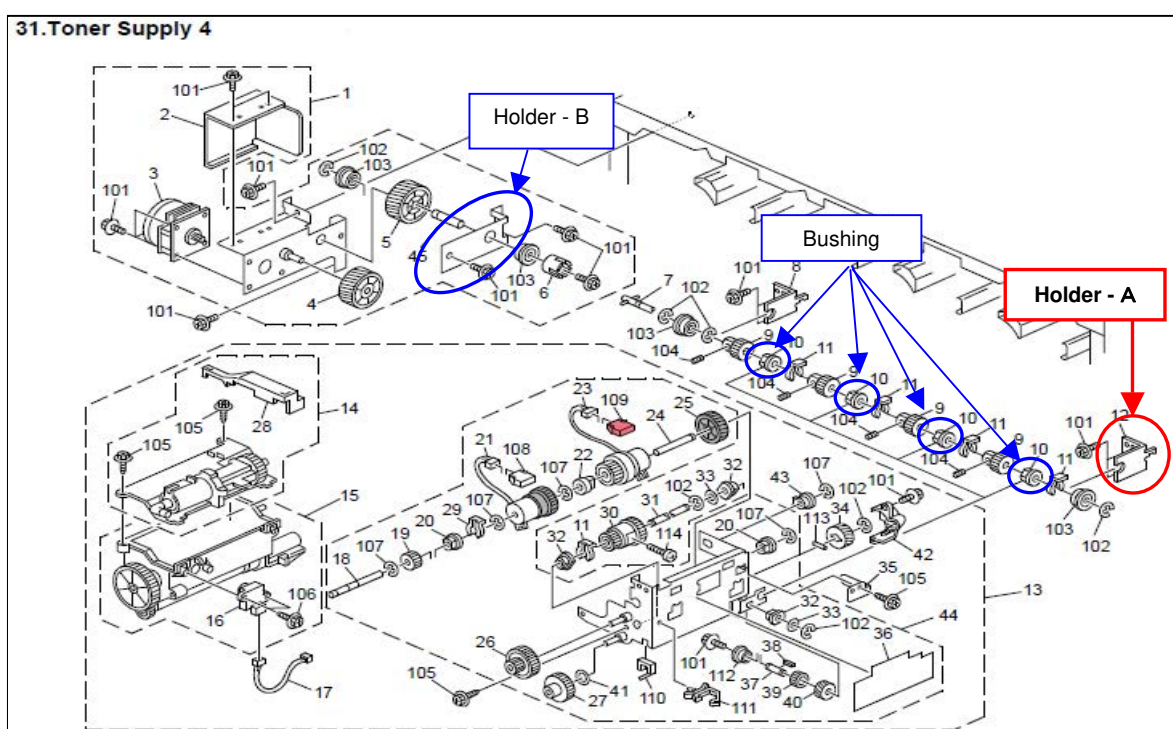
31.Toner Supply 4

Variations in the precision of assembly of the bushing/holders that fix the sub-hopper units' drive shaft apply stress and causes wear on the drive shaft. (Abrasion of the drive shaft occurs at the bushing closest to "Holder-A".)

- The bushings and Holder-B will give enough support to secure the drive shaft. Removal of the Holder-A will not affect the function.
- Removing the Holder-A will prevent further abrasion of the drive shaft and SC328.
- A worn drive shaft can be continuously used and will not affect the function.

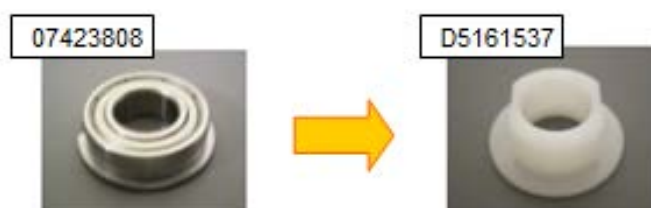
1, The bearing was changed as shown in the photo below.

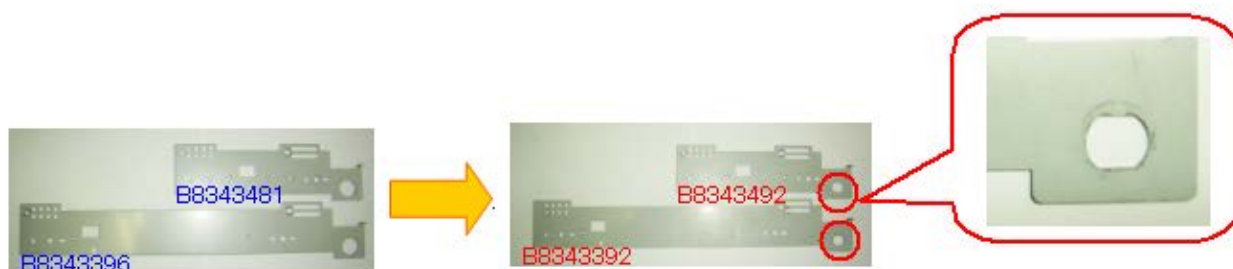
2, The size of the holes on the plates were reduced to correspond with the modified bearings.

- **Make sure all 3 parts shown in the above table are replaced as a set.**
- **The modification described in this bulletin also applies to Aegis-C1 (D016), Aries-C1 Lt (D097), LCT RT4000 (D350), LCT RT5020 (D355), and LCT RT5050 (D532).**

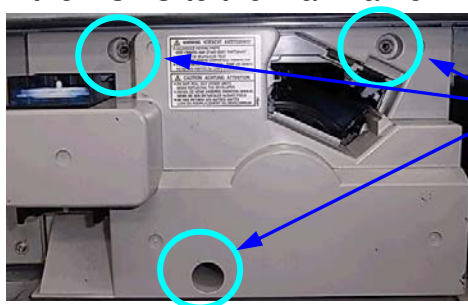
The Inner Cover must always be fastened with the 3 screws circled in blue in the photo below when in operation. Note that these screws not only function to hold the cover but fix the PCDU to the mainframe.

The development unit will be positioned incorrectly when operated without the Inner Cover and the screws, causing scratches on the drum surface and uneven image density.

Never operate the machine without the Inner Cover or the screws.

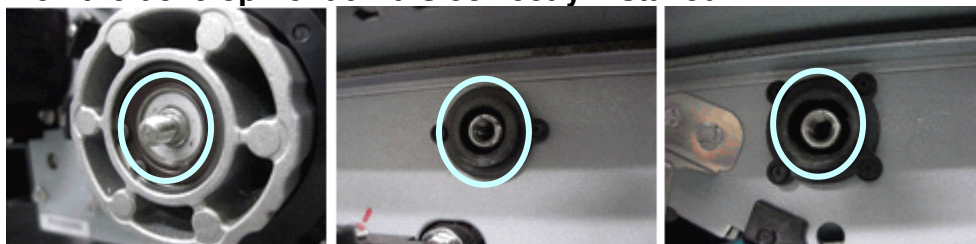
When the development unit is correctly installed...

The surface of the knob and the adjacent area (black-colored) is almost flush, as shown in the left photo. Also, the screw holes for attaching the inner cover should be clearly visible as shown in the center and right photos.

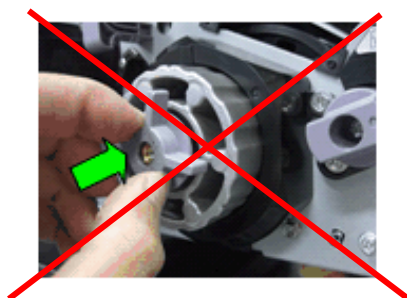
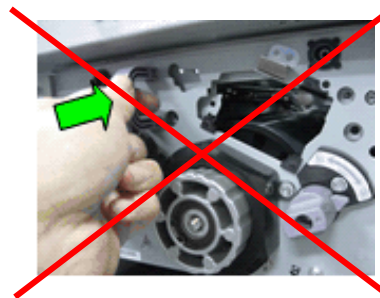
Do not attempt to forcefully fasten the (cross-shaped) drawer stop knob by shoving in the unit. Doing so will NOT help install the unit completely but will only damage the teeth of the internal gear.

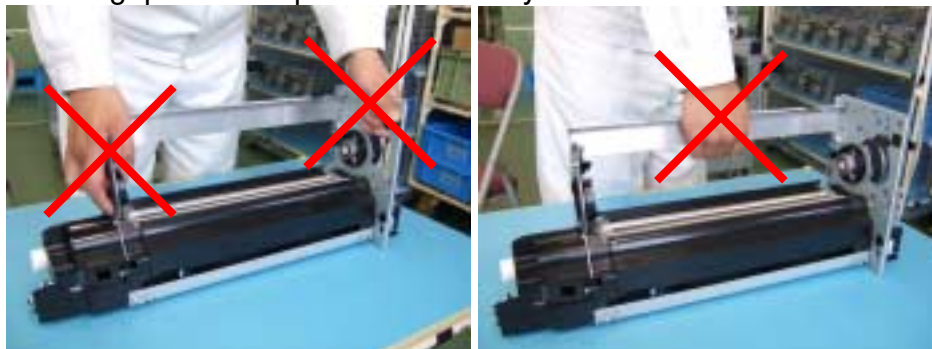
Do not grip the face plates or the stay.

Applying external pressure will deform the front and rear plates in vertical and horizontal directions, resulting in fluctuation of the PG.

- Always hold the prescribed locations when handling the development unit.
- Never apply external pressure to the front and rear plates and the stay.
