Model: Aries-P1.5	Date: 04-Oct-10	No.: RM077001h
-------------------	-----------------	----------------

Subject: Firmware Release Note: Engine		Prepared by: T. Miyamoto	
From: 1st PP Tech Service Sect., PP Tech Service Dept.			
Classification:	<input type="checkbox"/> Troubleshooting <input type="checkbox"/> Mechanical <input type="checkbox"/> Paper path <input type="checkbox"/> Product Safety	<input type="checkbox"/> Part information <input type="checkbox"/> Electrical <input type="checkbox"/> Transmit/receive <input checked="" type="checkbox"/> Other (Firmware)	<input type="checkbox"/> Action required <input type="checkbox"/> Service manual revision <input type="checkbox"/> Retrofit information <input checked="" type="checkbox"/> Tier 2

This RTB has been issued to announce the firmware release information for the **Engine**.

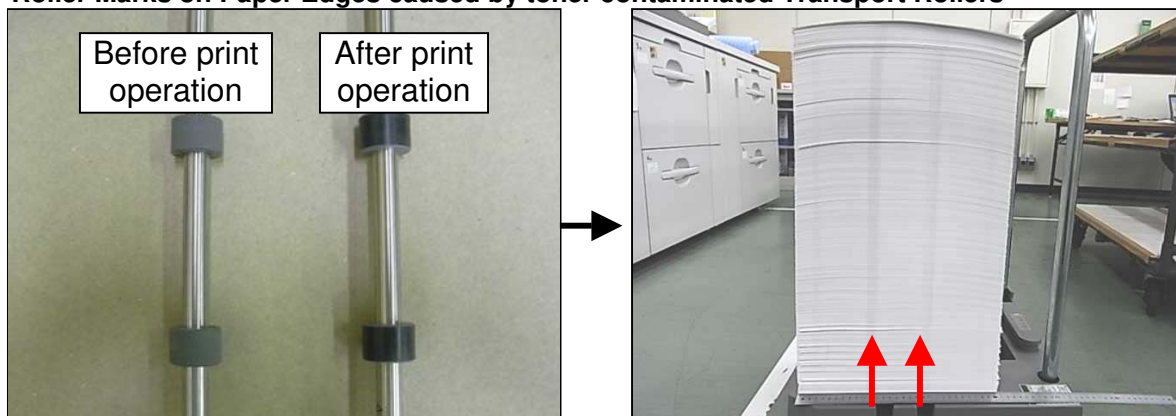
Roller Marks on Paper Edges caused by toner contaminated Transport Rollers

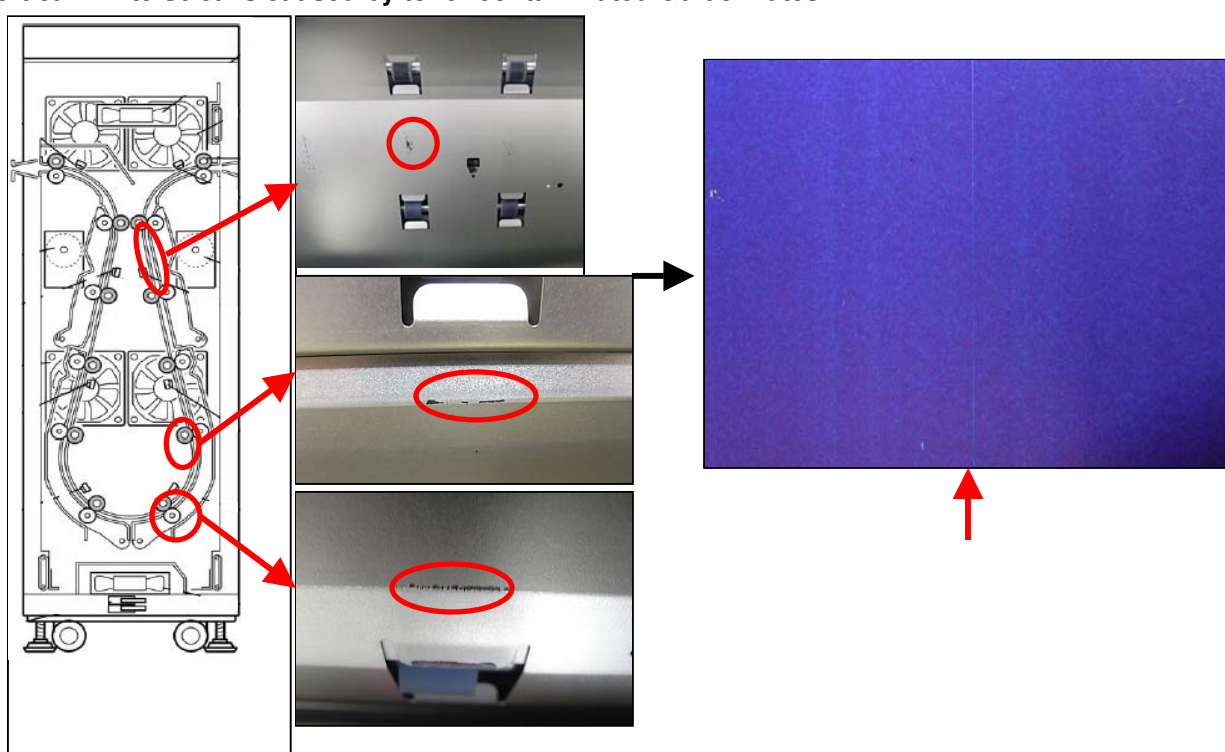
Vertical White Streaks caused by toner contaminated Guide Plates

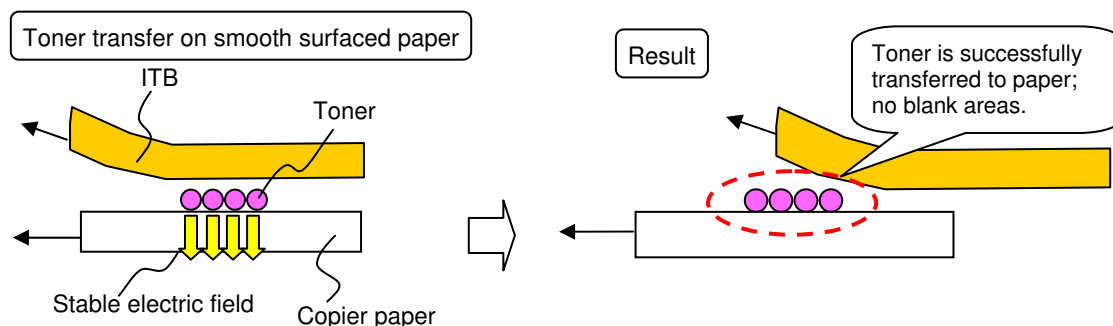
- Unsmooth paper surface; unstable electric field -

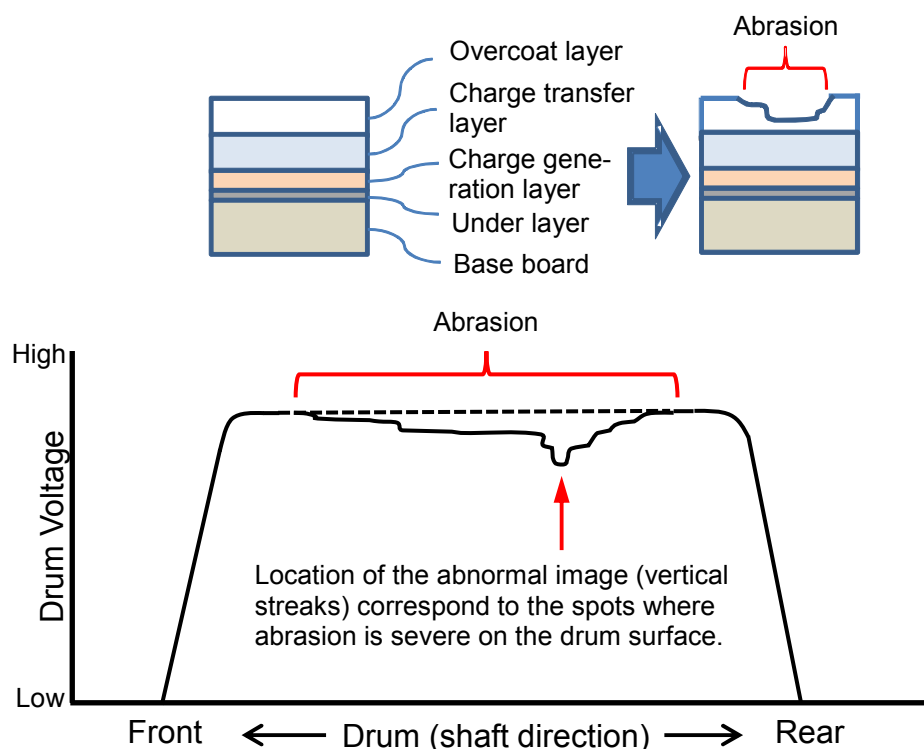
Contact between the cleaning components and OPC drum in the repeated cleaning operation wears the drum surface over time. As shown in the illustration below, the drum used for Aries consists of 5 layers. While the topmost overcoat layer is hard and durable, the charge transfer and charge generation layers are much more delicate. Once the overcoat layer is removed through abrasion, the two layers beneath will wear out very quickly, resulting in abnormal images. This however will not occur for 2,400kp, which is the prescribed drum life, provided that the machine is used under normal conditions.

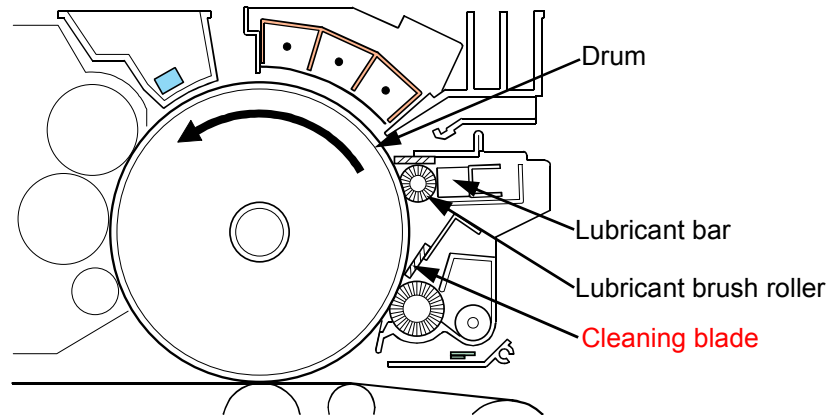
If the drum surface is not sufficiently lubricated, excess friction between the drum and cleaning blade could cause the cleaning bade to flip (or bend) and scratch the drum.

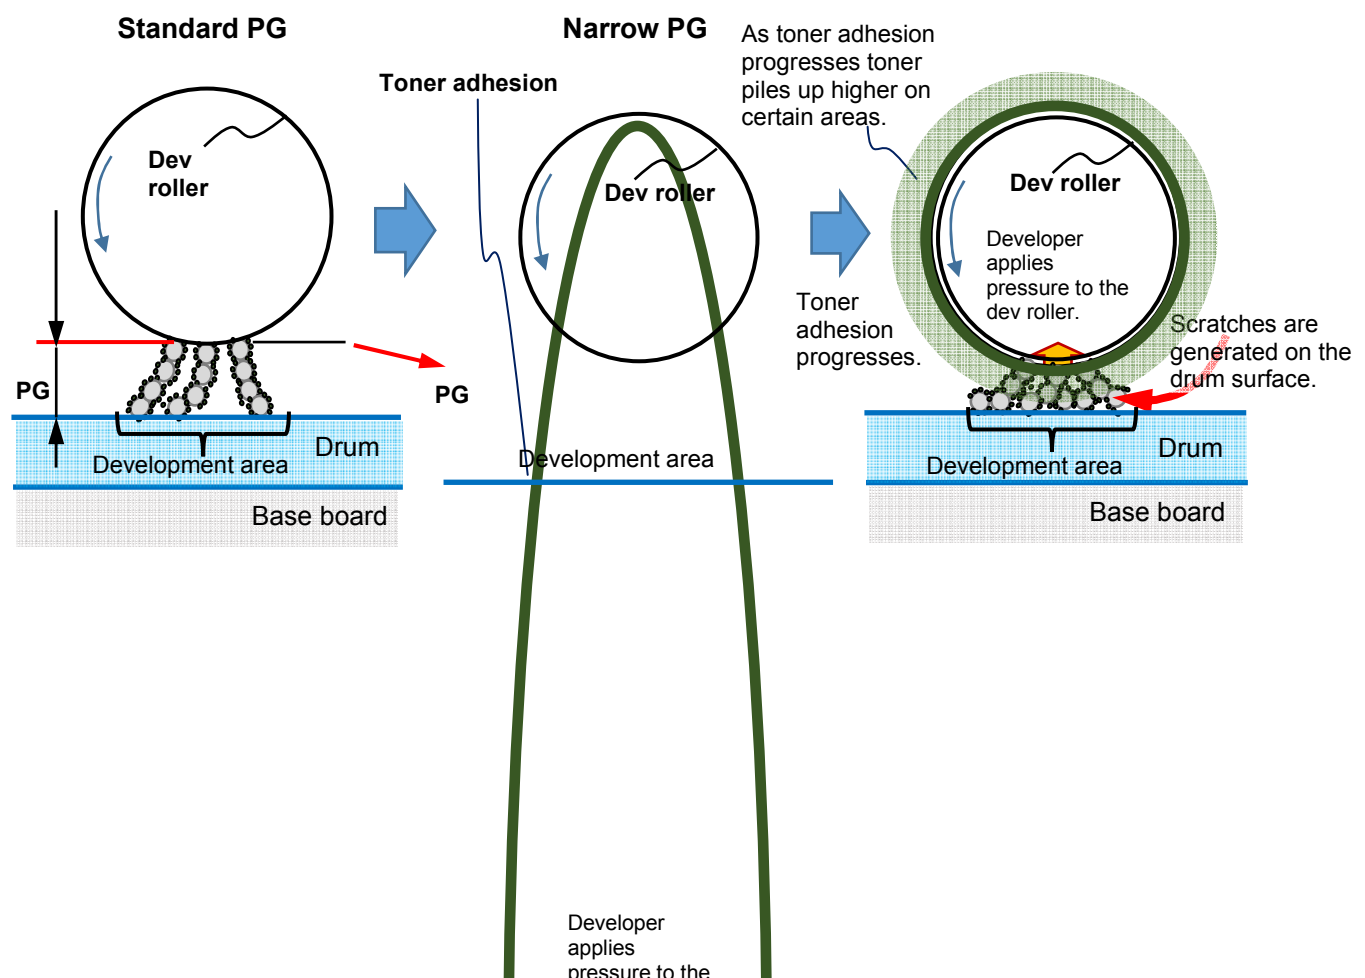
Another factor that causes drum scratches is a narrow PG (potential gap), in which the gap between the development roller and drum is narrower than the specification. In this condition, stress is applied to the developer in the development process because the developer is forced to move through a narrow gap, generating excess electrical current along with heat and pressure. As a result, developer adheres to the surface of the development roller and toner accumulation continues, eventually scratching the drum.

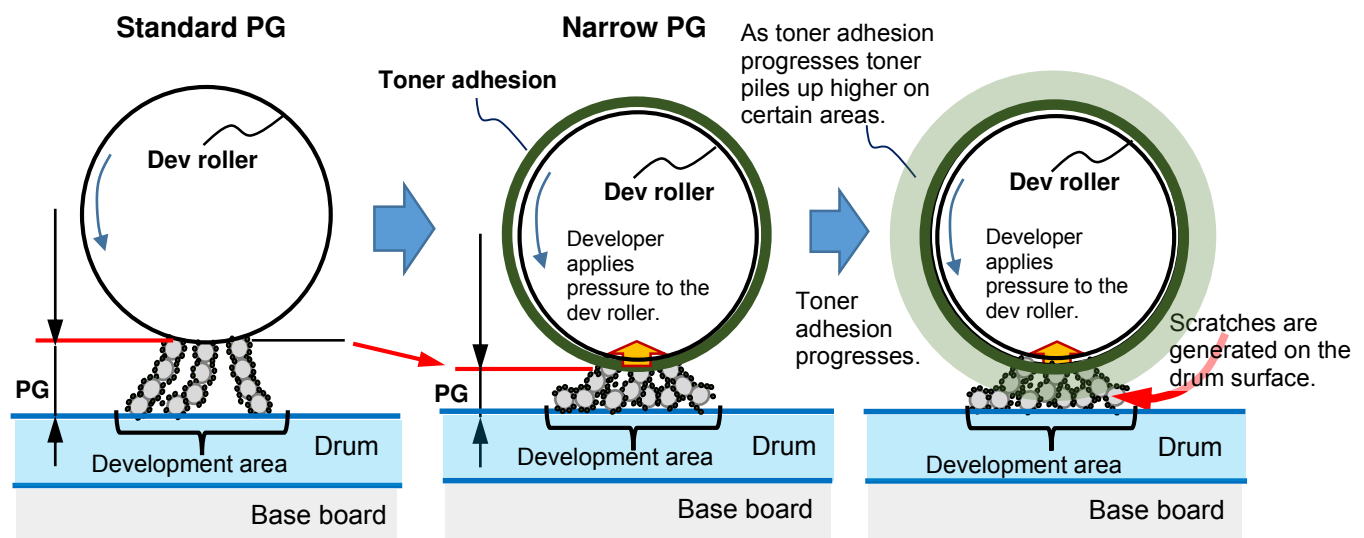
Drum scratches occur because the PG (potential gap; gap between the development roller and drum) is narrower than the specification. In this condition, stress is applied to the developer in the development process because the developer is forced to move through a narrow gap, generating excess electrical current along with heat and pressure. As a result, developer adheres to the surface of the development roller and toner continues to build up, eventually scratching the drum.

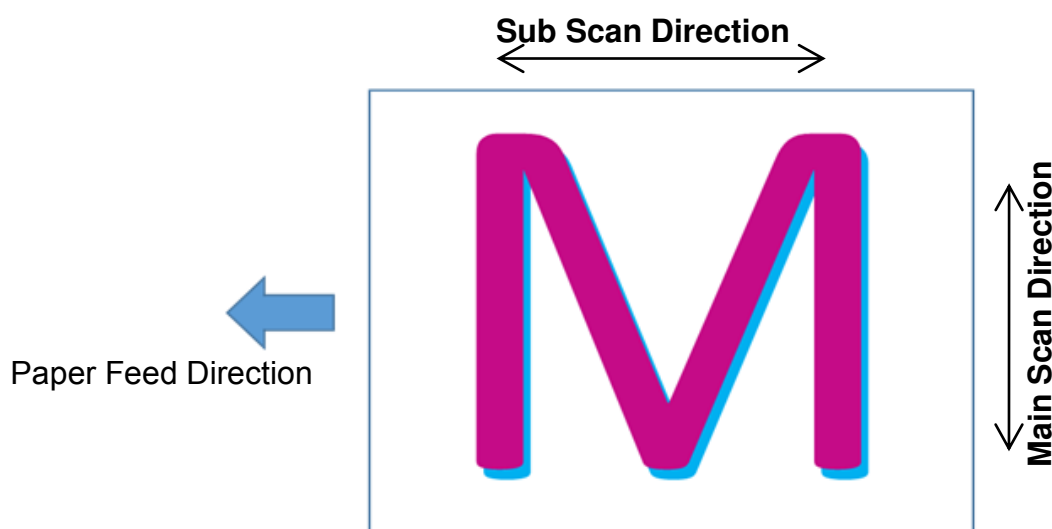
Color misalignment in Main and/or Sub scan direction even after executing MUSIC
