Technical Bulletin

Model: AG-P1	Date: 18-Sep-08	No.: RG178001c

a italioo haro boon addo			
Subject: Firmwar	re Release Note: NIB		Prepared	d by: H.Matsui
From: PPBG/Ser	vice Planning Dept.			
Classification:	☐ Troubleshooting ☐ Mechanical	☐ Part informa☐ Electrical	tion	☐ Action required ☐ Service manual revision
	☐ Paper path ☐ Other ()	☐ Transmit/rec	eive	☐ Retrofit information

This RTB has been issued to announce the firmware release information for the NIB.

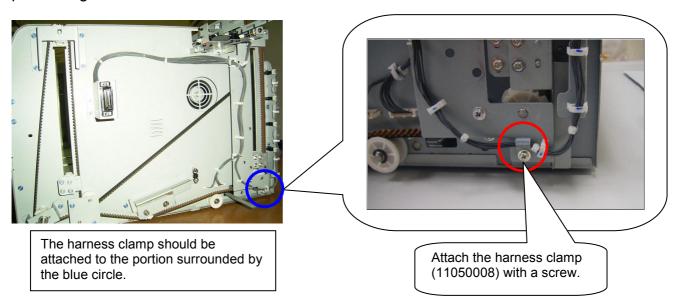
If the harness (PN D3555315B) was already damaged, replace it with a new one before performing this work.

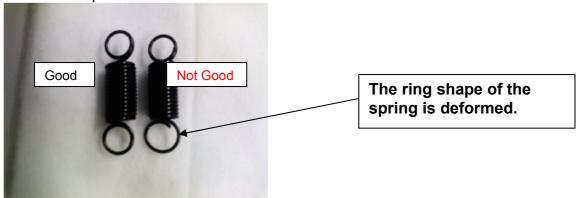
If the spring of the oil supply unit is stretched by long-nose pliers when it is removed from the oil supply unit, the spring may be deformed. As a result, the pressure of the oil supply roller may become uneven and this causes an oil mark problem. Refer to the picture below.

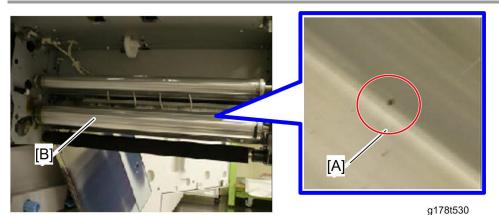
Black Spots at 125 mm Interval

If black spots at 125 mm interval appear on the outputs, these black spots may be caused by waste toner [A] adhered on the idle roller [B] against the ITB (Image Transfer Belt) cleaning brush roller. Clean the idle roller [B] against the ITB cleaning brush roller.

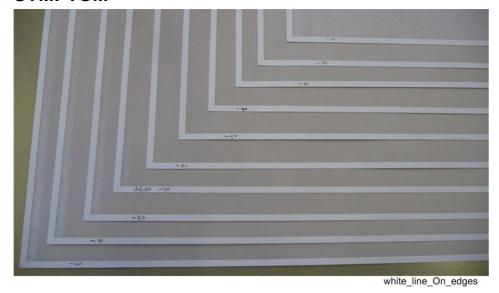
A white line appears on each edge of the paper when large size and heavy weight paper (A3 SEF or more, 200 g/m^2 or more) is used for printing or copying.

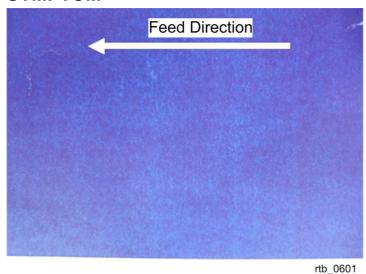
Poor image transfer occurs on the outputs in LL condition (Temperature: 10°C or less, Humidity: 15% or less).

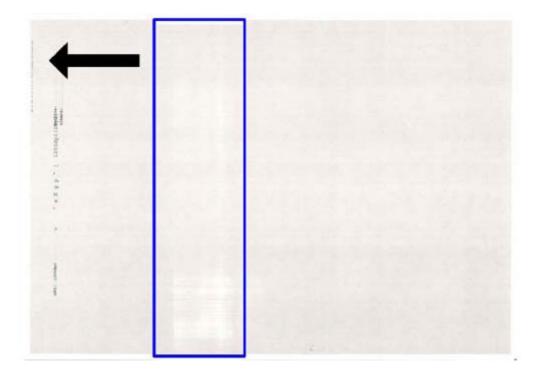
Blurred Image caused by ozone will appear (see below).

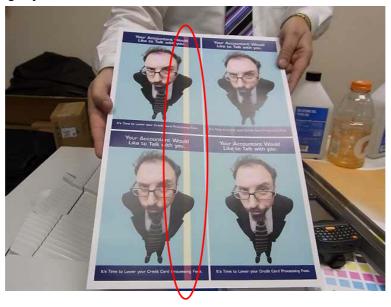
Partial discoloration; void of color(s). The photo below shows an example of an output not showing Cyan.

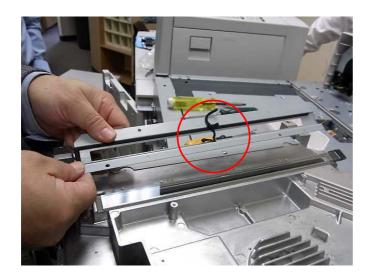
A dust shield glass that was inserted at an angle jams and peels off the guiding seal and blocks the laser beam, leaving the blocked area not written.

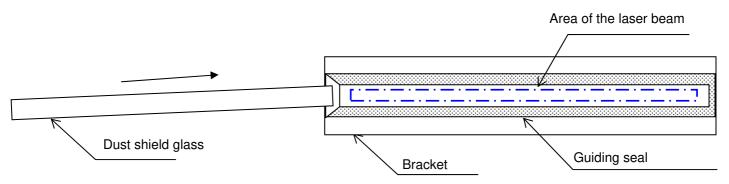
1. The dust shield glass is inserted in the bracket at an angle.

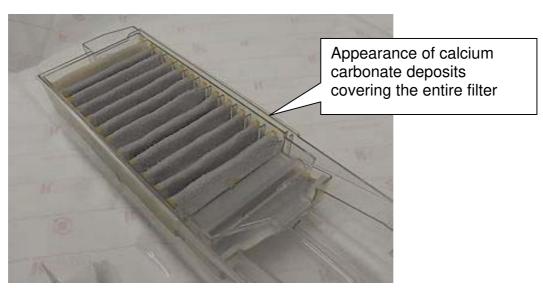
On your next service visit, please check for any calcium carbonate deposits in the Oil Tank Filter. If the entire filter is covered with the deposits, replace with a new filter regardless of the PM counter having or not having reached 400K. Replacement is required for both filters.

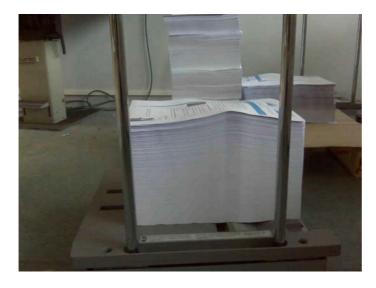
- 1. Curled sheets (Curls cannot be removed completely by the De-curl unit.)
- 2. Lump(s) formed in the stacked sheets (as in the photo below) caused by a particular area of the image containing high toner density

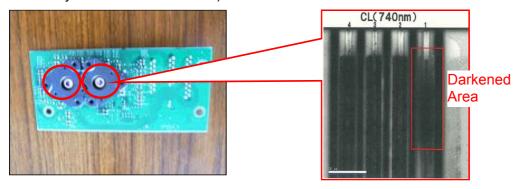
Machines of a particular lot have been identified with defect in the laser diode arrays in which the laser is not emitted due to a partially "darkened area" caused by a false production process. (This is the newly identified LDU defect.)

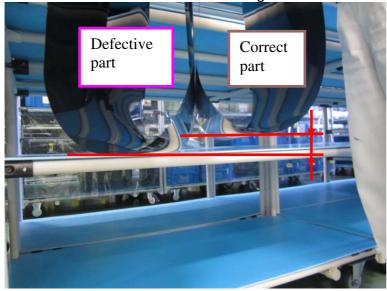
2 pieces of defective ITBs have been distributed to either NSPC, ESPC or both. The defective ITBs have 33 mm longer circumference than the correct ones.

If a defective ITB is used, tension cannot be applied and SC 476 will appear. The photos below show the defective ITB in which tension is not applied even the handle is turned to left.

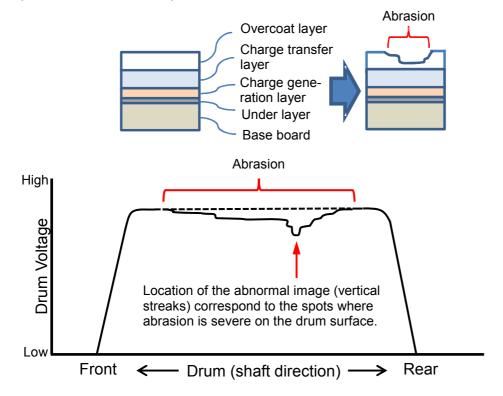
Contact between the cleaning components and OPC drum in the repeated cleaning operation wears the drum surface over time. As shown in the illustration below, the drum used for Aries consists of 5 layers. While the topmost overcoat layer is hard and durable, the charge transfer and charge generation layers are much more delicate. Once the overcoat layer is removed through abrasion, the two layers beneath will wear out very quickly, resulting in abnormal images. This however will not occur for 2,400kp, which is the prescribed drum life, provided that the machine is used under normal conditions.

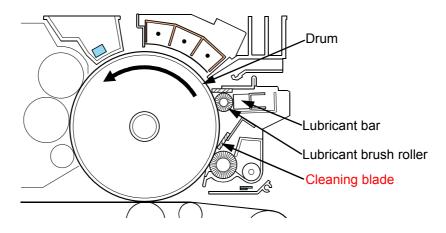
If the drum surface is not sufficiently lubricated, excess friction between the drum and cleaning blade could cause the cleaning bade to flip (or bend) and scratch the drum.

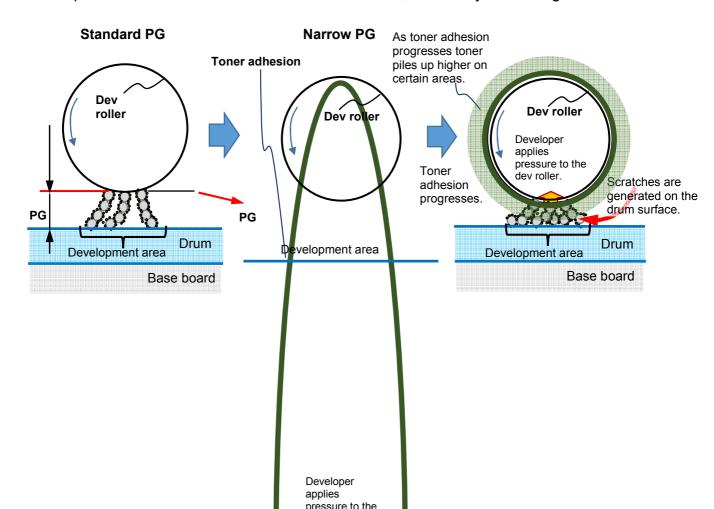
Another factor that causes drum scratches is a narrow PG (potential gap), in which the gap between the development roller and drum is narrower than the specification. In this condition, stress is applied to the developer in the development process because the developer is forced to move through a narrow gap, generating excess electrical current along with heat and pressure. As a result, developer adheres to the surface of the development roller and toner accumulation continues, eventually scratching the drum.
