Model: ME-P1	Date: 20-Oct-11	No.: RM101001d
--------------	-----------------	----------------

Subject: Firmware Release Note: Controller for China models		Prepared by: Y. Miyamoto	
From: 1st Tech Service Sect., MFP/Printer Tech Service Dept.			
Classification:	<input type="checkbox"/> Troubleshooting <input type="checkbox"/> Mechanical <input type="checkbox"/> Paper path <input type="checkbox"/> Product Safety	<input type="checkbox"/> Part information <input type="checkbox"/> Electrical <input type="checkbox"/> Transmit/receive <input checked="" type="checkbox"/> Other (Firmware)	<input type="checkbox"/> Action required <input type="checkbox"/> Service manual revision <input type="checkbox"/> Retrofit information <input checked="" type="checkbox"/> Tier 2

Model: ME-P1/MF1a/MF1b		Date: 22-Feb-12	No.: RM101006
Subject: Troubleshooting Guide for "Dirty Background"		Prepared by: Y. Murata	
From: 3rd Tech Service Sect., MFP/P Tech Service Dept.			
Classification:	<input checked="" type="checkbox"/> Troubleshooting <input type="checkbox"/> Mechanical <input type="checkbox"/> Paper path <input type="checkbox"/> Product Safety	<input type="checkbox"/> Part information <input type="checkb

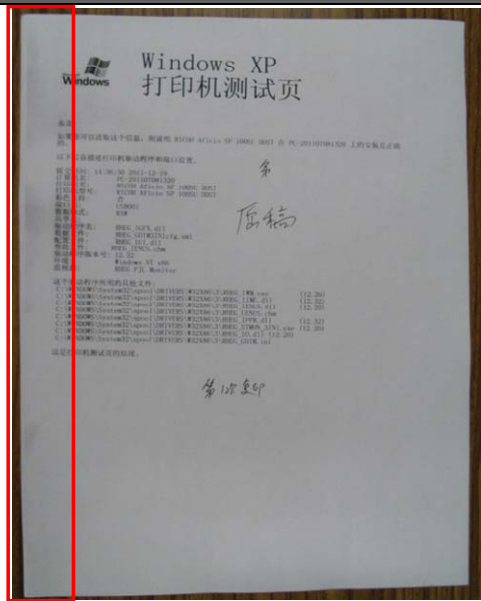
No.	Image Sample	No.	Image Sample
1

No.	Function	Model	Occurrence conditions, other details	Cause	Action
1	Copier	MF1a	<p>Appears on the left edge of the paper when making copies using the platen cover.</p>

<p>The white plate inside the platen cover warps, which lifts the left edge of the original off the glass.</p>

<p>Rear sponges were too far away from the edge to prevent warping</p>	<p>Replace the platen cover with the modified part (on which the positions and quantity of attachment sponges was changed to prevent warping).</p>

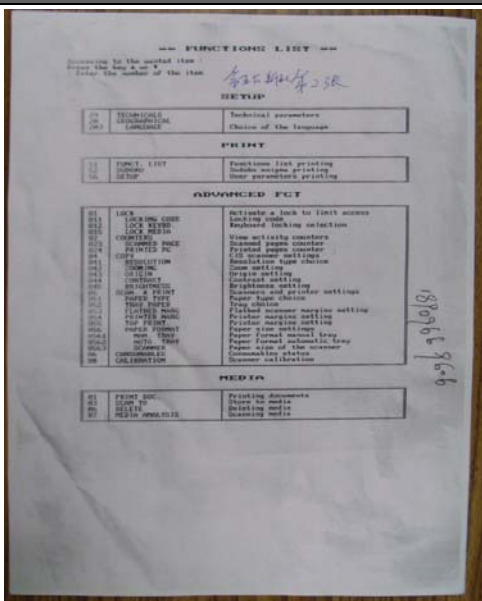
2

<p>The focal point of the CIS is relatively shallow, making it difficult to scan wrinkled or creased areas of the original.</p>	<p>Do the following to reduce the degree of dirty background. See the O/I for detailed procedures.</p> <ol style="list-style-type: none"> 1) Set the scanning mode (Original Type) to Text. 2) Decrease the scanning image density

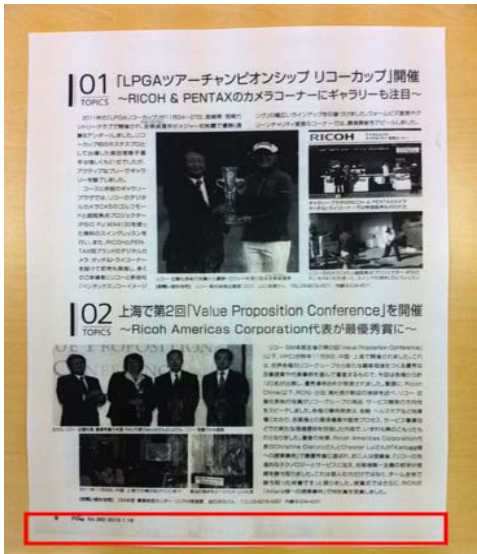
3	Copier	MF1b	<p>Appears at the trailing edge when making copies of stiff paper types using the ADF</p>

<p>If the paper (original) is very stiff, it will not be close to the scanning glass after passing through the ADF.</p>	<p>When making copies of originals with a relatively high stiffness, scan using the exposure glass (instead of the ADF), or perform the following settings. See the O/I for detailed procedures.</p> <ol style="list-style-type: none"> 1) Set the scanning mode (Original Type) to Text. 2) Decrease the scanning image density.

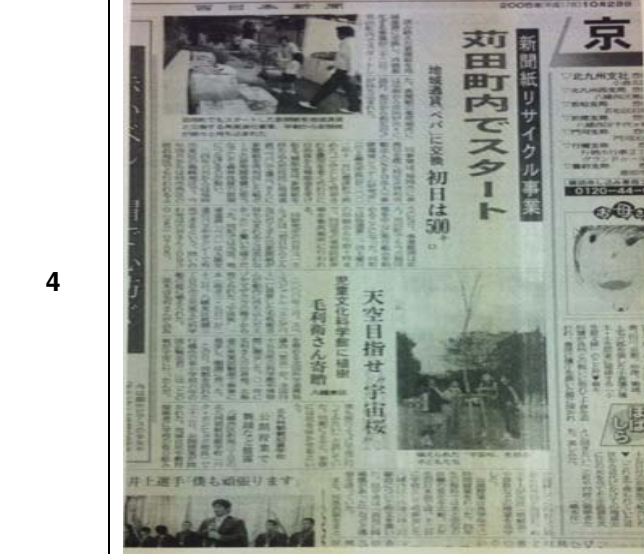
4	Copier	MF1a MF1b	Occurs when making copies of originals with dark backgrounds (Only copied area)

The scanner detects the background as part of the image.	(Same as No. 2 above)
5	Printer	P1 MF1a MF1b	Appears from the second sheet onward at the center of the leading edge, when making duplex prints or when printing onto pre-printed paper Note: This occurs more easily when there are solid image or halftone areas on the rear side of the paper.

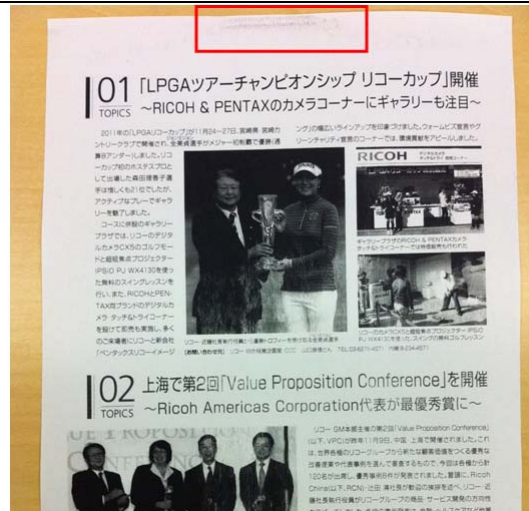
5

The rear side of the first sheet (on which the image has already been printed) rubs against the front side of the second sheet. This is a limitation of any machine on which the feed rollers contact the rear side of the paper, and which uses a friction pad paper-separation mechanism. (This also occurs in the RN-P/MF series).	When printing in duplex mode or onto pre-printed paper, feed each sheet individually, one by one.
6	Printer	P1 MF1a MF1b	Occurs when all of the following conditions are met: - The AIO is replaced - After this, more than 100 sheets are printed continually. Note: Dirty background may occur anywhere in the document.	The charge increases under these conditions, which attracts more toner to the paper.	If this occurs, wait a while before using the machine again.

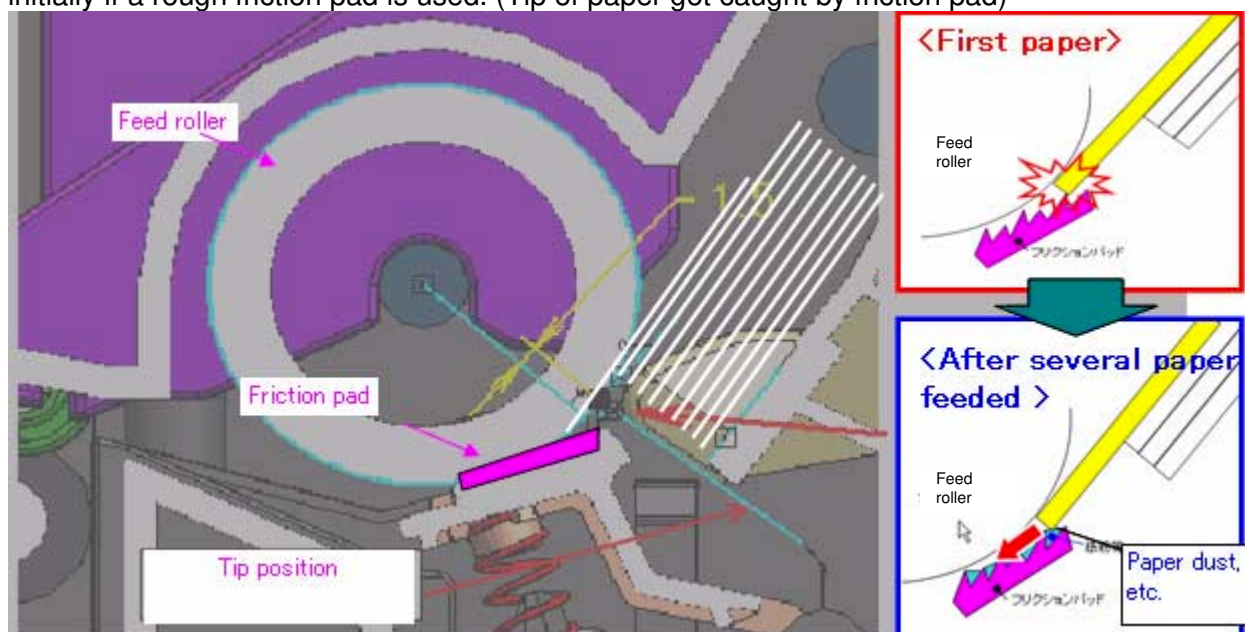
There is variation in roughness of the friction pad surface and some machines show high jam ratio initially if a rough friction pad is used. (Tip of paper got caught by friction pad)

*Paper dust will make the surface become smooth after several sheets of paper have been fed.

**Permanent countermeasure will be applied from July production. The material of the pad will be changed.

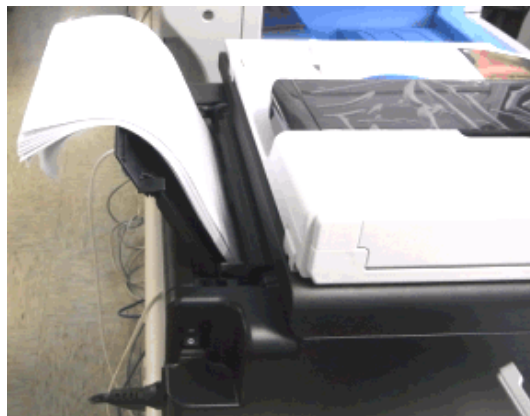
1. A paper jam or paper wrinkling may occur if curled paper is loaded in the paper tray.

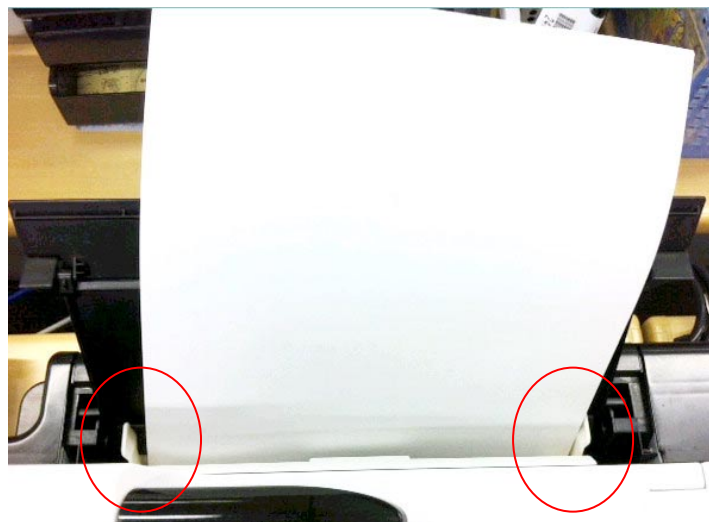
2. A paper feed jam may occur if the side fence is not locked tightly in place.

1. The paper absorbs moisture from the air, most easily during rainy/wet seasons
2. The loose side fences allow the paper to move from its parallel (straight) orientation.
