Model: Model PN-C1			Date: 4-Dec-06		No.: RB299001
RTB Reissue The items in bo	ld italics have been ad	lded.			
Subject: Firmware Release Note: System FW Prepared by: T. Shintani				Shintani	
From: 1st Tech. Support Sec. Service Support Dept.					
Classification:	Troubleshooting	☐ Part info	rmat	tion	n required
	☐ Mechanical ☐ Electrical		ıl	☐ Servi	ce manual revision
	☐ Paper path ☐ Transmit/re		t/rec	eive 🗌 Retro	fit information
	□ Other ()

Model: Model PN	Dat	Date: 7-Jul-07		No.: RB299003		
Subject : ADF No-feed problem					d by: T. S	Shintani
From: 1st Tech.	Support Sec. Service Support I	Dept.				
Classification:	☐ Troubleshooting ☐ Mechanical	☐ Part info		tion		n required ce manual revision
	Paper path	☐ Transm		eive		fit information
	☐ Product Safety	Other ()

Model: Model PN	Dat	te: 7-Jul-07		No.: RB299004		
Subject : The in	Prepared by: T. Shintani					
From: 1st Tech. S	Support Sec. Service Support [Dept.				
Classification:	□ Troubleshooting	☐ Part info	orma	tion	Action	required
		☐ Electric	al] Servic	e manual revision
	☐ Paper path	Transm	it/rec	eive	Retrof	it information
	☐ Product Safety	Other ()

ICOH	I echn	icai B	ull	etın		PAGE: 1/2
odel: Model PN	N-Fa / Model PN

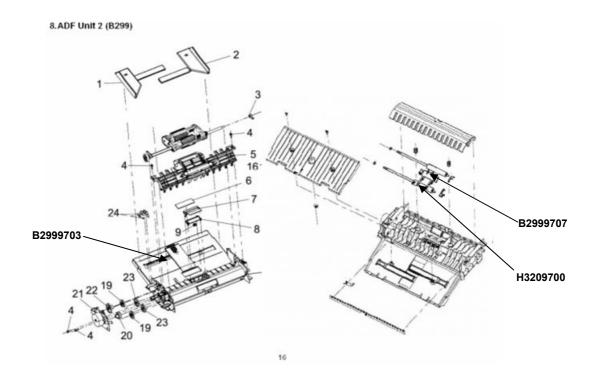
Model: Model PN-C1 Date: 7-Jul-07 No.: RB299003

The document cannot be fed when it is loaded in the ADF.

The paper catches on the ribs of the paper input guide.

If the symptom is reported on a machine produced before the cut-in S/N, replace the paper input guide, paper feed roller foam, and paper deflect guide with the following new parts **together as a set:**

B2999703: PAPER INPUT GUIDE

H3209700: PAPER FEED ROLLER FOAM COUNTERMEASURE

B2999707: PAPER DEFLECT GUIDE

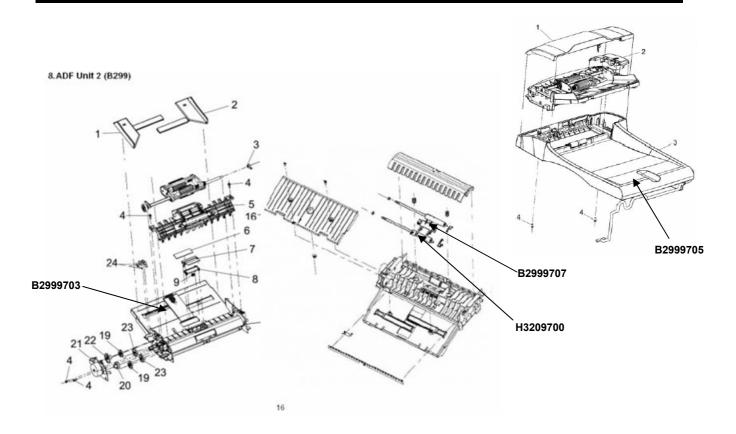
Model: Model PN-C1 Date: 7-Jul-07 No.: RB299004

When the document is scanned by the ADF, parts of the image are slightly elongated along the sub-scan direction (at 13mm, 50mm, 230mm from the leading edge).

The document bumps the paper guide and feed rollers during feeding.

If the symptom is reported on a machine produced before the cut-in S/N, replace the ADF exit tray, paper input guide, foam, and paper deflect guide with the following new parts **together as a set**:

B2999705: ADF EXIT TRAY **B2999703**: PAPER INPUT GUIDE

H3209700: PAPER FEED ROLLER FOAM_COUNTERMEASURE

B2999707: PAPER DEFLECT GUIDE

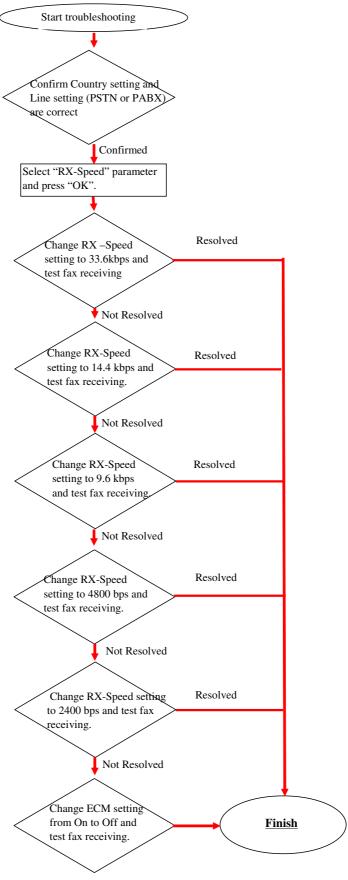
Date: 10-Dec-08 No.: RB299005

- 1. An incoming fax image is blank (but contains the fax headers)
- 2. Some parts of incoming fax Image are shifted or blank.

The fax line is unstable or electrical noise distorts the fax line signal.

Try the troubleshooting Procedure on the next page.

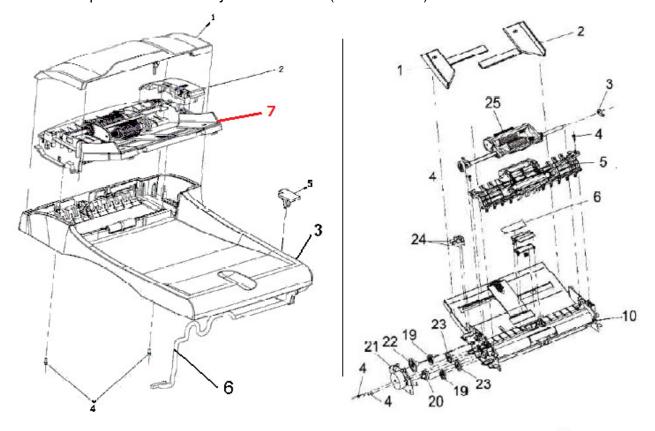
Change/Reason: Vendor change

Due to a vender change, Paper Roller Ass'y (Index 25) cannot be supplied any more. Please replace the assembly of M0489502 (New Index 7) instead.
