Model: PN-MF2a	Date: 27-04-09	No.: RM048001e
----------------	----------------	----------------

Subject: Firmware Release Note: System Firmware		Prepared by: Y.Gaman	
From: 2nd Overseas Tech Support Sec., 2nd PQM Dept.			
Classification:	<input type="checkbox"/> Troubleshooting <input type="checkbox"/> Mechanical <input type="checkbox"/> Paper path <input type="checkbox"/> Product Safety	<input type="checkbox"/> Part information <input type="checkbox"/> Electrical <input type="checkbox"/> Transmit/receive <input checked="" type="checkbox"/> Other ()	<input type="checkbox"/> Action required <input type="checkbox"/> Service manual revision <input type="checkbox"/> Retrofit information <input checked="" type="checkbox"/> Tier 2

Model: PN-MF2b		Date: 07-Aug-09	No.: RM048003
Subject: Fax background appears black		Prepared by: Y.Gaman	
From: 1st Tech. Support Sec. Service Support Dept.			
Classification:	<input checked="" type="checkbox"/> Troubleshooting	<input type="checkbox"/> Part information	<input type="checkbox"/> Action required
	<input type="checkbox"/> Mechanical	<input type="checkbox"/> Electrical	<input type="checkbox"/> Service manual revision
	<input type="checkbox"/> Pap

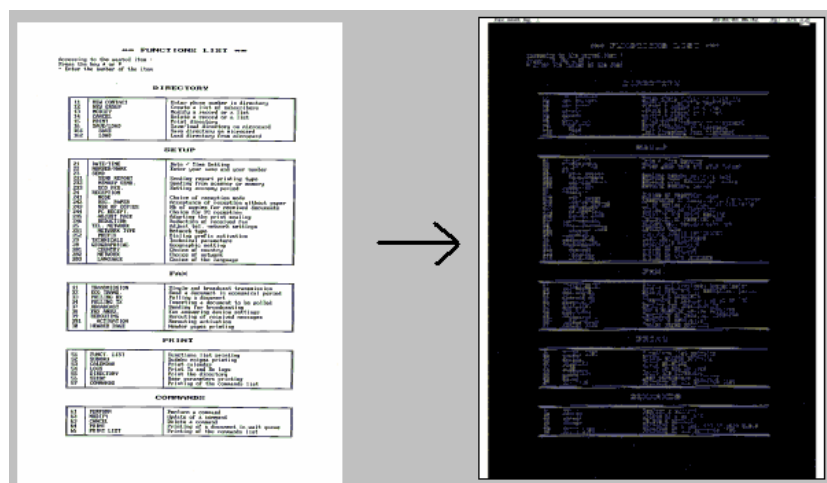
Under the following conditions, the background of a received fax appears black, as shown in the sample below:

- The fax is sent using Delayed Transmission (Memory Transmission)
- Contrast is set to “-----0” and Brightness set to “0-----”.

The same Contrast and Brightness settings for the scanning engine are applied to both copier and fax images. However, fax images are one-bit binary, while copier images are multi-bit digital. When the Contrast and Brightness settings are set to their extreme values (limits), the fax image will appear as shown above.

Please do not set Contrast and Brightness to the settings described above when using Delayed Transmission (Memory Transmission).

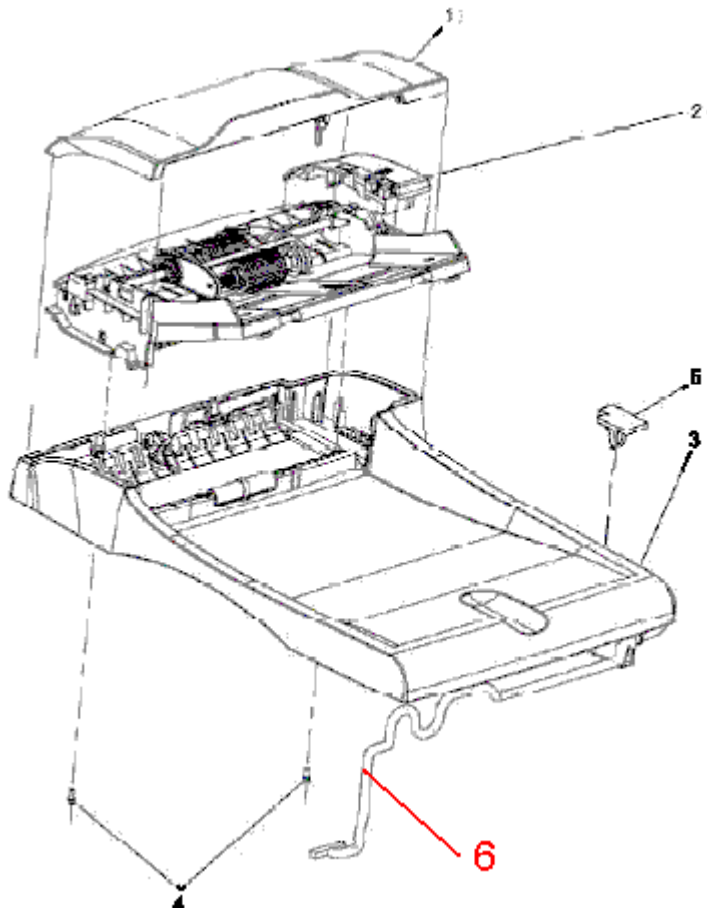
New part number	Description	Q'ty	Int	Page	Index	Note
M0481059	HARNESS:MOTOR & SENSOR	1	-	17	6

Change: This part was added.

Reason: Requests from the field.

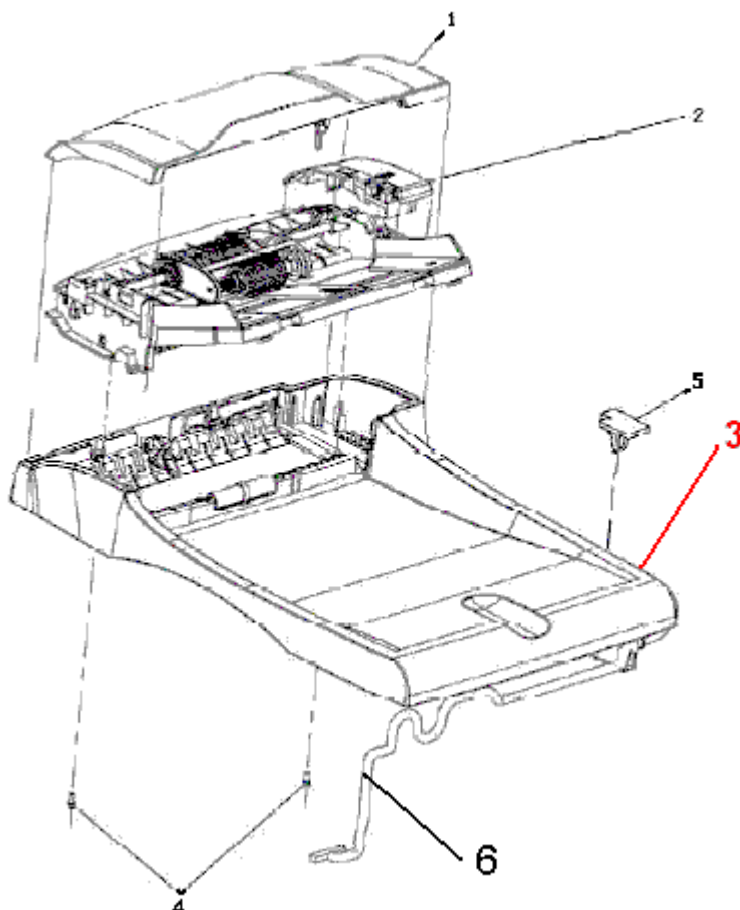
Incorrect part number	Correct part number	Description	Q'ty	Int	Page	Index	Note
M0481056	M0481057	ADF Exit Tray	1	X/O	17	3

Change/Reason: The part number listed in the Parts Catalog for the DF Exit Tray was corrected.

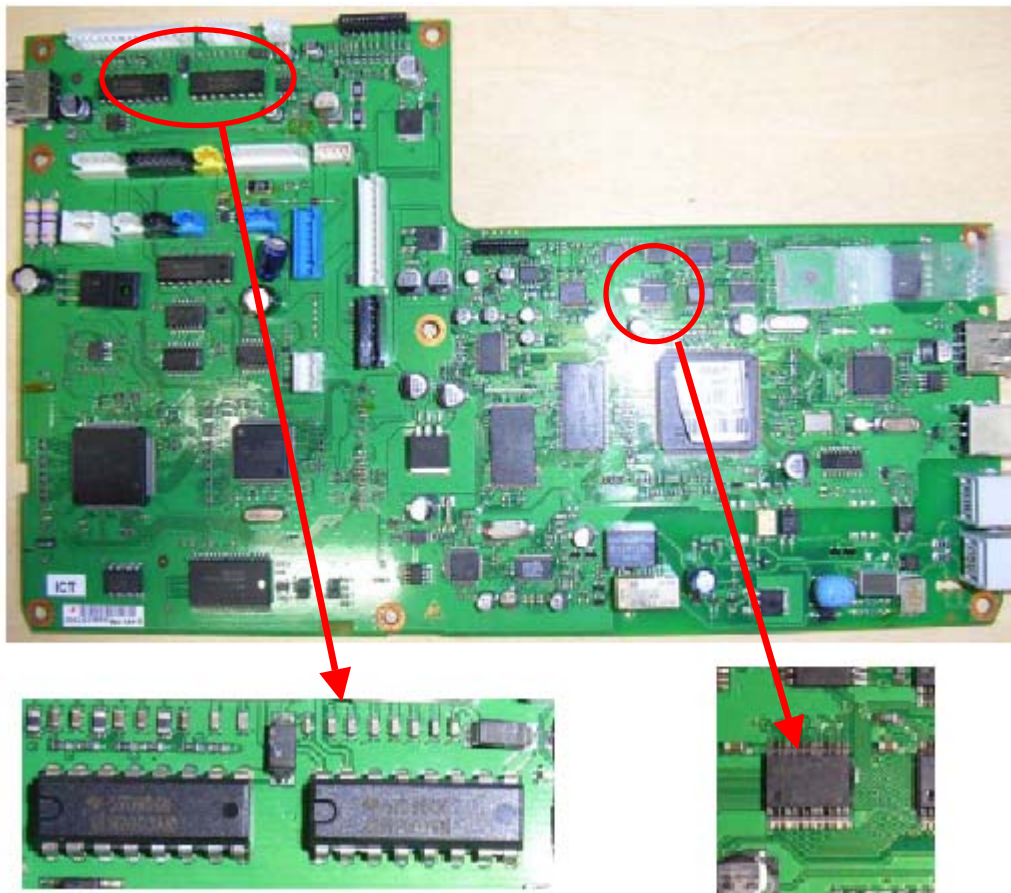
Electronic components to check

An abnormal motor control signal is sent, causing the ADF motor or scanner motor to fail. Eventually, this failure damages the main board.

1. Check the elements of the main board for any damage (see the photos below).
2. If any of the elements are damaged, replace the ADF motor, the scanner motor, and the main board **together as a set**.

Important: If the elements appear normal, you do not need to replace these parts at this time. However if the symptom recurs later, replace these parts (two motors and main board) at that time, together as a set.

3. Upgrade the System firmware to **v2.07g** or newer.

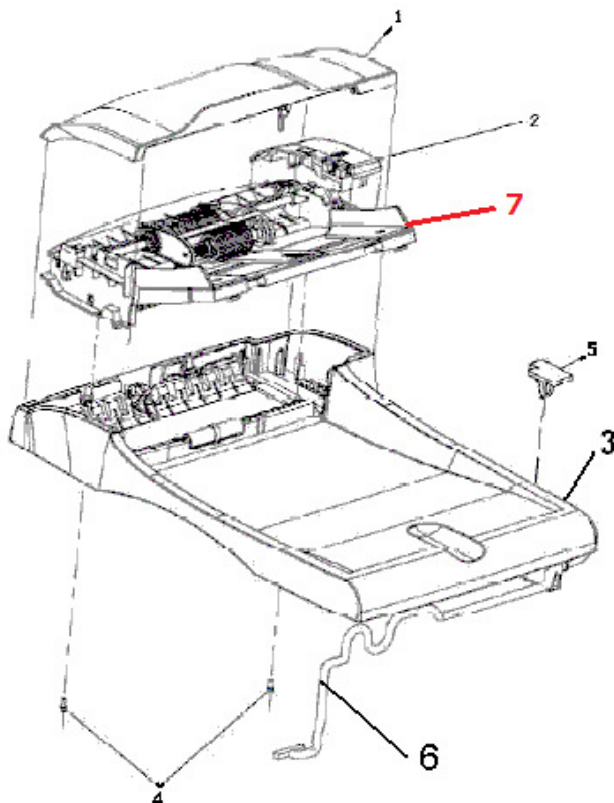
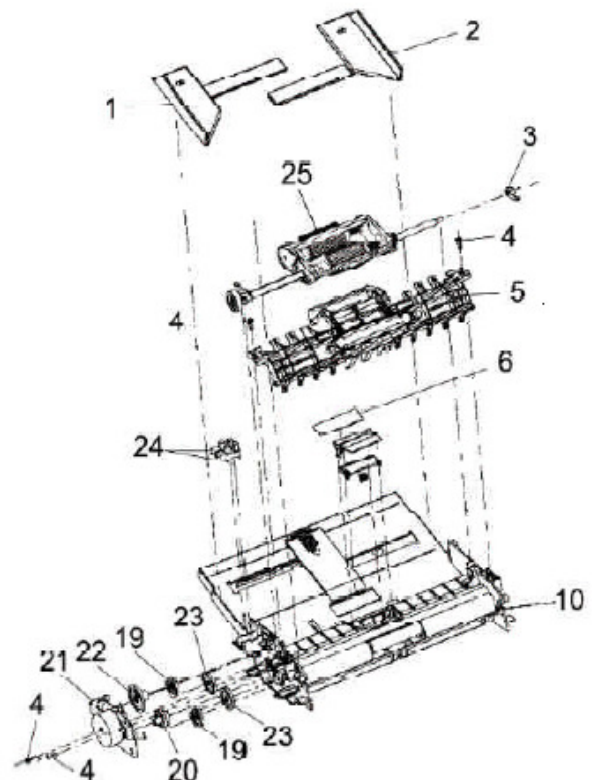
Old part number	New part number	Description	Q'ty	Int	Page	Index	Note
M0489501	-	PAPER FEED ROLLER ASS'Y:253240690	1	X/O	19	25	
-	M0489502	ADF PAPER FEED ASS'Y 253017421:252970629	1	X/O	17	7

Change/Reason: Vendor change

Due to a vender change, Paper Roller Ass'y (Index 25) cannot be supplied any more. Please replace the assembly of M0489502 (New Index 7) instead.
