Model: OP-P2	Date: 11-Jun-14	No.: RM223001f
--------------	-----------------	----------------

Subject: Firmware Release Note: GDI		Prepared by: Y. Miyamoto	
From: 1st Tech Service Sect., MFP/Printer Tech Service Dept.			
Classification:	<input type="checkbox"/> Troubleshooting	<input type="checkbox"/> Part information	<input type="checkbox"/> Action required
	<input type="checkbox"/> Mechanical	<input type="checkbox"/> Electrical	<input type="checkbox"/> Service manual revision
	<input type="checkbox"/> Paper path	<input type="checkbox"/> Transmit/receive	<input type="checkbox"/> Retrofit information
	<input type="checkbox"/> Product Safety	<input checked="" type="checkbox"/> Other (Firmware)	<input checked="" type="checkbox"/> Tier 2

Model: OP-P2/MF2		Date: 15-Jun-15	No.: RM223001
Subject: Stretched image when printing with 1200 x 600 dpi resolution setting		Prepared by: K.Nakano	
From: Field Quality Management Dept.			
Classification:	<input checked="" type="checkbox"/> Troubleshooting <input type="checkbox"/> Mechanical <input type="checkbox"/> Paper path <input type="checkbox"/> Product Safety	<input type="checkbox"/> Part information <input type="checkbox"/> Electrical <inpu

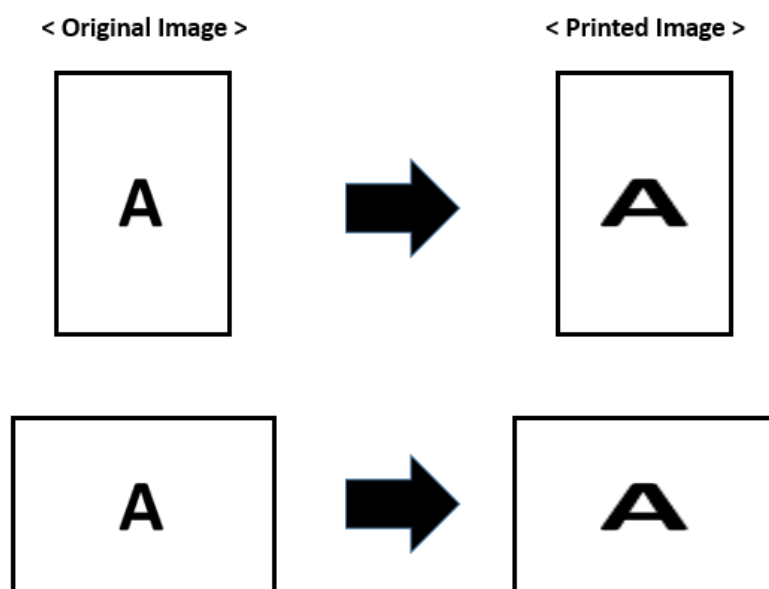
The image is stretched along the main scan direction when printing at 1200 x 600 dpi.

The firmware has not been updated along with the driver (which is required in order to enable 1200x600dpi printing).

Update the firmware to **V.1.01 or later**.

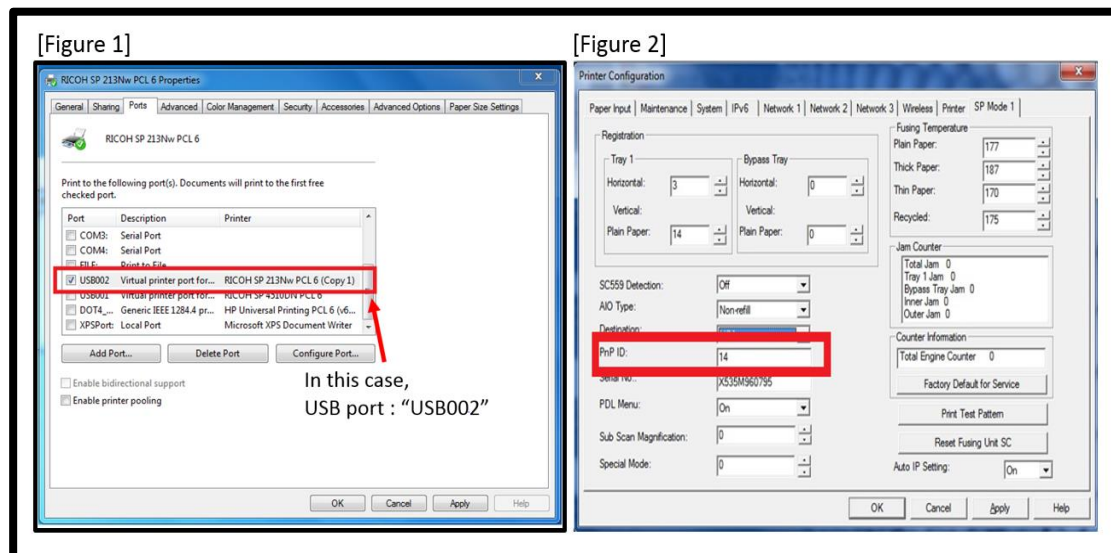
- Install the printer driver and SOM.
- Create a USB port for the printer. (Figure 1 below)
- Verify the PnP ID of the printer. (Figure 2 below)

1. Turn OFF the device and replace the main board with a new one.
2. Turn ON the device.
3. Connect SOM to the device with a USB cable.
4. Verify that the port is identical to that created in the preparation step (Figure 1 above). If not, correct the port.
5. Type in the PnP ID verified in the preparation step (Figure 2 above).
6. Reboot.
