Model: OP-P3/MF3	Date:4-Nov-16	No.: RM0A1001a
------------------	---------------	----------------

Subject: Launch of the new model OP-P3/MF3 (differences from the predecessor model)		Prepared by: Y.Miyamoto	
From: 1nd Tech Service Sect., MFP/Printer Tech Service Dept.			
Classification:	<input type="checkbox"/> Troubleshooting	<input type="checkbox"/> Part information	<input type="checkbox"/> Action required
	<input type="checkbox"/> Mechanical	<input type="checkbox"/> Electrical	<input type="checkbox"/> Service manual revision
	<input type="checkbox"/> Paper path	<input type="checkbox"/> Transmit/receive	<input type="checkbox"/> Retrofit information
	<input type="checkbox"/> Product Safety	<input checked="" type="checkbox"/> Other (New model)	<input checked="" type="checkbox"/> Tier 2

Model: OP—MF3 3in1		Date: 9-Mar-17	No.: RM0A2005
Subject: Troubleshooting for vertical white streaks		Prepared by: K.Nakano	
From: Printer Sec., MFP/P FQM Dept.			
Classification:	<input checked="" type="checkbox"/> Troubleshooting <input type="checkbox"/> Part information <input type="checkbox"/> Action required <input type="checkbox"/> Mechanical <input type="checkbox"/> Electrical <input type="c

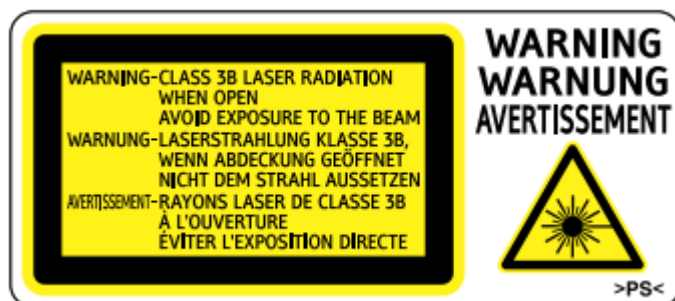
Important Safety Notices (pg.5)

The laser caution decal was modified in line with the revised laser safety standard.

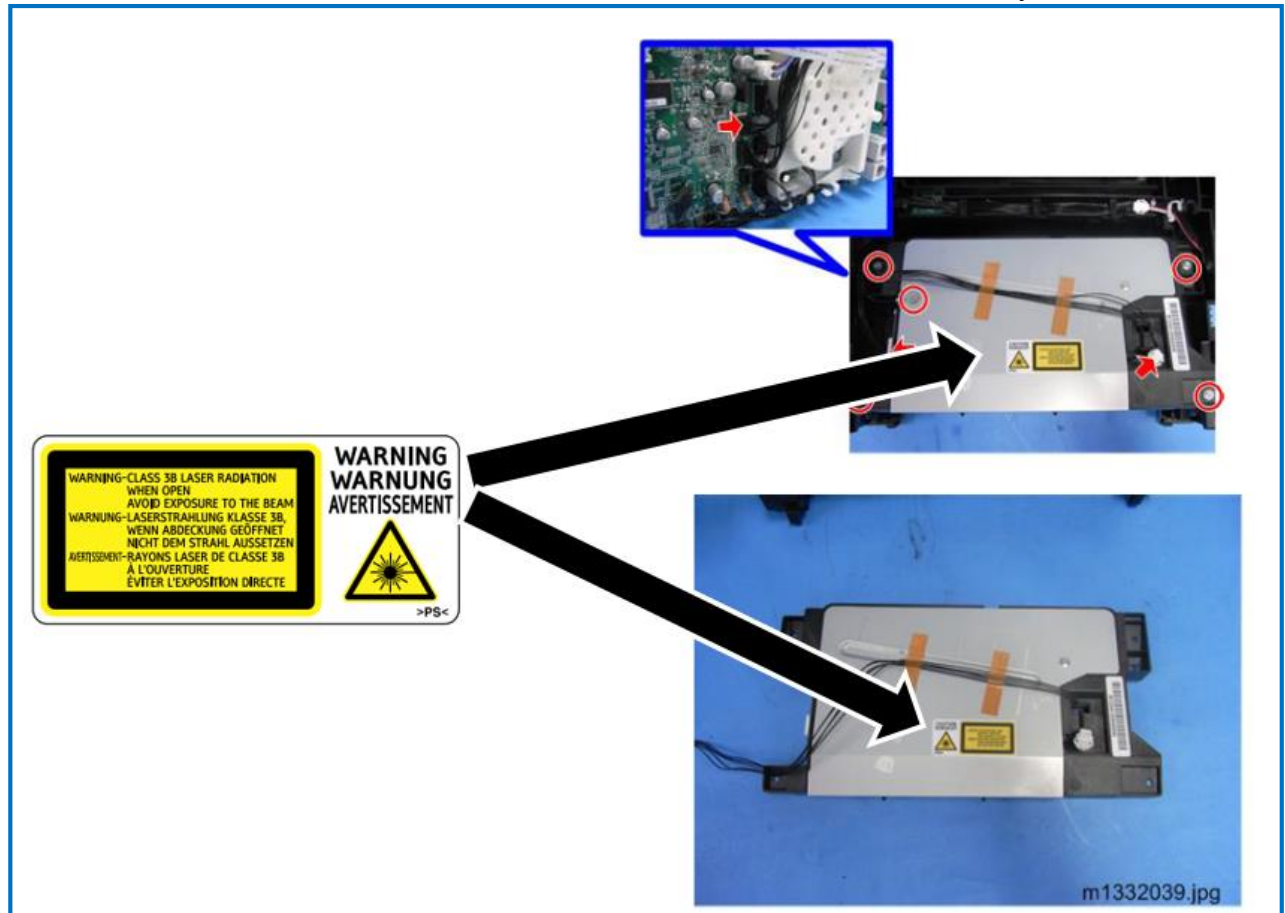
Laser Unit (pg.58)

The laser caution decal was modified in line with the revised laser safety standard.

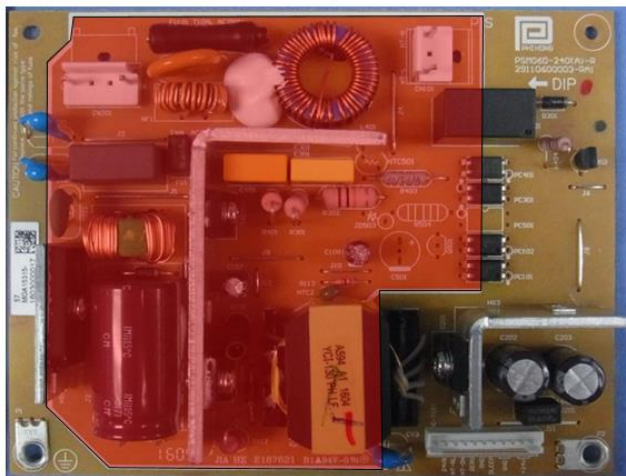
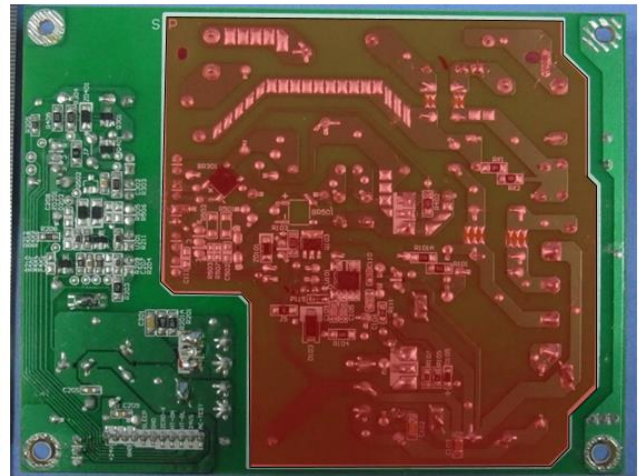
M0A15315 : TWN : PSU ASS'Y

NEVER touch the areas outlined in red in the photos below to prevent electric shock caused by residual charge.

Residual charge of about 100V-400V remains on the PSU board for several months even if the board had been removed from the machine with the machine power turned off and the power cord unplugged.

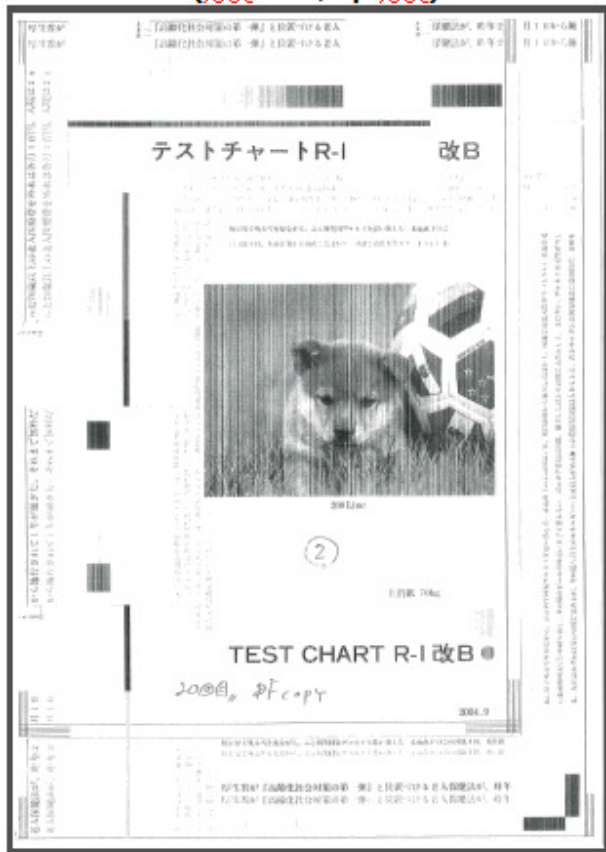
White streaks (ADF scan, Op-MF3):

Vertical white streaks may appear on the image.

Note: This occurs regardless of whether the original is scanned with the ADF or on the exposure glass.

Firmware bug.

The firmware was modified to Ver.1.04 (Cut-in S/N below)

Update the firmware to Ver.1.04 or newer.
