Model: Rmy-P1	Date: 17-Jul-13	No.: RM156001e
---------------	-----------------	----------------

Subject: Firmware Release Note: Main		Prepared by: Y. Miyamoto	
From: 1st Tech Service Sect., MFP/Printer Tech Service Dept.			
Classification:	<input type="checkbox"/> Troubleshooting <input type="checkbox"/> Mechanical <input type="checkbox"/> Paper path <input type="checkbox"/> Product Safety	<input type="checkbox"/> Part information <input type="checkbox"/> Electrical <input type="checkbox"/> Transmit/receive <input checked="" type="checkbox"/> Other (Firmware)	<input type="checkbox"/> Action required <input type="checkbox"/> Service manual revision <input type="checkbox"/> Retrofit information <input checked="" type="checkbox"/> Tier 2

Model: RM-MF		Date: 20-Nov-14	No.: RM156003
Subject: ADF part change information		Prepared by: T. Sakakibara	
From: 3rd Tech Service Sect., MFP/P Tech Service Dept.			
Classification:	<input type="checkbox"/> Troubleshooting <input checked="" type="checkbox"/> Part information <input type="checkbox"/> Action required <input type="checkbox"/> Mechanical <input type="checkbox"/> Electrical <input type="checkbox"/> Service manual revision <input type="

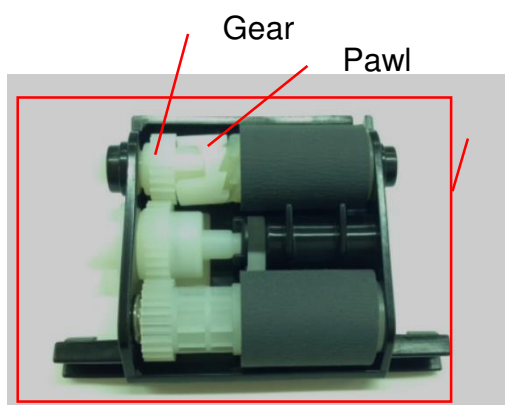
1. Material of the gear (M1562825) and the pawl (M2021773) used in the feed roller of the ADF feed unit were changed from nylon to POM (Polyoxymethylene).
2. Discharge brush (M2021779) was newly added.
3. PICKUP ROLLER:ASS'Y was newly available.

Above changes 1 and 2 were made to improve ADF no-feed problems in a low temperature and low humidity environment (LL environment: 10°C, 15% RH).

Both changes were made to neutralize static electricity.

Replace the entire PICKUP ROLLER:ASS'Y or ADF ASS'Y when its sub pieces are damaged.

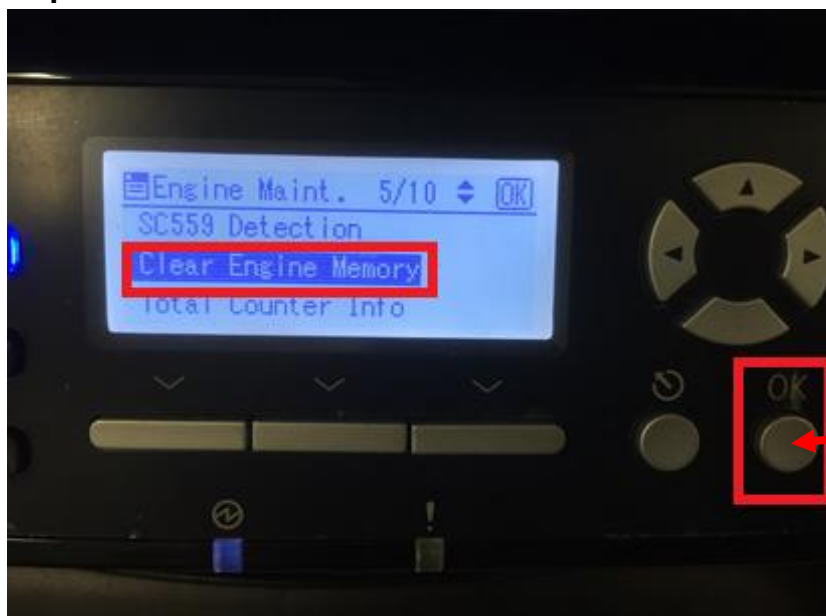
Copier model SP mode

Clicking the "Clear Engine Memory" button in the SOM (printer configuration screen) or the SP mode will falsely reset all the engine related values stored in the main board, preventing the device from recognizing the AIO.

DO NOT select [Clear Engine Memory] and click OK!

DO NOT click the "Clear Engine Memory" button.

If the Clear Engine Memory button had been pressed, update the Main firmware to "ver.1.04" or later to resolve the situation.

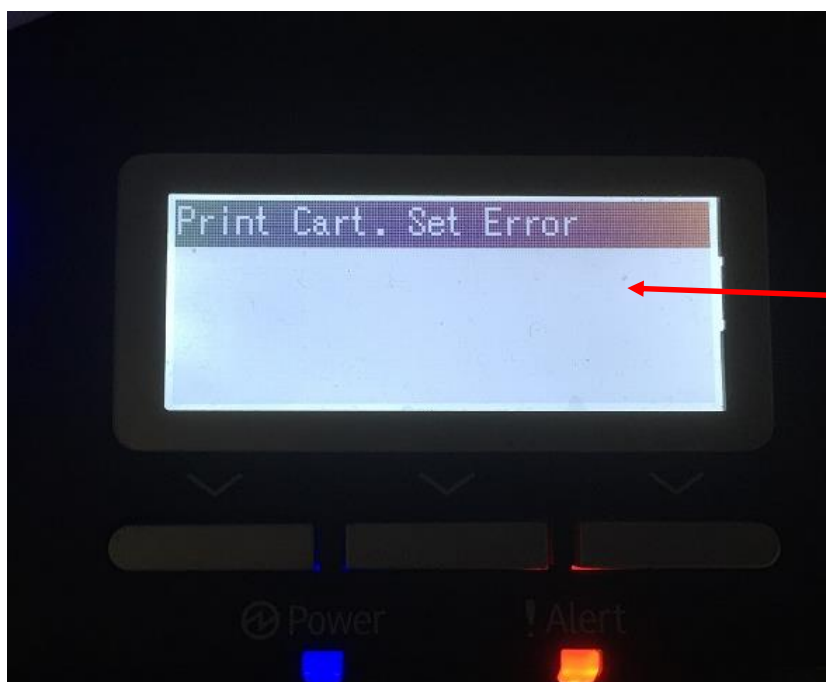
Device no longer detects AIO.
