Model: RMY-P2/MF2		Date: 18-Oct-16	No.: RM0A7001
Subject: Launch of the new model RMY-P2/MF2 (differences from the predecessor model)		Prepared by: Y.Miyamoto	
From: 1nd Tech Service Sect., MFP/Printer Tech Service Dept.			
Classification:	<input type="checkbox"/> Troubleshooting	<input type="checkbox"/> Part information	<input type="checkbox"/> Action required
	<input type="checkbox"/> Mechanical	<input type="checkbox"/> Electrical	<input type="checkbox"/> Service manual revision
	<input type="checkbox"/> Paper path	<input type="checkbox"/> Transmit/receive	<input type="checkbox"/> Retrofit information
	<input type="checkbox"/> Product Safety	<input checked="" type="checkbox"/> Other (New model)	<input checked="" type="checkbox"/> Tier 2

This bulletin announces the differences between the new model RMY-P2/MF2 and its predecessor model RMY-P1/MF1. As you are probably aware, an FSM exclusive for the new model will not be released. Please refer to the FSM of the predecessor model and this bulletin when servicing RMY-P2/MF2.

Model: Rmy-MF2a		Date: 9-Mar-17	No.: RM0A8002
Subject: Troubleshooting for vertical white streaks		Prepared by: K.Nakano	
From: Printer Sec., MFP/P FQM Dept.

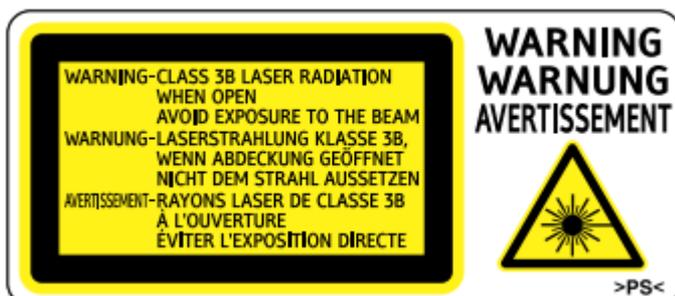
The laser caution decal was modified in line with the revised laser safety standard.

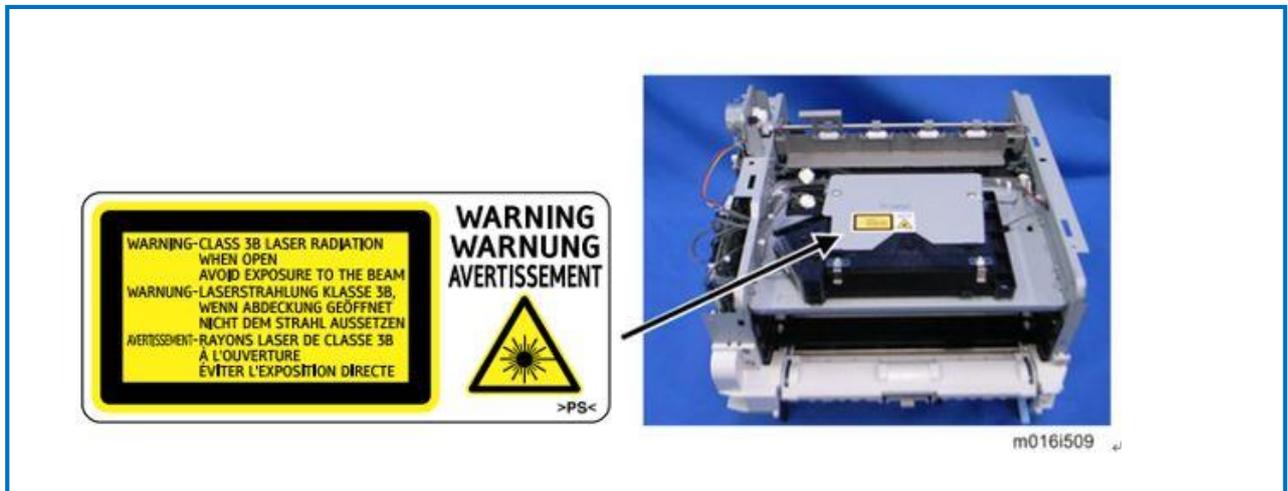
Laser Unit (pg.39)

The laser caution decal was modified in line with the revised laser safety standard.

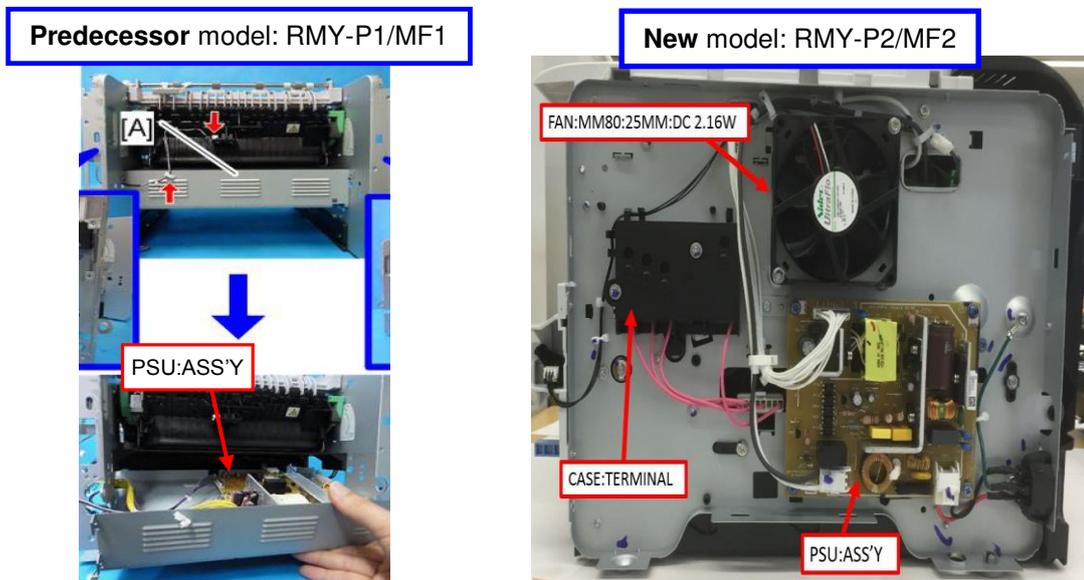
The replacement procedure of the PSU has changed due to the difference in the location of the PSU between the two models. In the predecessor model, the PSU is installed at the bottom of the machine, and in the new model it is in the right cover.

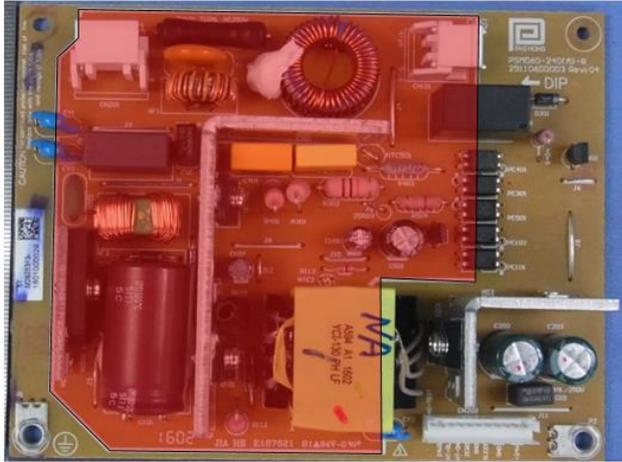
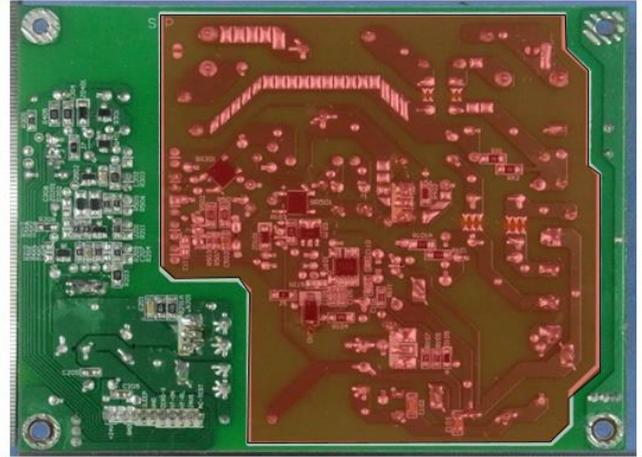
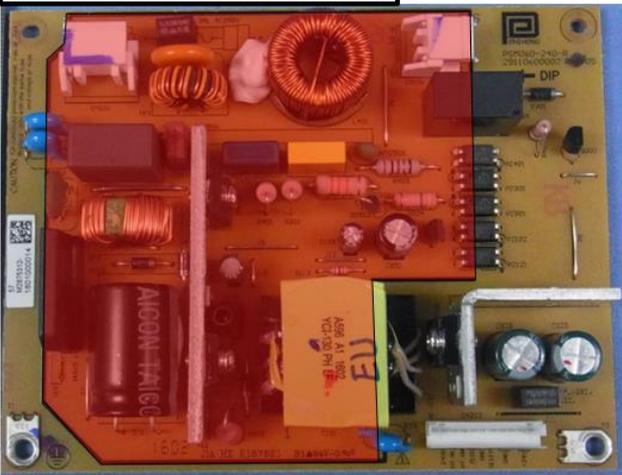
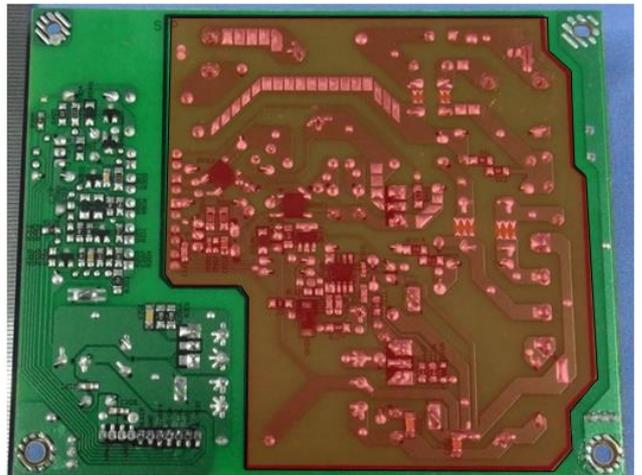
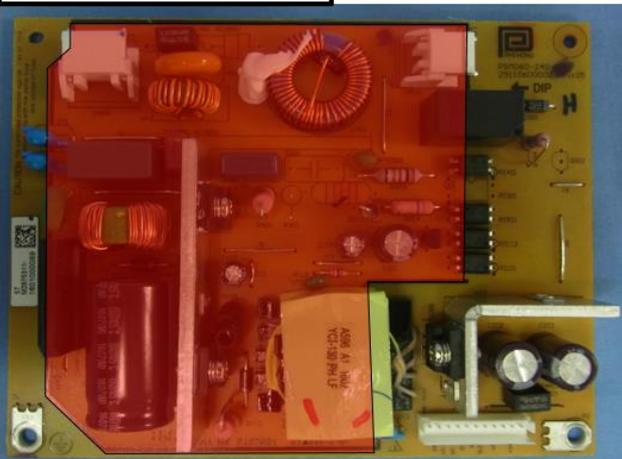
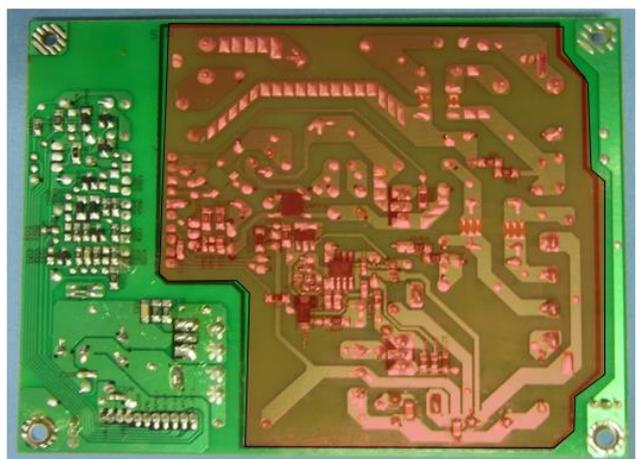
NEVER touch the areas outlined in red in the photos below to prevent electric shock caused by residual charge.

Residual charge of about 100V-400V remains on the PSU board for several months even when the board has been removed from the machine after turning off the machine power and unplugging the power cord.

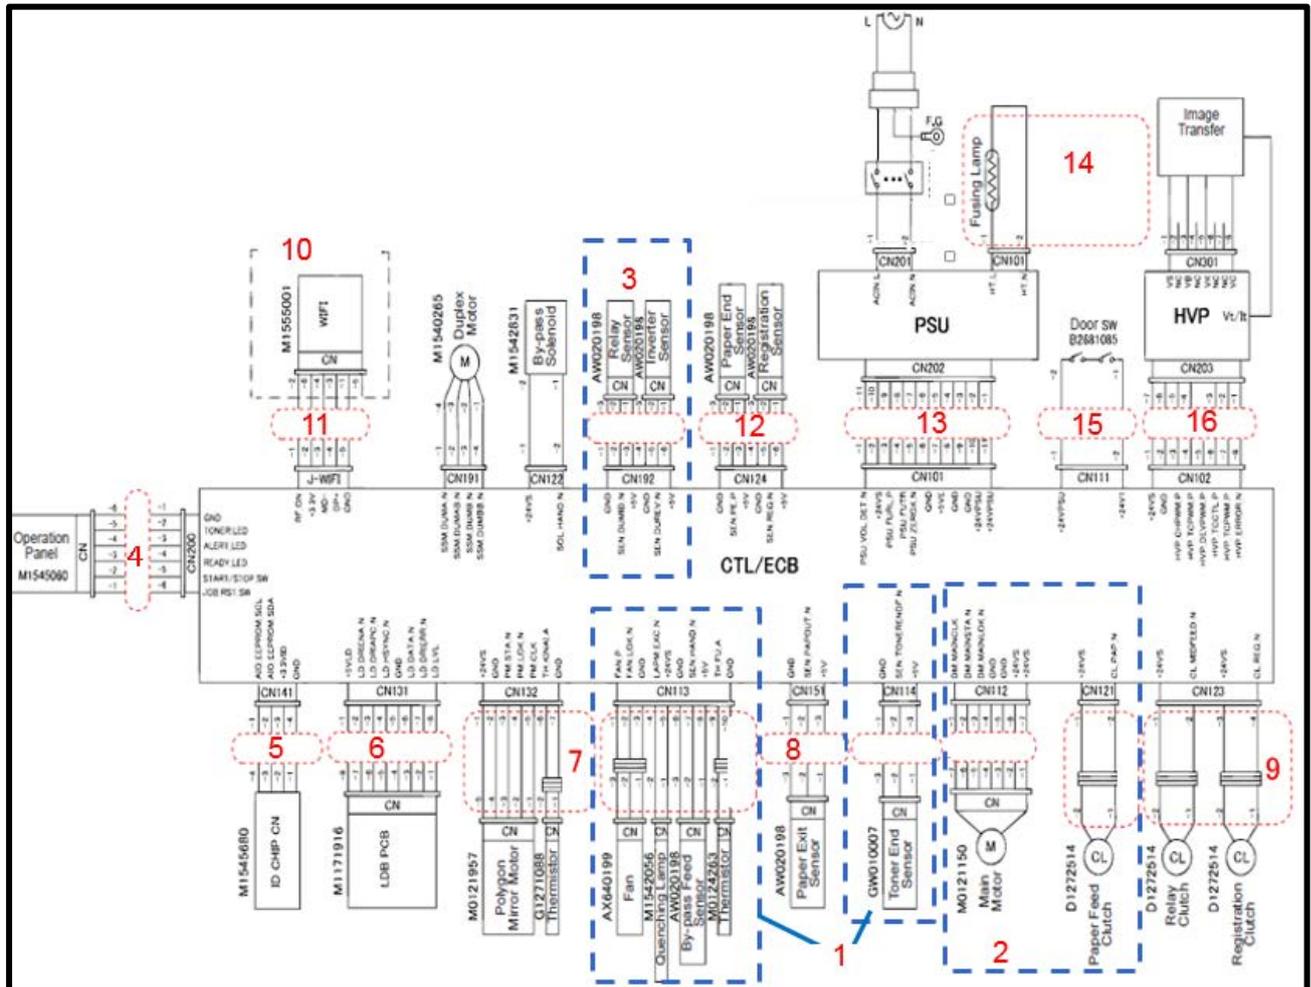
RMY-P2:

1. The toner end sensor is installed together with the fan, quenching lamp, by-pass feed sensor and thermistor (**#1**).
2. The main motor and paper feed clutch are combined (**#2**).
3. The relay sensor was deleted (**#3**).
4. Part numbers were changed (**#4 ~ #16**).

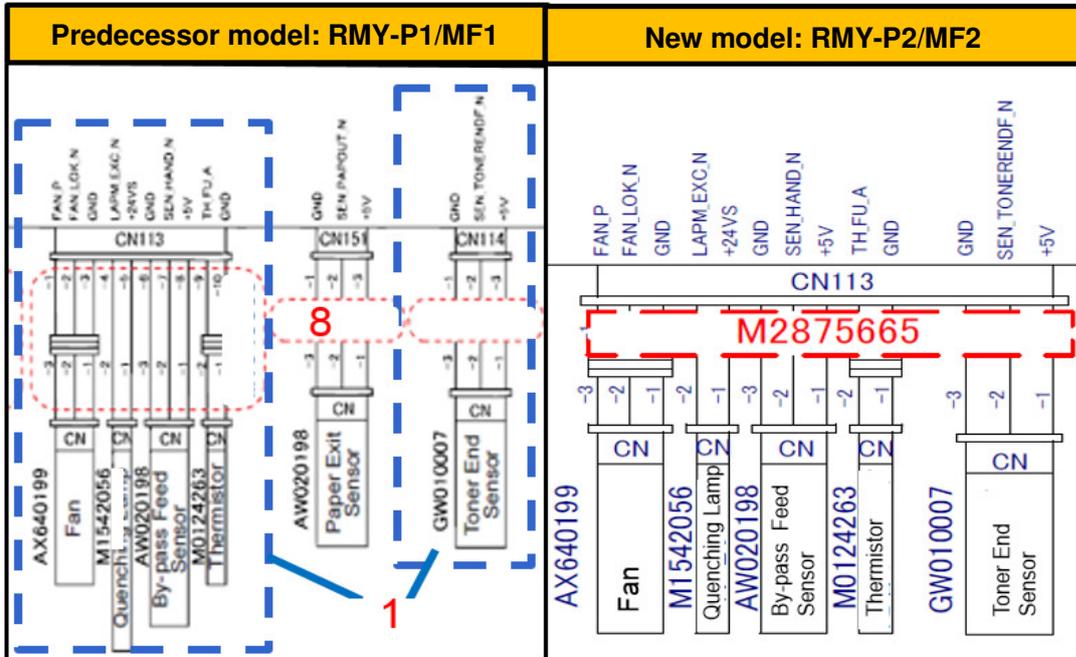
1. The toner end sensor is installed together with the fan, quenching lamp, by-pass feed sensor and thermistor (#1).

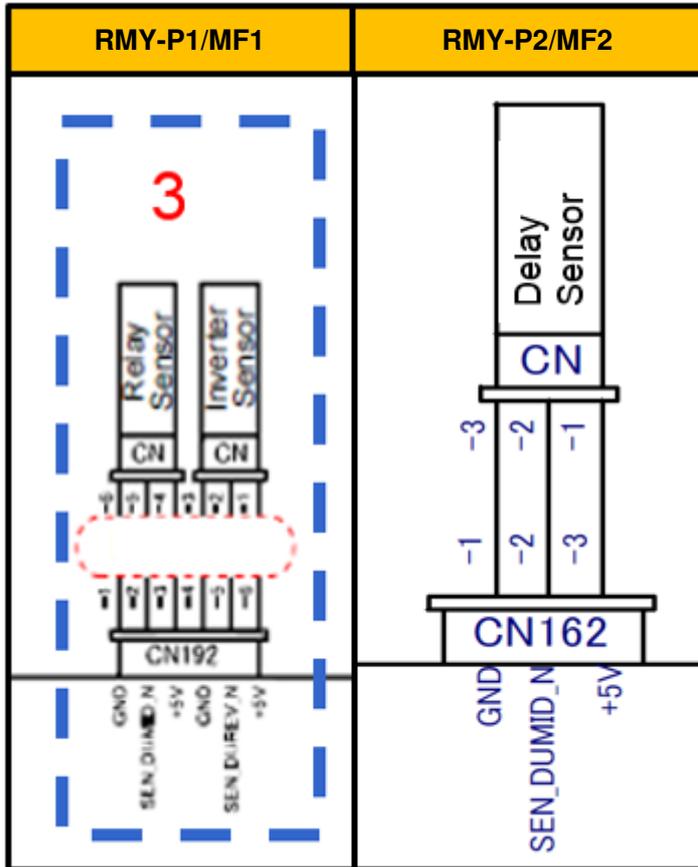
3. The relay sensor was deleted (#3).

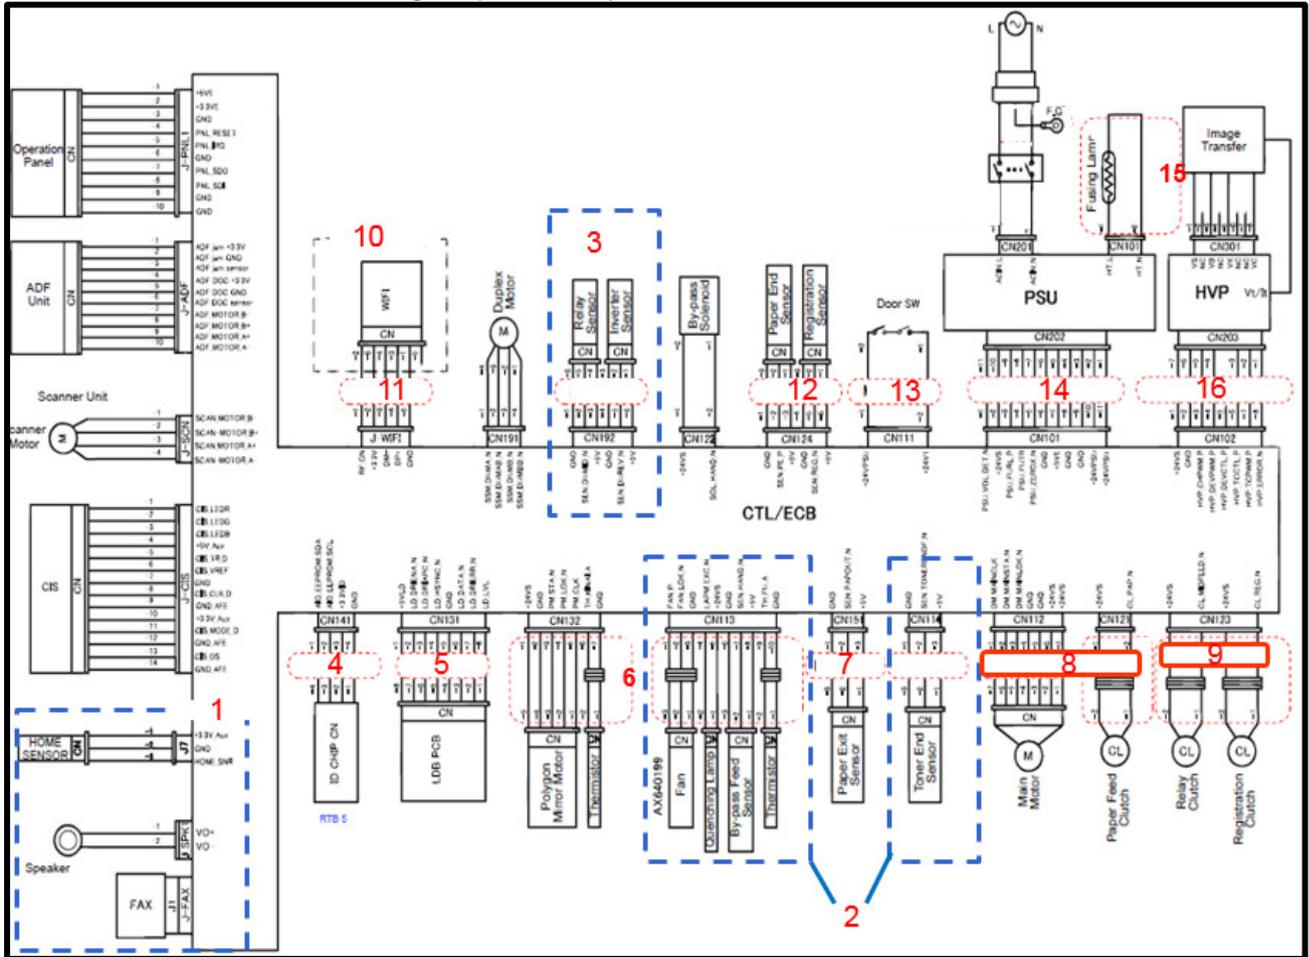
RMY-MF2:

1. A USB is added (#1).
2. The toner end sensor is installed together with the fan, quenching lamp, by-pass feed sensor and thermistor (#2 in red).
3. The relay sensor was deleted (#3).
4. Part numbers were changed (#4 ~ #16).

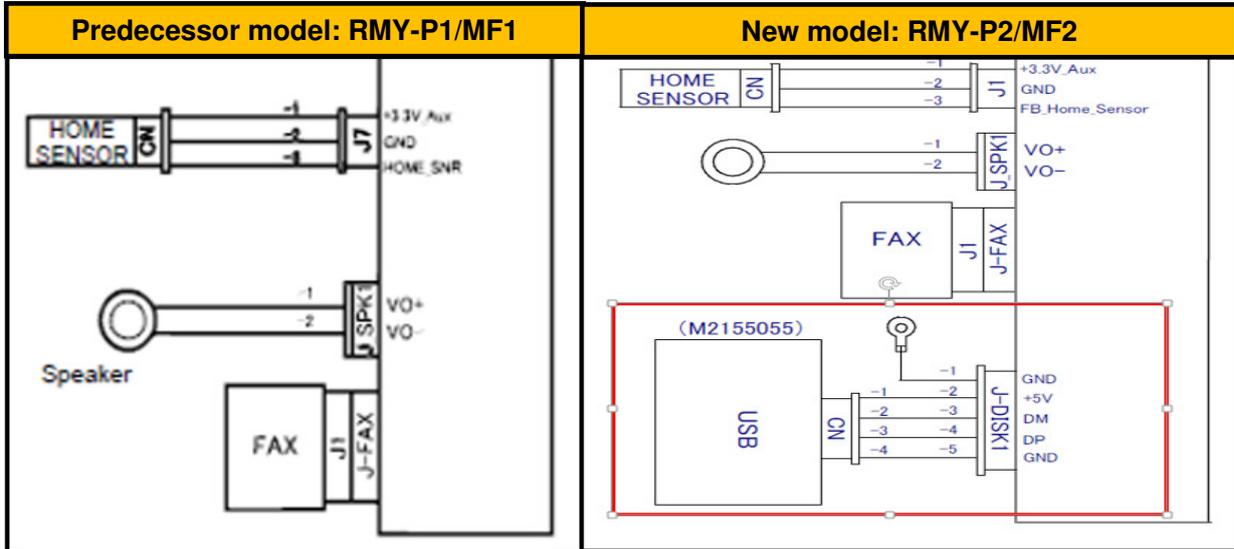
1. A USB is added (#1).

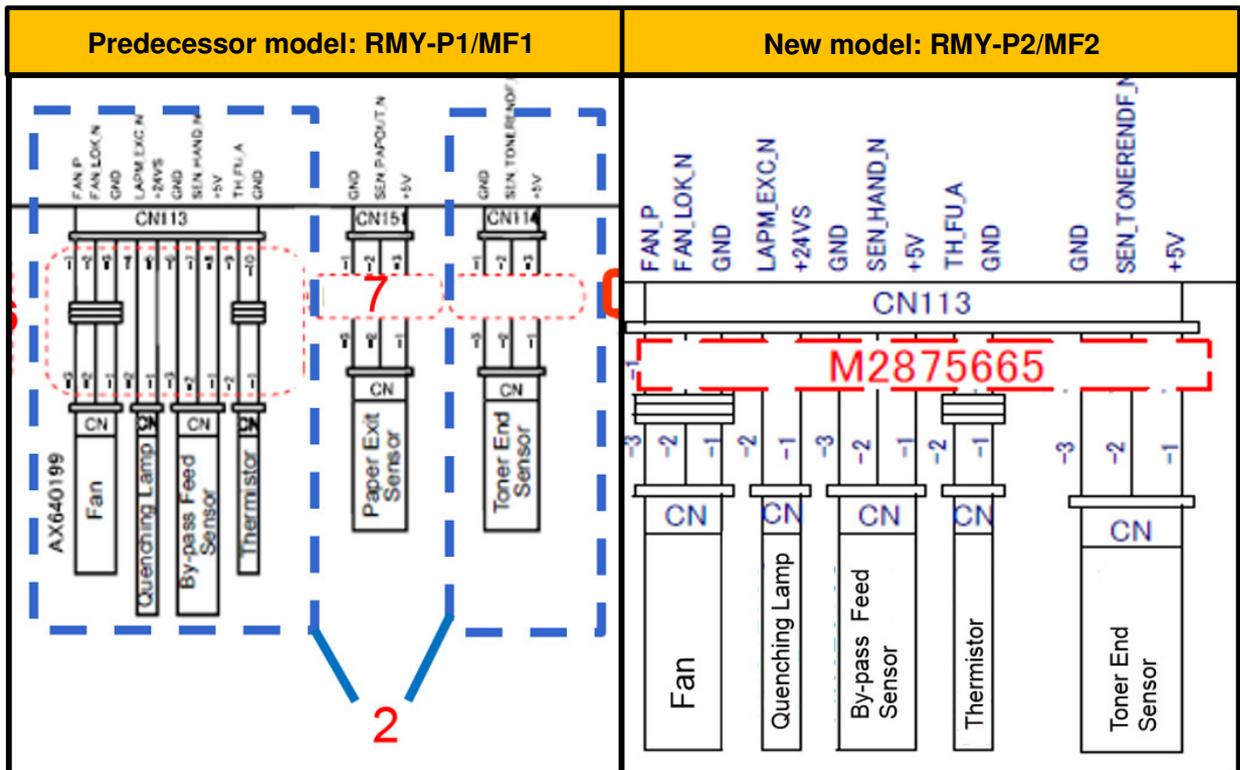
2. The toner end sensor is installed together with the fan, quenching lamp, by-pass feed sensor and thermistor (#2 in red).

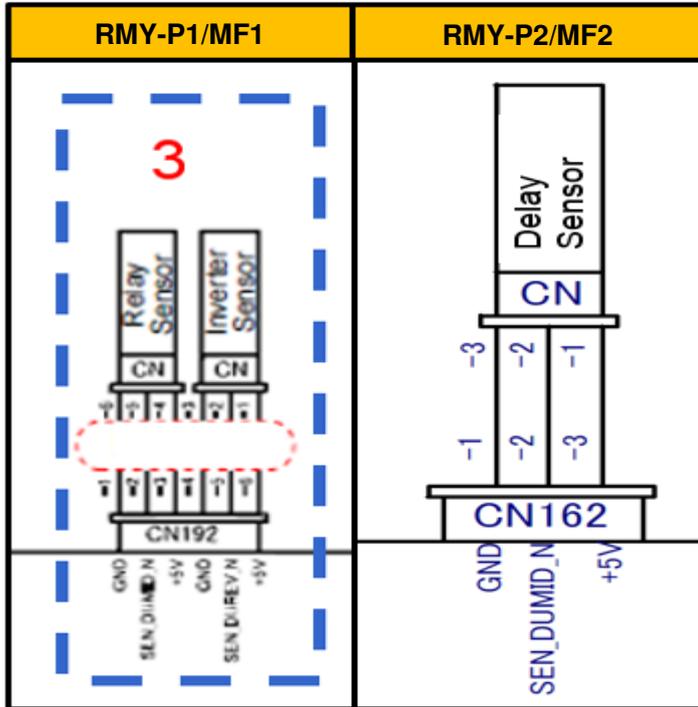
3. The relay sensor was deleted (#3).

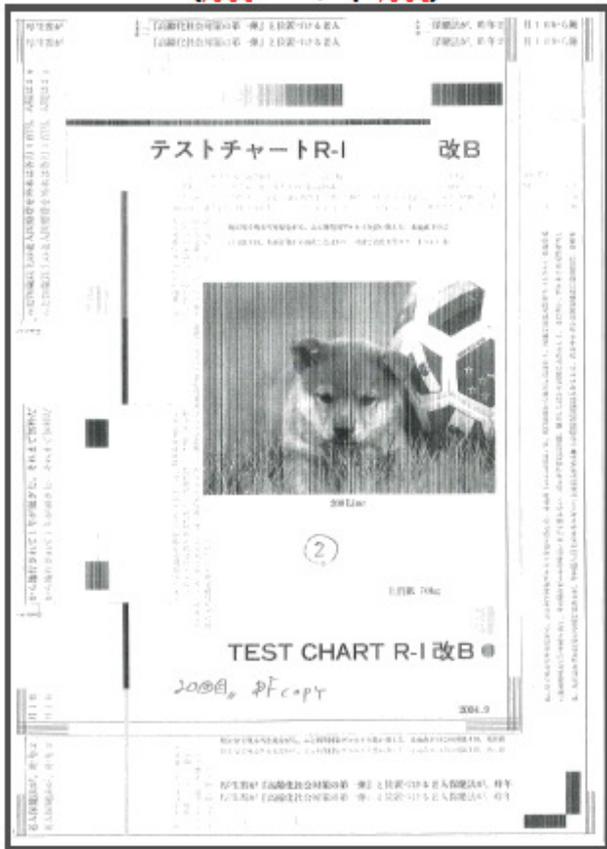
Vertical white streaks may appear on the image.

White streaks (ADF scan, Op-MF3):

Firmware bug.

Update the firmware to Ver.1.09 or newer.
