Model: Model CM-C2	Date: 24-Aug-07	No.: RG960001a
--------------------	-----------------	----------------

Subject: Firmware history (Local)		Prepared by: Y.Gaman	
From: Technical Services Sec., Service Planning Dept.			
Classification:	<input type="checkbox"/> Troubleshooting <input type="checkbox"/> Mechanical <input type="checkbox"/> Paper path <input type="checkbox"/> Product Safety	<input type="checkbox"/> Part information <input type="checkbox"/> Electrical <input type="checkbox"/> Transmit/receive <input checked="" type="checkbox"/> Other ()	<input checked="" type="checkbox"/> Action required <input type="checkbox"/> Service manual revision <input type="checkbox"/> Retrofit information <input checked="" type="checkbox"/> Tier 2

Model: CM-C2		Date: 15-Jan-09	No.: RG960003
Subject: Service Manual Correction		Prepared by: Y.Gaman	
From: 1st Tech. Support Sec. Service Support Dept.			
Classification:	<input type="checkbox"/> Troubleshooting <input type="checkbox"/> Mechanical <input type="checkbox"/> Paper path <input type="checkbox"/> Product Safety	<input type="checkbox"/> Part information <input type="checkbox"/> Electrical <input type="checkbox"/> Transmit/receive <input ty

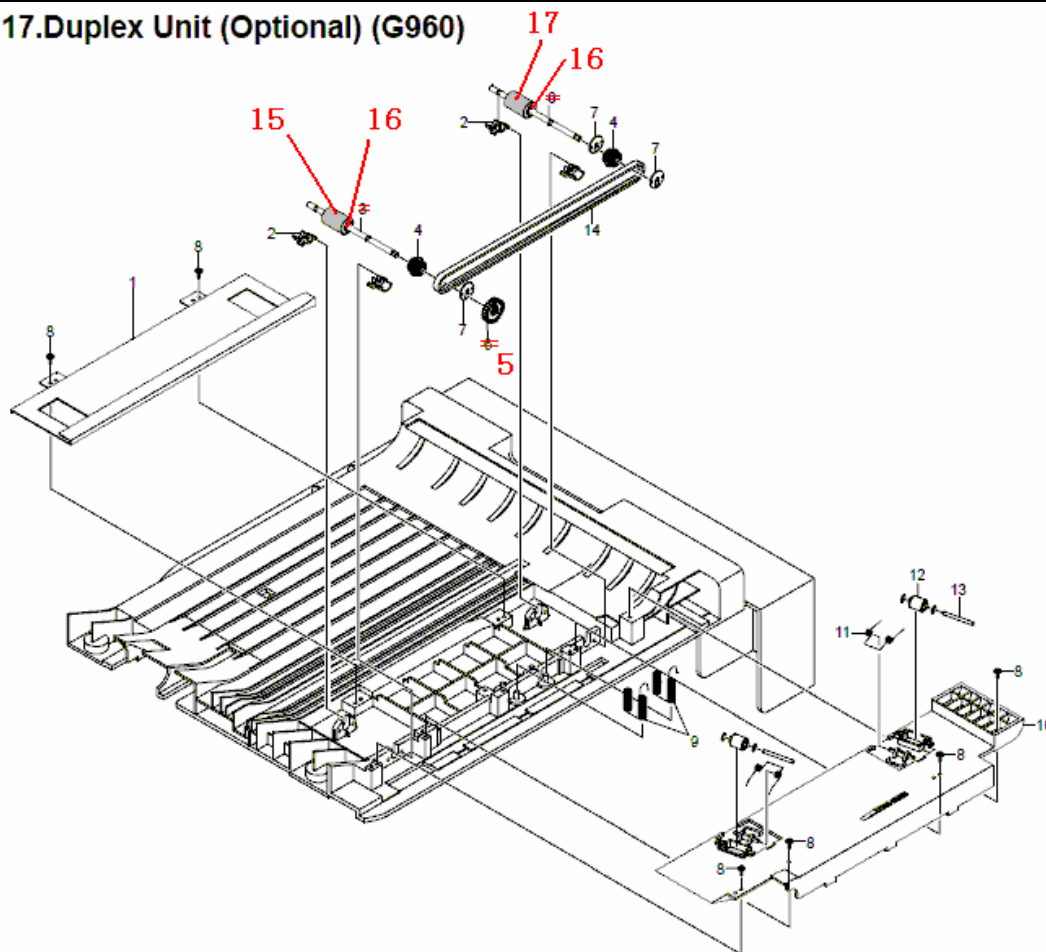
17.Duplex Unit (Optional) (G960)

Change: The two assemblies in the table below (P/N G9601422 and G9601423) were each divided into two parts.

Reason: The parts vendor stopped supplying P/N G9601422 and G9601423 as assemblies.

Old Part Number	New Part Number	Description	Q'ty	Int	Page	Index	Note
G9601422	M3071032	DUPLEX FEED ROLLER	1	O/O	35	6→17	
	M3071033	C-RING	1			6→16	
G9601423	G9601604	DUPLEX FEED ROLLER	1	O/O		3→15	
	M3071033	C-RING	1			3→ 16

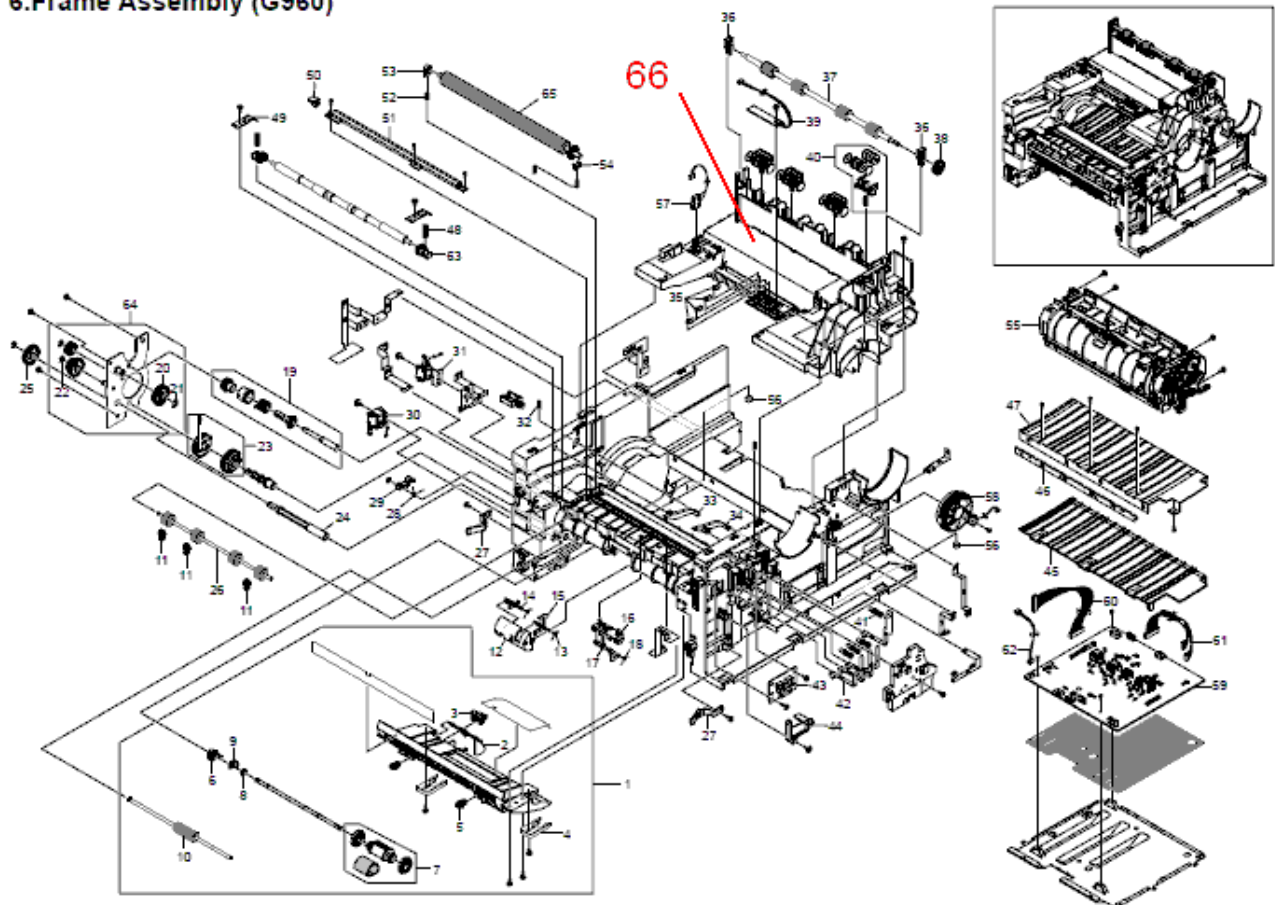
6.Frame Assembly (G960)

New part number	Description	Q'ty	Int	Page	Index	Note
G9601258	FRAME-M_EXIT	1	-	13	66

Change: This part was added.

Reason: Requests from the field.

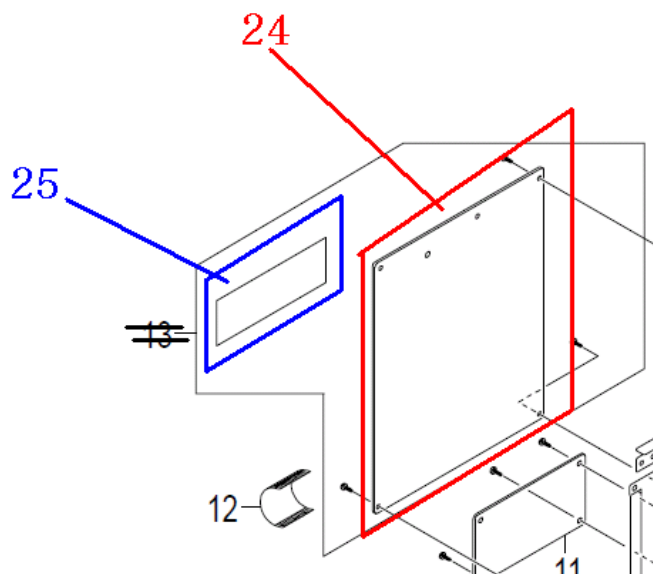
1.Main Exploded Views (G960)

The main board assembly is divided into two separate parts as follows:

Old part #	New Part #	Description	Q'ty	Int	Page	Index	Note
G9601375	G9601454	Main Board	1	O/O	3	13→24	
	G9601460	SDRAM	1	O/O	3	25

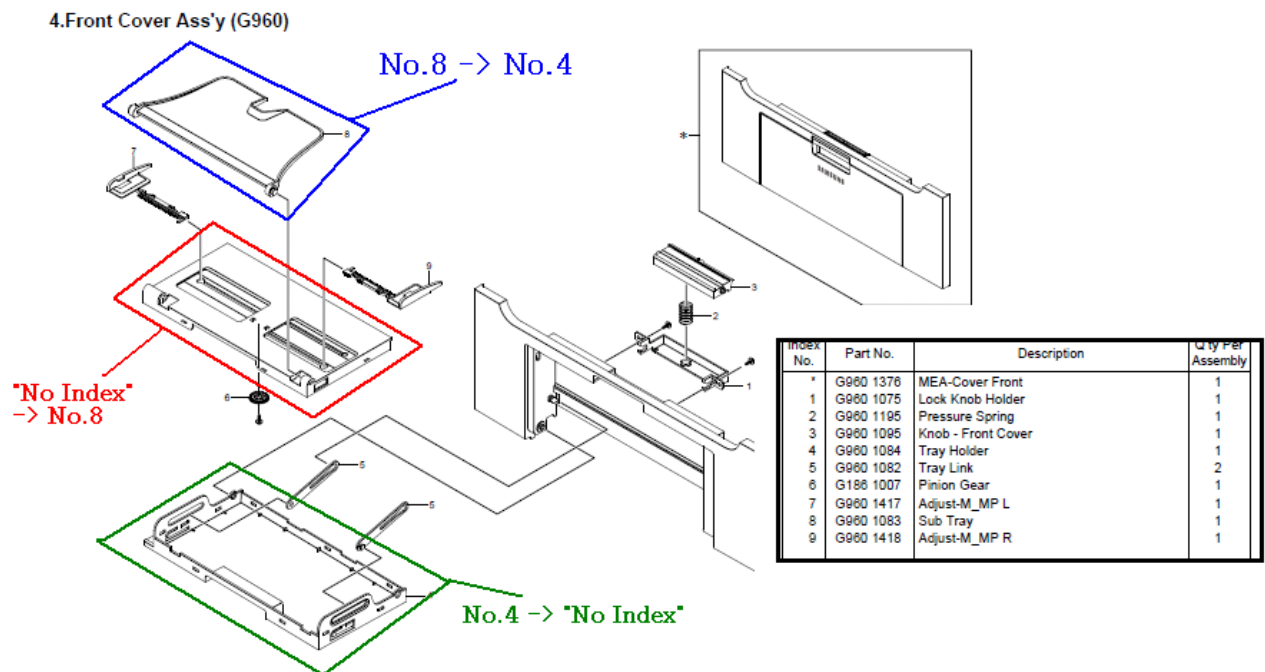
Page 8 of Parts Catalog:

The indices of the following parts are corrected.

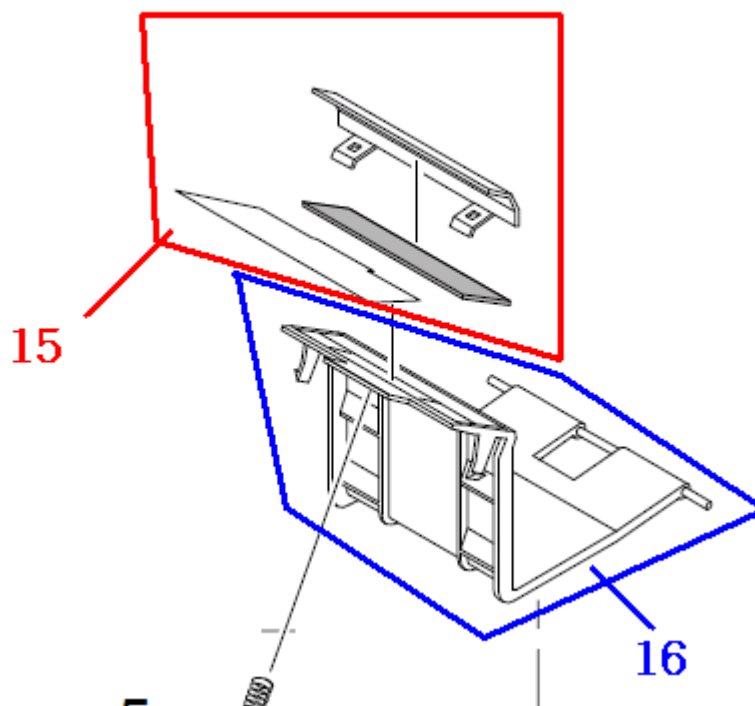
Parts Catalog on page 30:

The Friction Pad assembly is divided into two separate parts as follows:

Old part #	New Part #	Description	Q'ty	Int	Page	Index	Note
G9601177	G9601609	Friction Pad	1	O/O	31	15	
	M0001043	Pad Holder	1	O/O	31	16

The parts vendor cannot supply the parts as an assembly.
