Model: Model RN-MF1		Date: 25-May-09	No.: RM016001
Subject: How to access Maintenance Mode		Prepared by: Y.Yoshida	
From: 1st Tech. Support Sec. Service Support Dept.			
Classification:	<input type="checkbox"/> Troubleshooting <input type="checkbox"/> Mechanical <input type="checkbox"/> Paper path <input type="checkbox"/> Product Safety	<input type="checkbox"/> Part information <input type="checkbox"/> Electrical <input type="checkbox"/> Transmit/receive <input type="checkbox"/> Other ()	<input type="checkbox"/> Action required <input checked="" type="checkbox"/> Service manual revision <input type="checkbox"/> Retrofit information <input checked="" type="checkbox"/> Tier 2

Model: RN-MF1		Date: 08-Jan-10	No.: RM016004
Subject: Duplex Jam (Defective Feeler)		Prepared by: Y. Gaman	
From: 2nd Overseas Tech Support Sec. 2nd PQM Dept			
Classification:	<input checked="" type="checkbox"/> Troubleshooting <input type="checkbox"/> Mechanical <input checked="" type="checkbox"/> Paper path <input type="checkbox"/> Product Safety	<input type="checkbox"/> Part information <input type="checkbox"/> Electrical <input type="checkbox"/> Transmit/receive <input type="checkbox"/> Other ()	<input typ

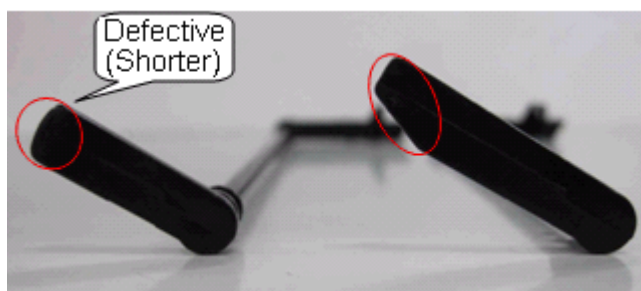
A defective feeler in the duplex unit (Horizontal Paper Feed) may cause a detection failure.

Defective feeler: M0134778 (Feeler:Sensor:Horizontal Transport)

The defective feeler is shorter than a normal feeler. This is not a design problem.

Check the feeler (M0134778) and if it is defective, replace it. Refer to the procedure.

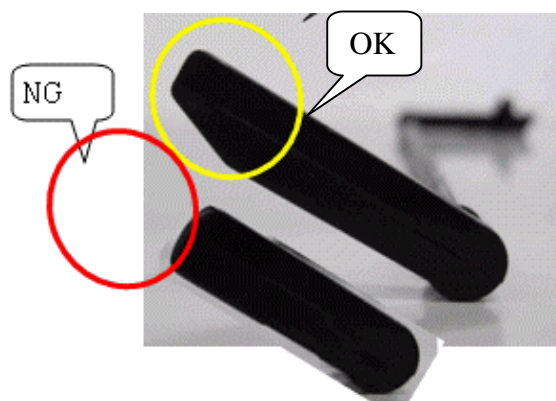
Check the shape of the feeler in the middle of the lower guide with a flashlight.

The defective feeler is shorter.

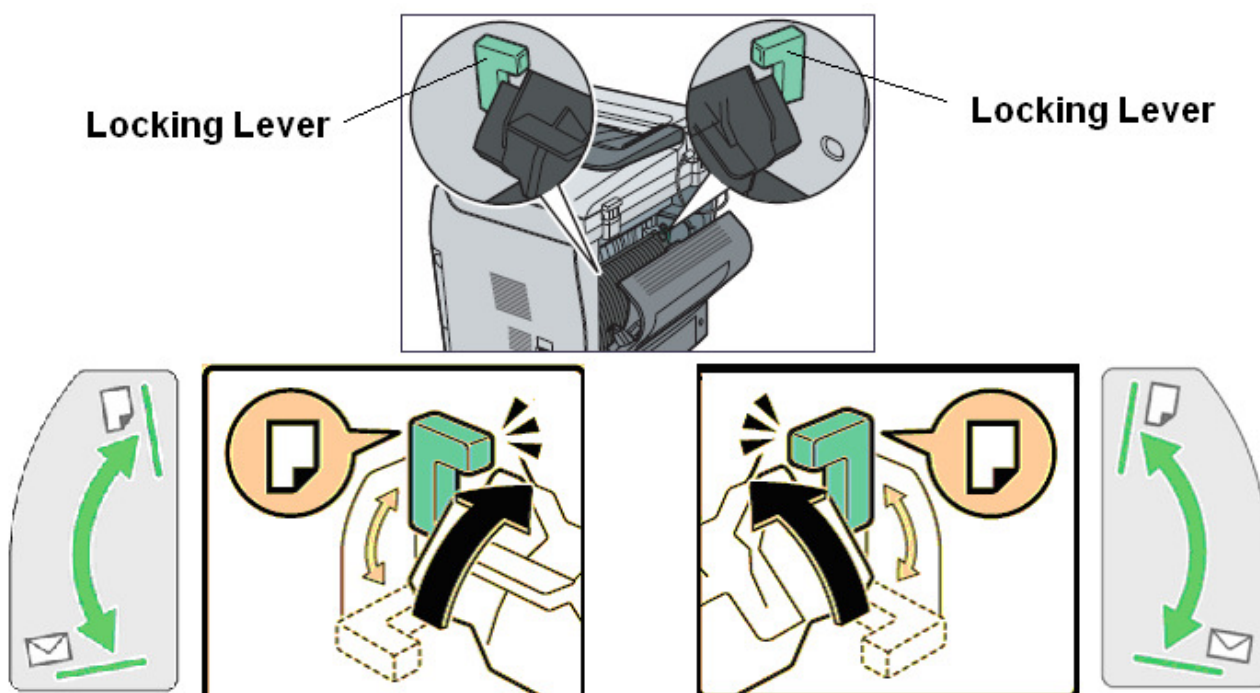
Some areas of the image are missing when printing onto plain paper.

The locking levers are not in the raised position when printing begins.

Note: Toner may not fuse properly to the paper when printing onto plain paper with the locking levers in the lowered position.

- If this symptom occurs, raise both locking levers and try printing again.
- As mentioned in the CAUTION sheet, raise both locking levers when setting up this machine. This is because the levers should always be in the raised position when printing onto regular paper.

Important: When printing onto envelopes, lower the levers. Then, after the job is completed, return the levers to the raised position.

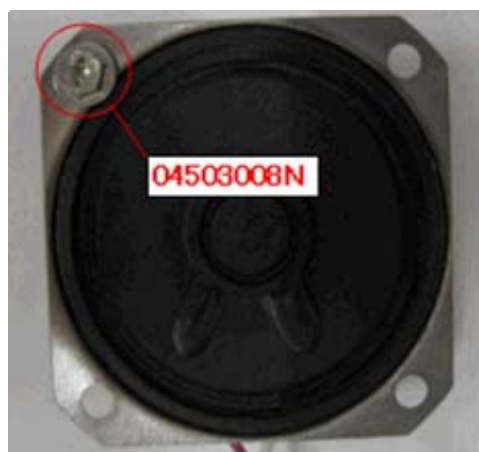
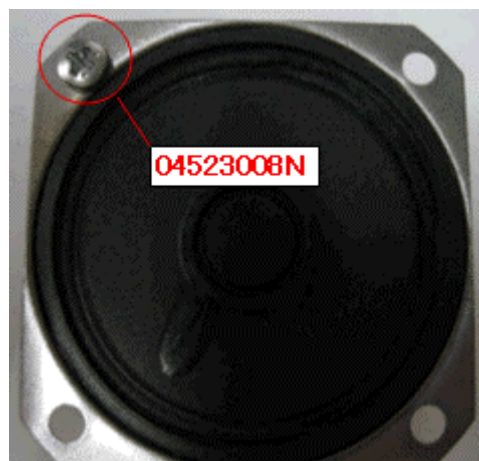
Change: The type of tapping screw was changed.

Reason: To make sure that the screw does not overlap the edge of the speaker.

Old part number	New part number	Description	Q'ty	Int	Note
04503008N	04523008N	TAPPING SCREW - M3X8	2	X/O

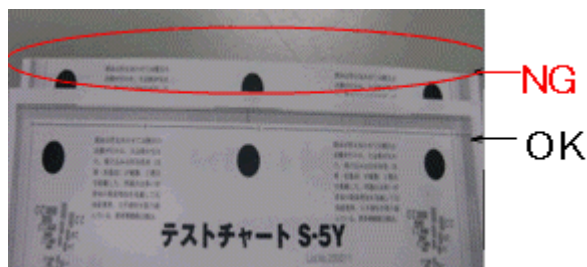
The image is shifted toward the leading edge of the paper (registration is out of alignment) when continuous prints are made.

Note: This occurs with a frequency of about once every ten sheets to once every hundred sheets.

The spring for the registration feeler is not strong enough, causing the registration sensor to mis-detect the position of the paper.

The tension of the spring for the registration feeler was optimized.

P/N: M0122724 → **M0122725** (SPRING:FEELER:REGISTRATION)

If this issue is reported in the field, replace the machine.
