Model: RN-MF2/RN-P2	Date: 15-Mar-12	No.: RM118001
----------------------------	-----------------	---------------

Subject: Firmware Release Note: Engine		Prepared by: Y. Gaman	
From: 3rd Tech Service Sect., MFP/Printer Tech Service Dept.			
Classification:	<input type="checkbox"/> Troubleshooting <input type="checkbox"/> Mechanical <input type="checkbox"/> Paper path <input type="checkbox"/> Product Safety	<input type="checkbox"/> Part information <input type="checkbox"/> Electrical <input type="checkbox"/> Transmit/receive <input checked="" type="checkbox"/> Other (Firmware)	<input type="checkbox"/> Action required <input type="checkbox"/> Service manual revision <input type="checkbox"/> Retrofit information <input checked="" type="checkbox"/> Tier 2

Model: RN-MF2		Date: 7-Mar-13	No.: RM118005
Subject: White Stripes		Prepared by: Y. Gaman	
From: 3rd Tech Service Sect., MFP/P Tech Service Dept.			
Classification:	<input checked="" type="checkbox"/> Troubleshooting <input type="checkbox"/> Mechanical <input type="checkbox"/> Paper path <input type="checkbox"/> Product Safety	<input type="checkbox"/> Part information <input type="checkbox"/> Electrical <input type="checkbox"/> Trans

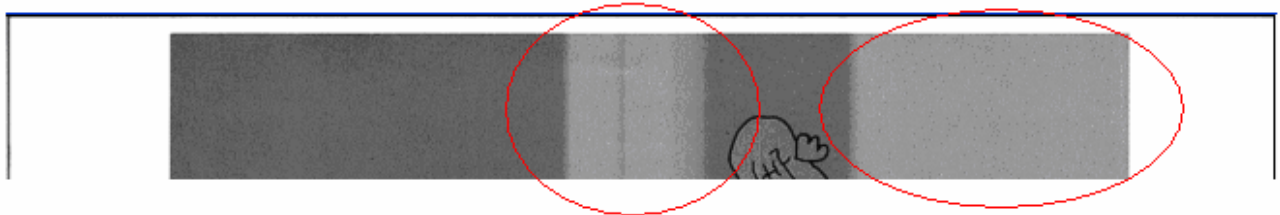
White stripes may appear on copies.

The glue that fixes the calibration white plate to the edge of the exposure glass melts. As a result, it leaks out and is picked up by the scanner.

1. If the symptom occurs, replace the upper scanner case or scanner unit.
2. To prevent occurrences, do the following:
 - Do not use cleaning solvents (including pure alcohol) to clean the white plate, exposure glass, or internal area around the scanner unit.
 - Advise customers not to use cleaning solvents (including pure alcohol) to clean the exposure glass. Rather, as mentioned in the User Guide, advise them to clean it with a soft, damp cloth and then dry it with the dry cloth.
 - Advise customers to turn Energy Saver mode ON. This is because if it is OFF, the temperature around the scanner unit will tend to increase.

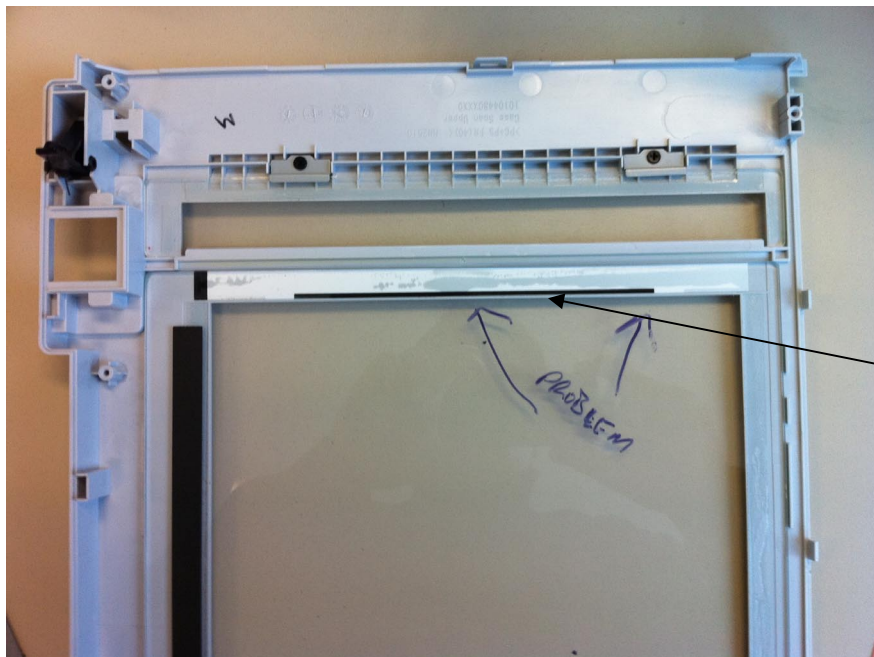
Note: The glue tends to melt when the temperature and humidity are high (40C/90%), and when the exposure glass is cleaned with alcohol.

Glue melted

Upper Scanner Case

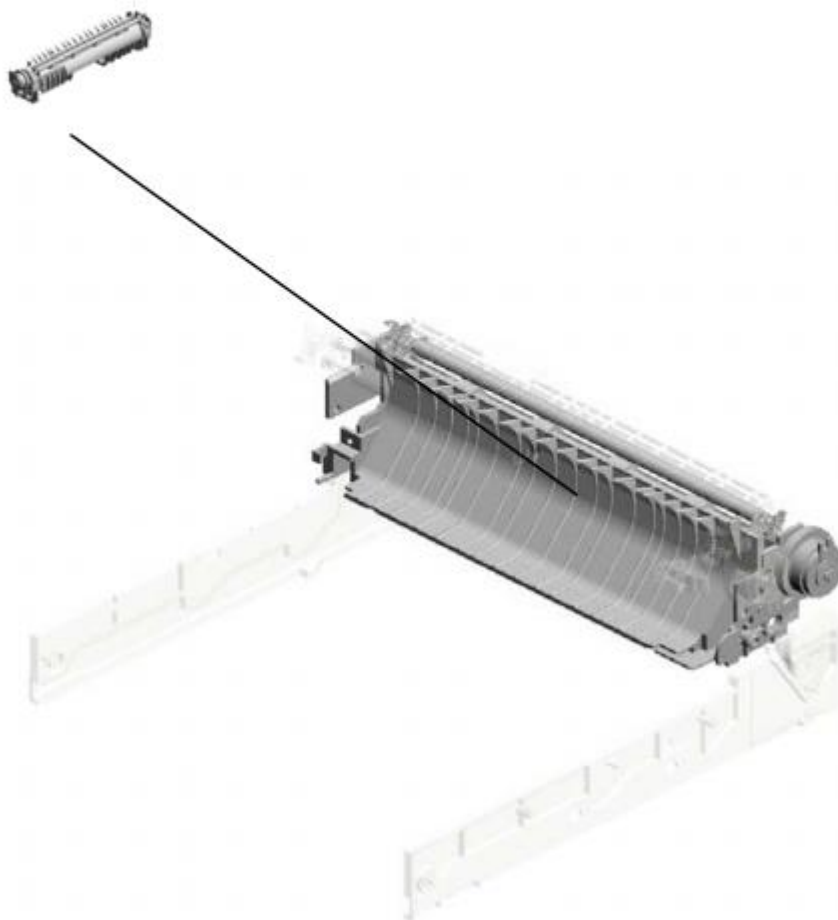
U006 S001
M1172516
JOINT UNIT:ASS'Y

JOINT UNIT: ASS'Y is available as a spare part.
