Model: PE-P1E	Date: 07-Apr-09	No.: RM035001c
---------------	-----------------	----------------

Subject: Firmware History - Engine		Prepared by: H.K.	
From: 2nd Overseas Tech Support Sec., 2nd PQM Dept.			
Classification:	<input type="checkbox"/> Troubleshooting	<input type="checkbox"/> Part information	<input type="checkbox"/> Action required
	<input type="checkbox"/> Mechanical	<input type="checkbox"/> Electrical	<input type="checkbox"/> Service manual revision
	<input type="checkbox"/> Paper path	<input type="checkbox"/> Transmit/receive	<input type="checkbox"/> Retrofit information
	<input type="checkbox"/> Product Safety	<input checked="" type="checkbox"/> Other (Firmware History)	<input checked="" type="checkbox"/> Tier 2

Model: Model PE-P1E		Date: 31-Aug-09	No.: RM035003
Subject: Reducing the color toner consumption in BK mode		Prepared by: H.K.	
From: 1st Tech. Support Sec. Service Support Dept.			
Classification:	<input checked="" type="checkbox"/> Troubleshooting	<input type="checkbox"/> Part information	<input type="checkbox"/> Action required
	<input type="checkbox"/> Mechanical	<input type="checkbox"/> Electrical	<input type="checkbox"/> Service manual revision
	<inp

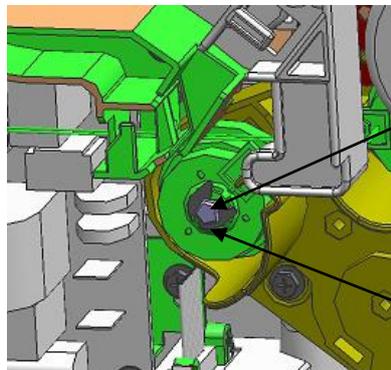
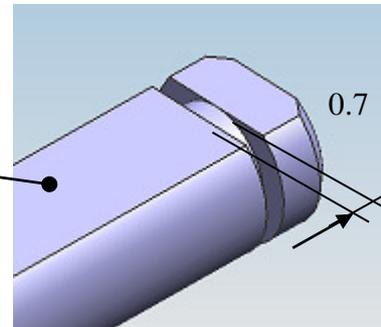
Old

- 1) The width of the e-ring groove in the paper feed roller shaft was increased.
- 2) The e-ring was changed to a C-ring.

G1662580 Paper Feed Roller Shaft

08050089 E-ring

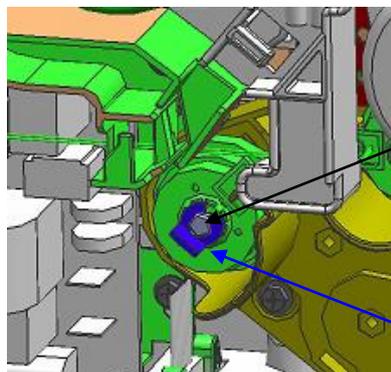
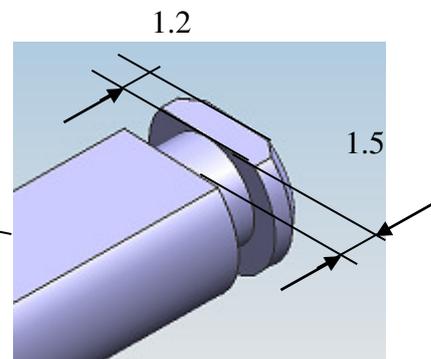
Reason: To facilitate assembly.

M1982580 Paper Feed Roller Shaft

H5213355 C-ring

08050089 → H5213355 New index
27
