Model: Model PE-MF2	Date: 16-Feb-09	No.: RM018001f
---------------------	-----------------	----------------

Subject: Firmware History - Engine		Prepared by: H.K.	
From: 2nd Overseas Tech Support Sec., 2nd PQM Dept.			
Classification:	<input type="checkbox"/> Troubleshooting	<input type="checkbox"/> Part information	<input type="checkbox"/> Action required
	<input type="checkbox"/> Mechanical	<input type="checkbox"/> Electrical	<input type="checkbox"/> Service manual revision
	<input type="checkbox"/> Paper path	<input type="checkbox"/> Transmit/receive	<input type="checkbox"/> Retrofit information
	<input type="checkbox"/> Product Safety	<input checked="" type="checkbox"/> Other (Firmware)	<input checked="" type="checkbox"/> Tier 2

Model: Model PE-MF2		Date: 16-Apr-09	No.: RM018004
Subject: Scanner Lock Error		Prepared by: H.K.	
From: 1st Tech. Support Sec. Service Support Dept.			
Classification:	<input checked="" type="checkbox"/> Troubleshooting	<input checked="" type="checkbox"/> Part information	<input type="checkbox"/> Action required
	<input type="checkbox"/> Mechanical	<input type="checkbox"/> Electrical	<input checked="" type="checkbox"/> Service manual revision
	<input

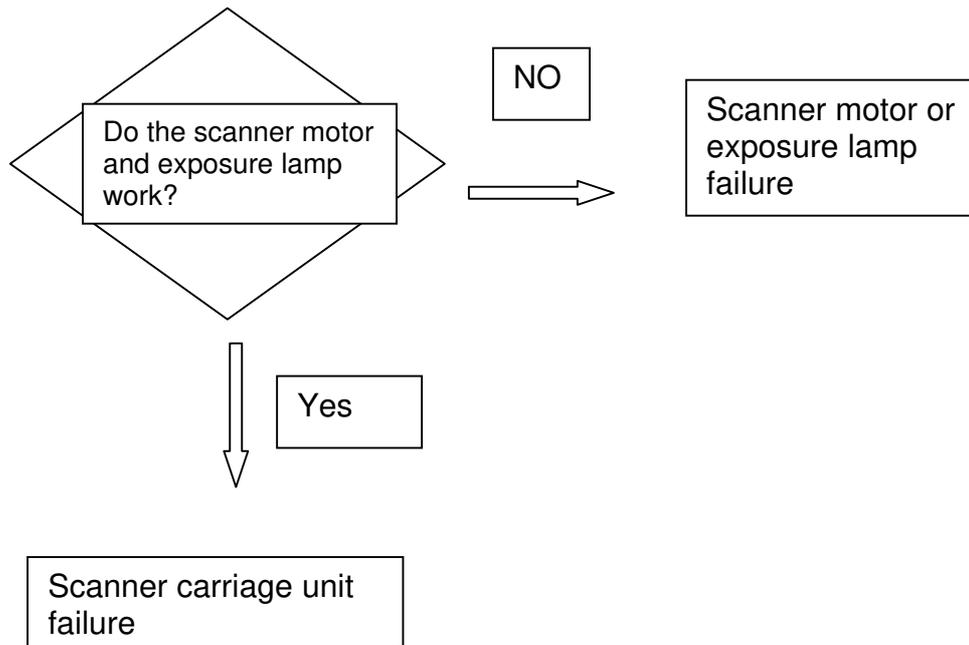
“Scanner Lock Error” (The CCD cannot detect the black patch on the white plate).

- Scanner motor malfunction
- Exposure lamp malfunction
- Scanner carriage unit malfunction (home position sensor, CCD)

Open the ADF cover and then turn on the main power.

- If the scanner carriage unit does not move, the scanner motor is defective.
- If the exposure lamp does not turn on, the exposure lamp is defective.
- If the scanner carriage moves and the exposure lamp turns on, the scanner carriage unit is defective.

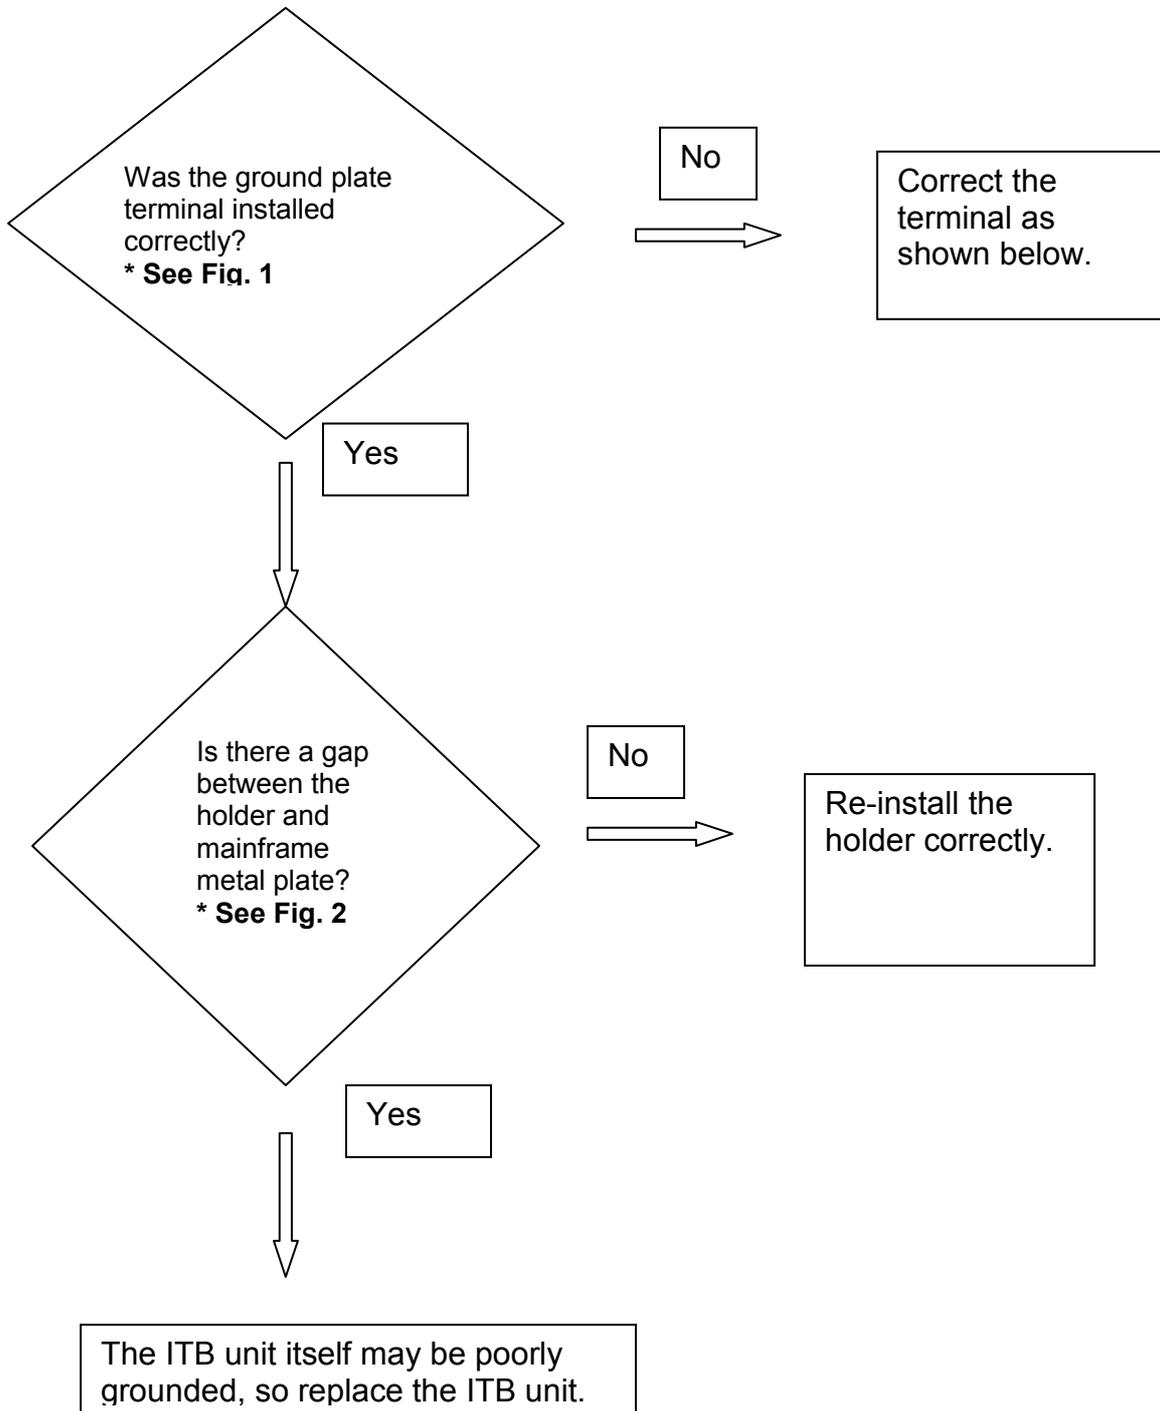
Poor grounding of the ITB (image transfer belt)

5. Follow the flowchart below to check the ground plate terminal and sensor bracket:

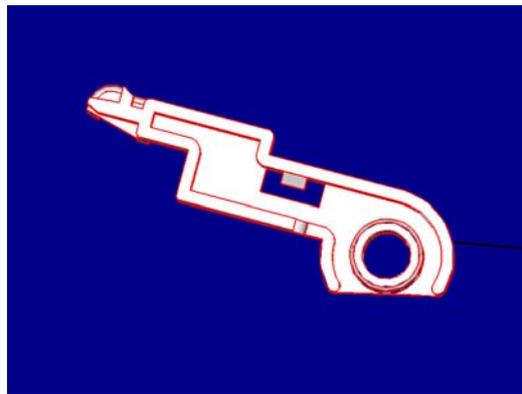
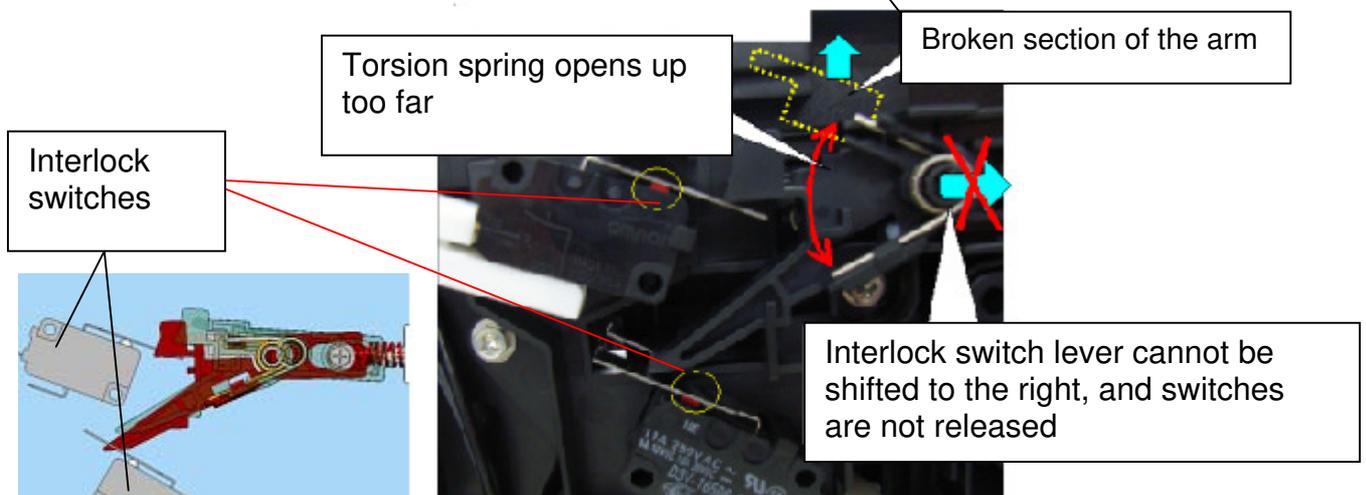
Interlock switch arm

1. The "Paper jam" alert message does not clear after jammed paper is removed and the front or top cover is closed.
2. The "Toner End" alert message does not clear after the print cartridge is replaced at Toner End. Following this, if the main power switch is turned OFF/ON, the message changes to "X Toner Independent supp".

The interlock switch arm (G1665747) breaks, which causes the torsion spring to open up too far. As a result, the interlock switch lever cannot be shifted and the interlock switches are not released, preventing the machine from detecting the cover open condition.

**SOLUTION****In the field**

Replace the interlock switch arm with a new one (G1665754).

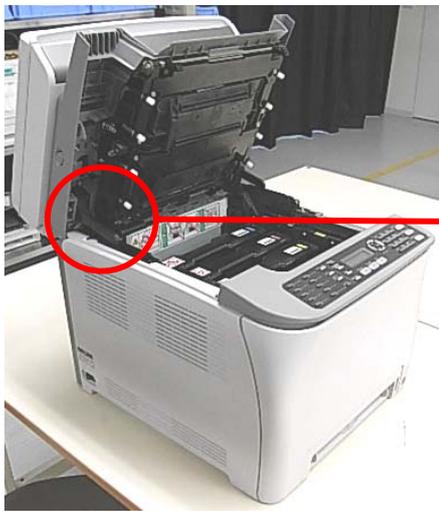
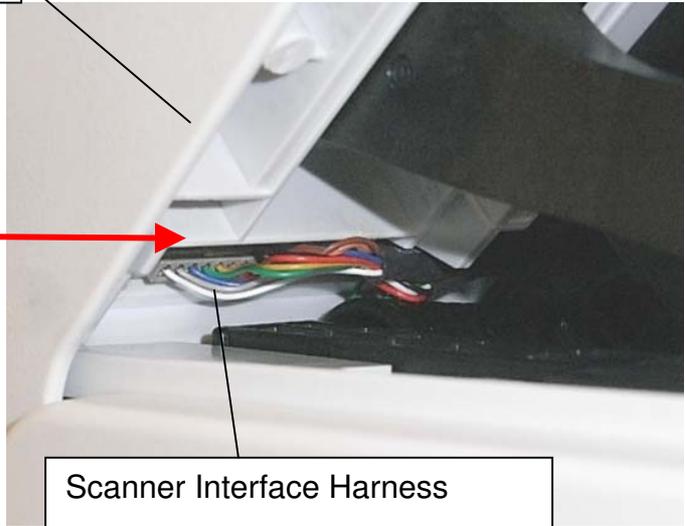
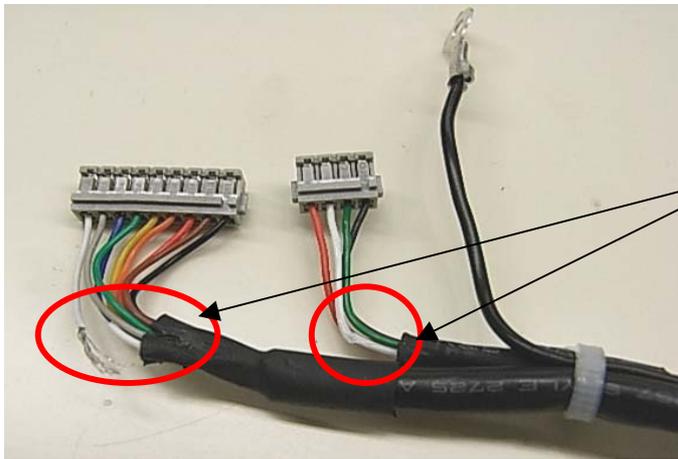
Pinched Scanner Interface Harness

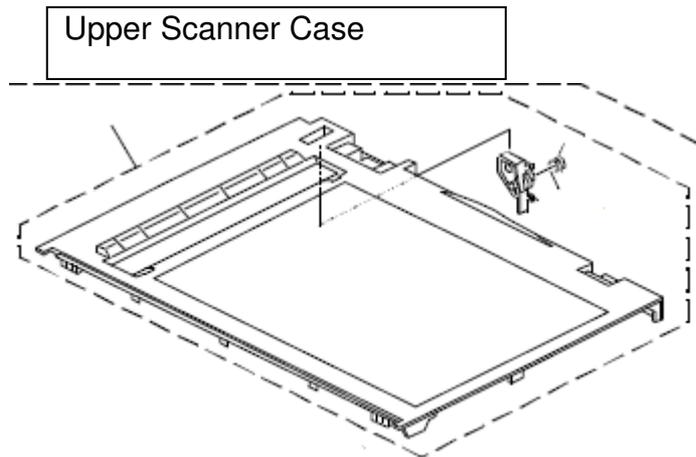
Change/Reason: P/N G1831820, which does not include the white plate, was registered as a service part by mistake.

Note: It is not possible to replace the white plate in the field individually. P/N G1831757 contains this white plate.

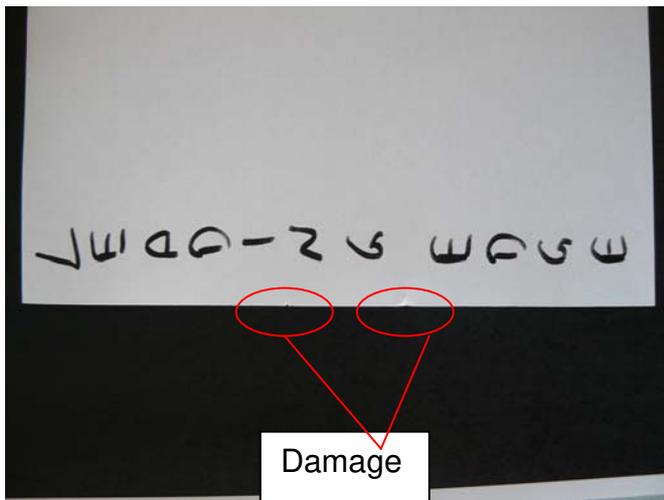
The leading edge of the original may sometimes be damaged when feeding from the ADF.

The leading edge sometimes touches the ribs on the scanner upper case.

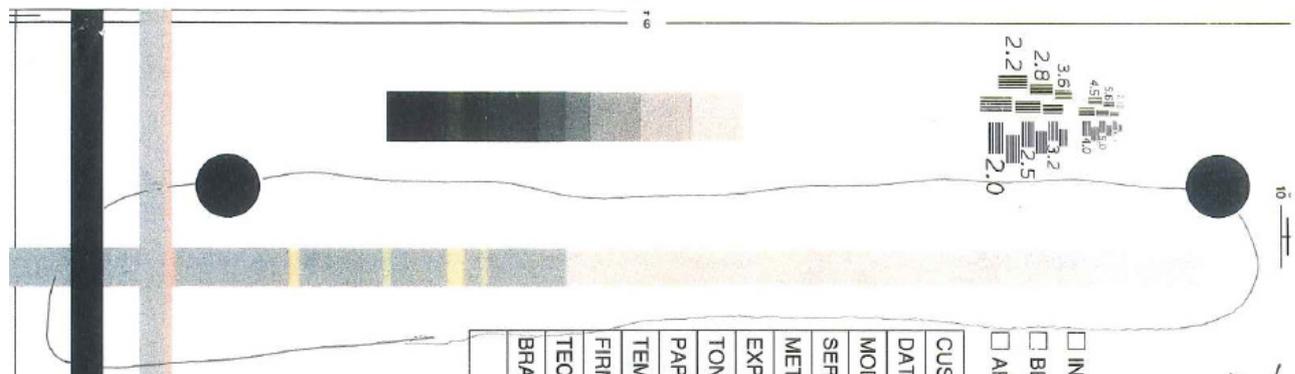
White or colored stripes may appear on copies.

The glue that fixes the calibration white plate to the edge of the exposure glass melts. As a result, it leaks out and is picked up by the scanner.

Note: The glue tends to melt when the temperature and humidity are high (40C, 90%), and when the exposure glass is cleaned with alcohol.

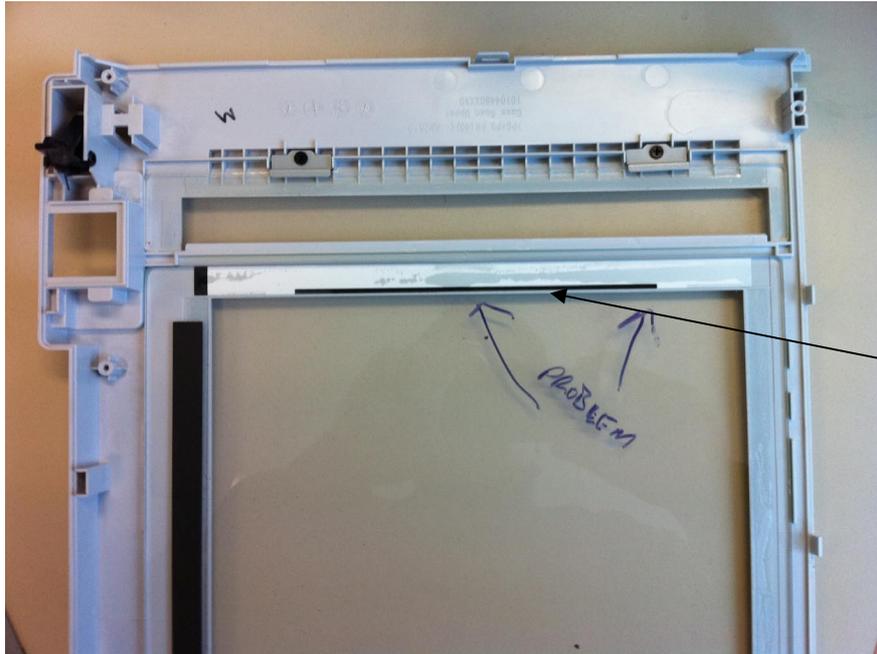
Glue melted
Upper Scanner Case

1. If the symptom occurs, replace the upper scanner case or scanner unit.
2. To prevent occurrences, do the following:
