| Model: PE-P2/MF3 (P2 only) | Date: 12-Aug-11 | No.: RM096001e |

| Subject: Firmware Release Note: MAIN-PDL | | Prepared by: J.Kitagawa | |

This RTB has been issued to announce the firmware release information for the PE-P2 **MAIN-PDL**.

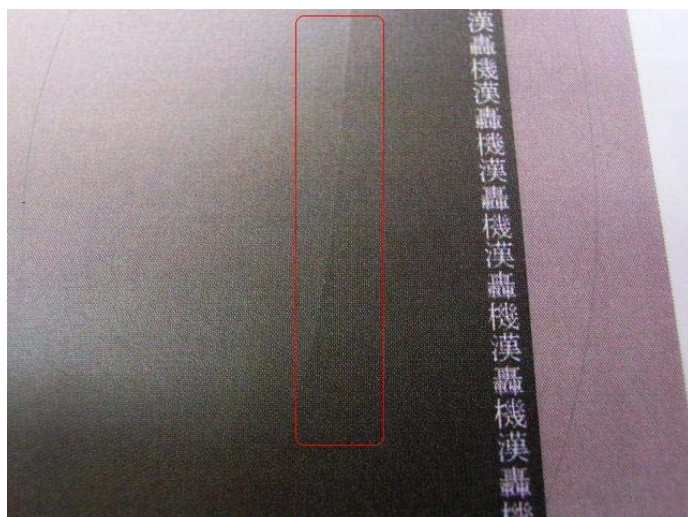
Paper creasing occurs when printing in Fine resolution mode just after printing in Standard resolution mode.

The fusing temperature is lowered when switching to Fine resolution, but sometimes the actual temperature on the fusing roller surface does not decrease as quickly as expected.

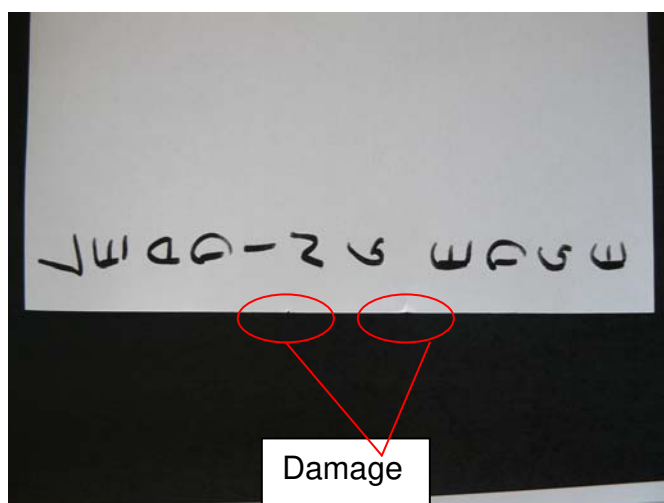
The leading edge of the original may sometimes be damaged when feeding from the ADF.

The leading edge sometimes touches the ribs on the scanner upper case.

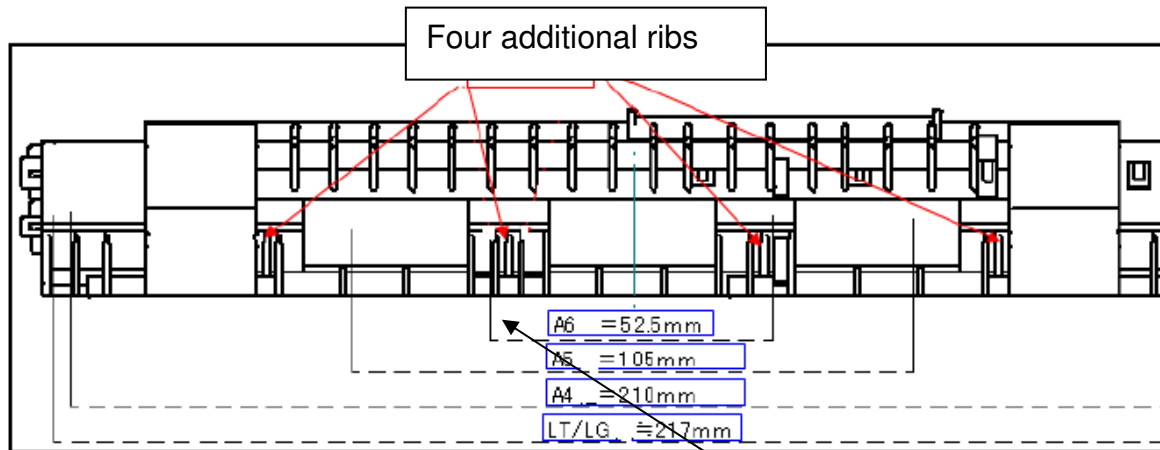
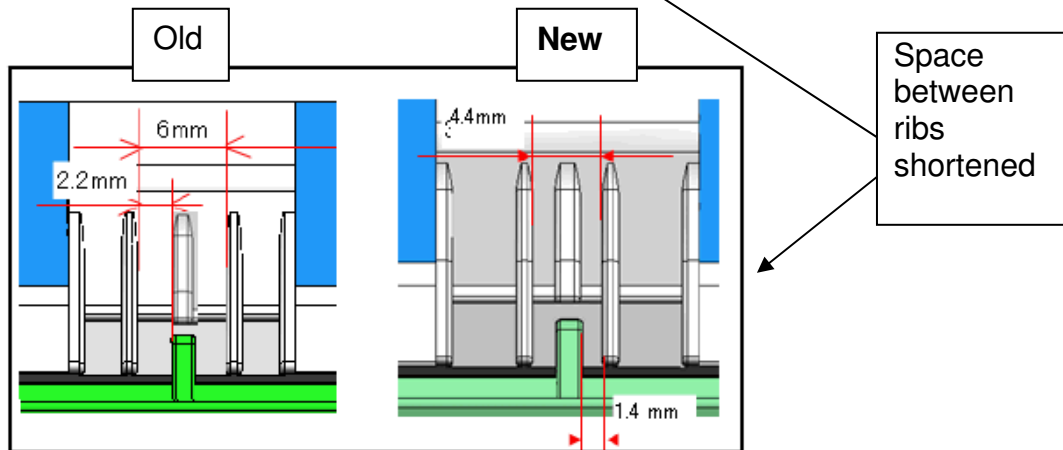
Four ribs added to Guide:Feed:Driven

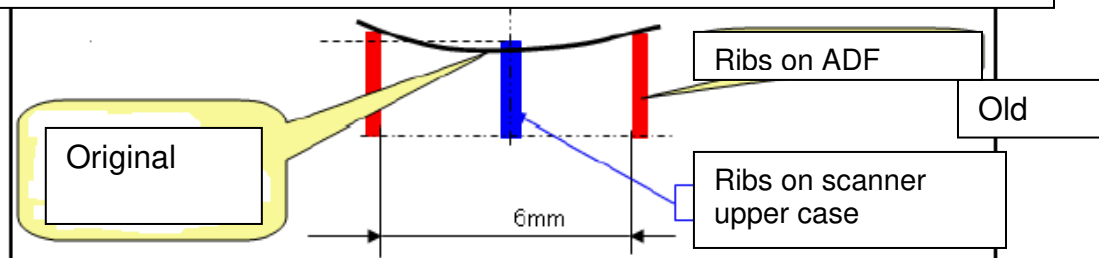
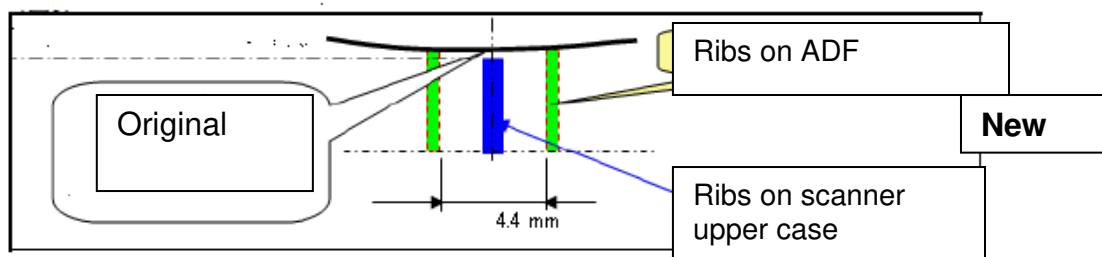
Height of ribs on ADF increased by 1 mm

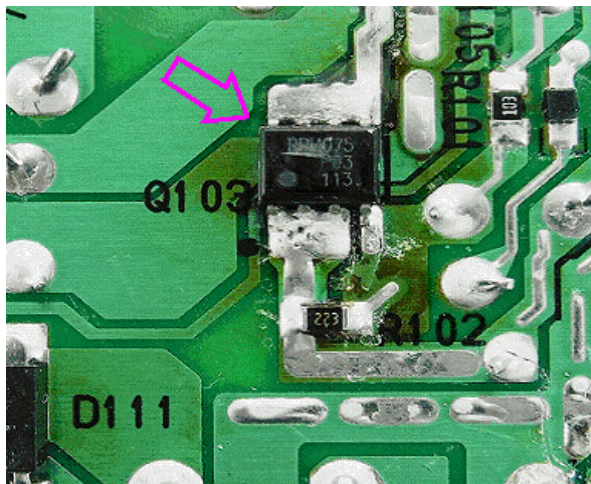
The sensor EGB harness for the PSU is pinched, which causes a short circuit between the harness and machine ground. As a result, Q103 (FET) on the PSU is damaged.

Q103: Rear side of the PSU

1. Check Q103 on the rear side of the PSU to see if it was damaged.

2. If it was damaged, replace the PSU with the following:

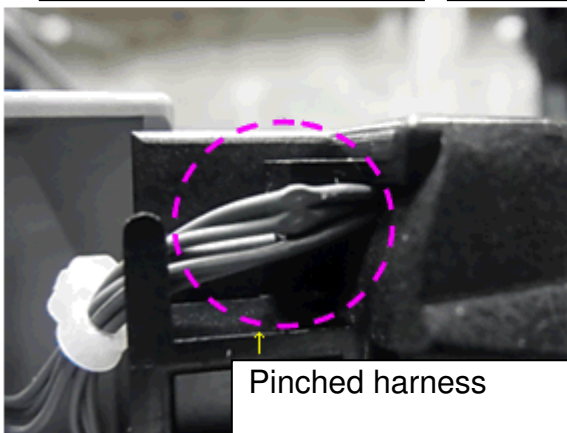
Pinched harness

4. If the harness is pinched, but the cables inside are not cut or broken, wrap the affected area with insulating tape.
5. If any of the harness cables are cut or broken, or if the temporary taping solution in Step 4 is not effective, replace the harness so that it is not pinched.

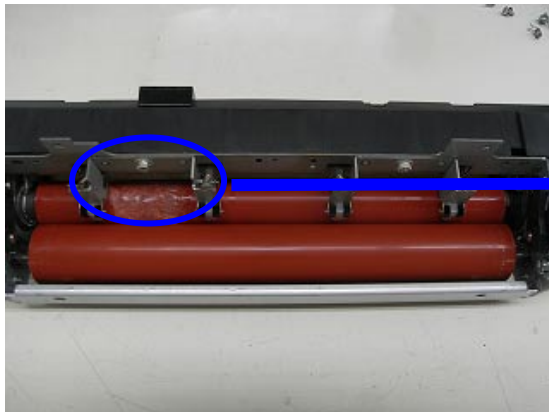
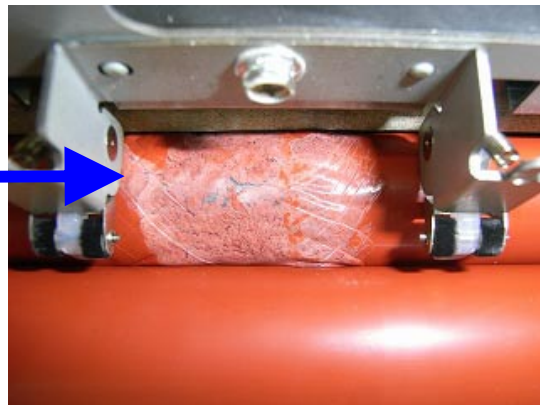
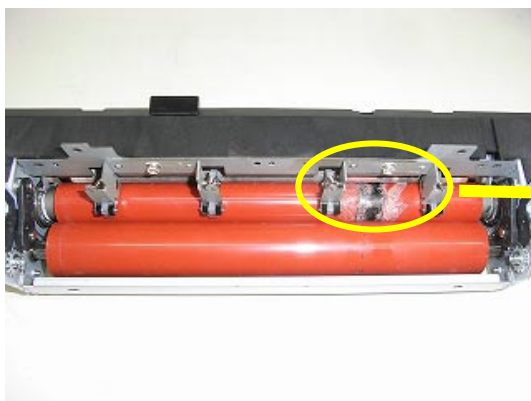
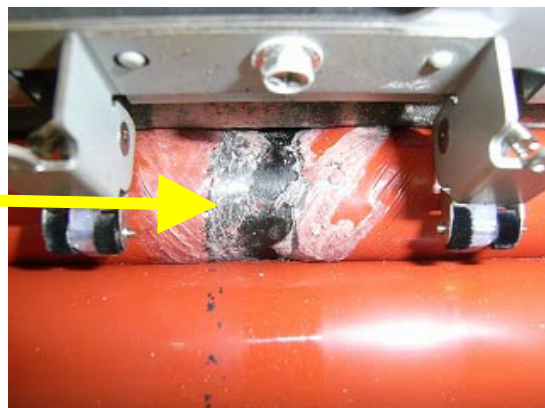
One or more of the following occur at 50-100mm from the center of the hot roller (right side, left side, or both):

- Creases develop in the tube around the hot roller
- The hot roller's rubber layer separates from the metallic core
- The tube and rubber layer are damaged

The actual temperature of the hot roller surface was higher than the target (especially in the damaged areas) under the following conditions. The accumulated temperature stress triggers the symptom.

1. Replace the fusing unit.
2. Update the **Engine** firmware to **v1.05** or later.
