Technical Bulletin

Model: Per-P5/MF5			Dat	te: 11-Sep-17	No.: RM0AW001	
Subject: Main Firmware for 1st Mass Production				Prepared by: T. Tachibana		
From: 2nd Tech Service Sect., MFP/P Tech Service Dept.						
Classification:	Assification: Troubleshooting Part inform Mechanical Electrical Paper path Transmit/re Product Safety Other (Firm		al it/rec	eive 🗌 Servic	required e manual revision it information

Model: PE-MF5			Dat	e: 14-Sep	-18	No.: RM0AW002
Subject: Parts Catalog Correction				Prepared by: Taiga Itoh		
From: 1st Tech. Support Sec. Service Support Dept.						
Classification:	Troubleshooting	🛛 Part informa		ation Action required		n required
	Mechanical	Electric	al		Servic	ce manual revision
	Paper path	Transm	it/rec	eive	Retro	fit information
	Product Safety	Other ()	Tier 2

Model: PE-P5/MF5			Date: 23-A	No.: RM0AW003	
Subject: Revised laser safety regulation Prepared by:					
From: Tech Support Sect., Product Marketing Dept.					
Classification:	Troubleshooting	Part inform	mation		equired
	Mechanical	Electrical		🛛 Service manual revision	
	Paper path	Transmit/re	eceive	Retrofit information	
	Product Safety	Other ()		Tier 2

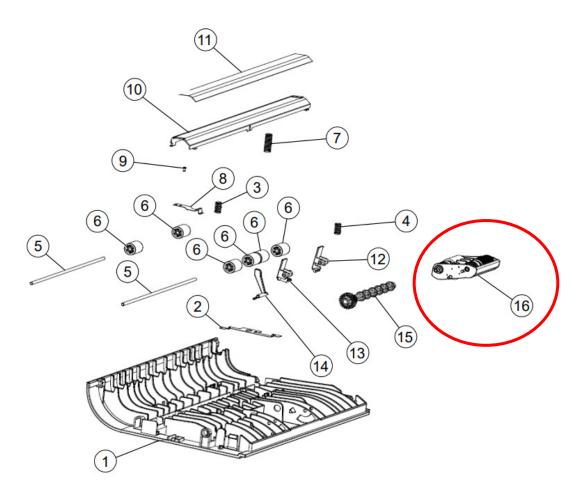
3. DADF-2

Incorrect part number	Correct part number	Description	Q'ty	Page	Index	Note
M0AX1758	M0AX1710	PAPER FEED UNIT:ASS'Y	1	6	16

Please use the correct part number **M0AX1710**.
