Model: Kaiser1	Date: 29-Feb-00	No.: RH306001a
----------------	-----------------	----------------

Subject: ROM History (Kaiser 1)		Prepared by: M. Mano	
From: Technical Services Dept., GTS Division			
Classification:	<input type="checkbox"/> Troubleshooting <input type="checkbox"/> Part information <input type="checkbox"/> Action required		
	<input type="checkbox"/> Mechanical <input type="checkbox"/> Electrical <input type="checkbox"/> Service manual revision		
	<input type="checkbox"/> Paper path <input type="checkbox"/> Transmit/receive <input checked="" type="checkbox"/> Retrofit information		
	<input type="checkbox"/> Other (       )

Firmware history for the Kaiser1 (USA Model)

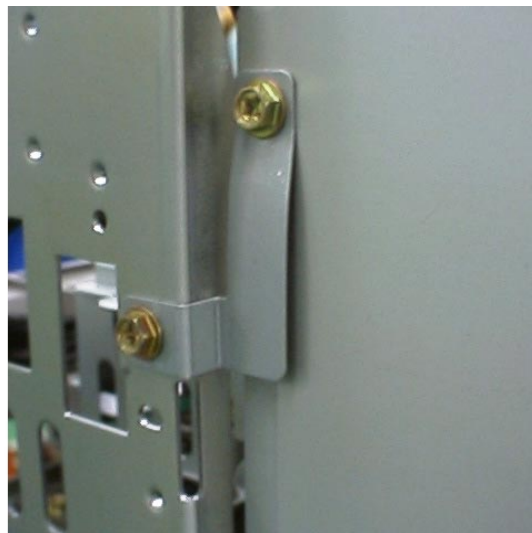
[Fig. 2]

The PIF option grounding plate [A] (P/N: H3064662) in the following 15 units will bend slightly when you attach it, as shown in figure 2.

However, the plate will function normally and the slight bending will not affect the operations of the printer unit or mainframe in any way.

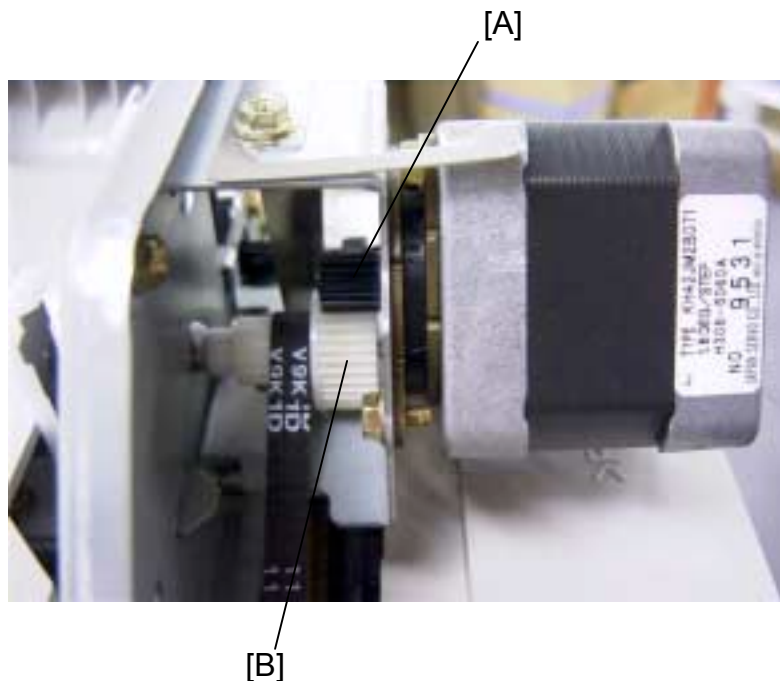
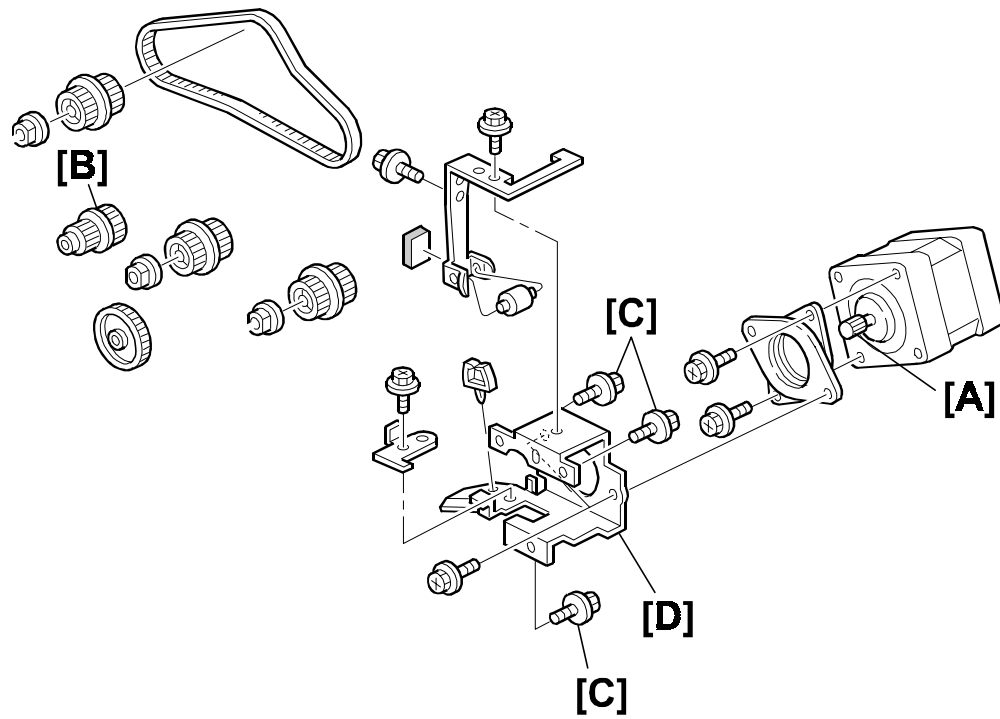
A squeaking sound can be heard coming from the ADF unit.

Vibration of the ADF motor gear [A] and ADF rear slow down gear [B] as shown below.

In the field, please re-tighten the 3 screws [C] (see the next page) that secure the ADF motor bracket [D] to the ADF unit. This will ensure that the 2 gear shafts are parallel.

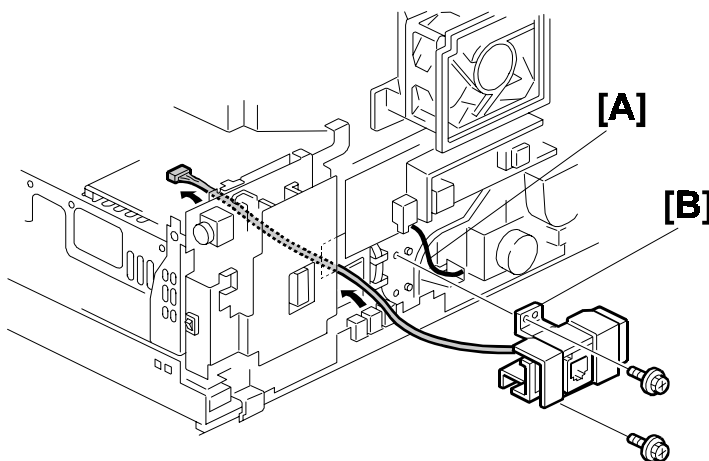
When the following option(s) are installed, the paper end sensor harness [A] may be pinched between the mainframe and the bracket [B].

If the harness [A] is pinched, a number of symptoms can occur such as:

- Power LED is not lit
- Operation panel is not lit
- Other

When installing the bracket for the options mentioned above, please make sure that the harness remains to the right of the bracket and does not get pinched.

For the N. America model, the routing of the harness has been changed from the beginning of March 2000 production.

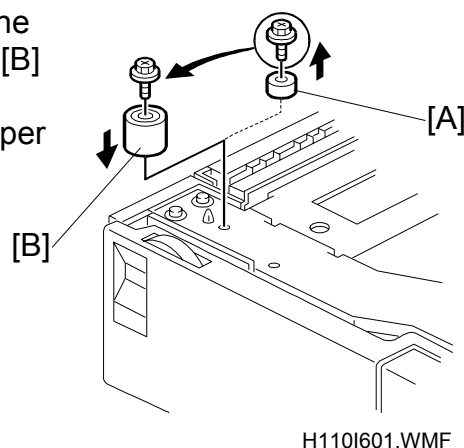
■ ***If you do not remove the 2 tie-wraps, the PFU cannot properly feed the paper.***

1. When the paper feed unit is installed just under the machine, change the small leg [A] to the big one [B] that is enclosed.

**NOTE:** Remove the 2 tie-wraps securing the paper feed rollers (located under the red tag).
