Model: Model-K3		Date: 5-Sep-02	No.: RH310001
Subject: SG3 Option ROM History (Model K3)		Prepared by: M. Mano	
From: Technical Services sec. Service Planning Dept.			
Classification:	<input type="checkbox"/> Troubleshooting <input type="checkbox"/> Part information <input type="checkbox"/> Action required <input type="checkbox"/> Mechanical <input type="checkbox"/> Electrical <input type="checkbox"/> Service manual revision <input type="checkbox"/> Paper path <input type="checkbox"/> Transmit/receive <input checked="" type="checkbox"/> Retrofit information <input type="checkbox"/> Other ()

Firmware history of the optional SG3 for Model K3.

Model: Model K3		Date: 5-Sep-02	No.: RH310003
Subject: Note at the Installation for Model K3		Prepared by: M. Mano	
From: Technical Services sec. Service Planning Dept.			
Classification:	<input type="checkbox"/> Troubleshooting <input type="checkbox"/> Mechanical <input type="checkbox"/> Paper path <input type="checkbox"/> Other ()	<input type="checkbox"/> Part information <input type="checkbox"/> Electrical <input type="checkbox"/> Transmit/receive	<input type="checkbox"/> Action required <input type="checkbox"/> Service manual revision <inp

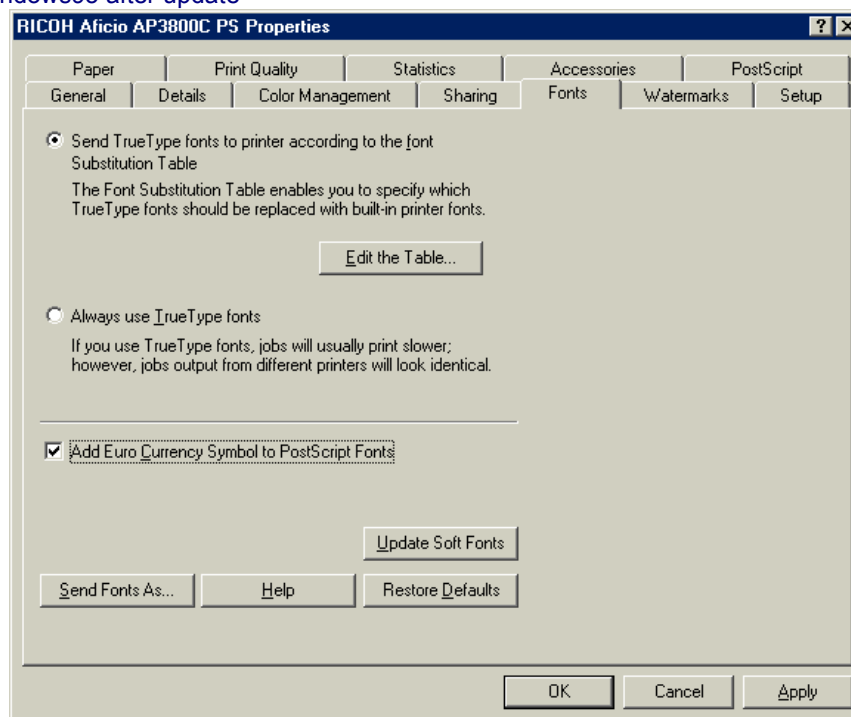
Windows95 after update

Update Windows95 to "Euro Currency Support for Windows95".

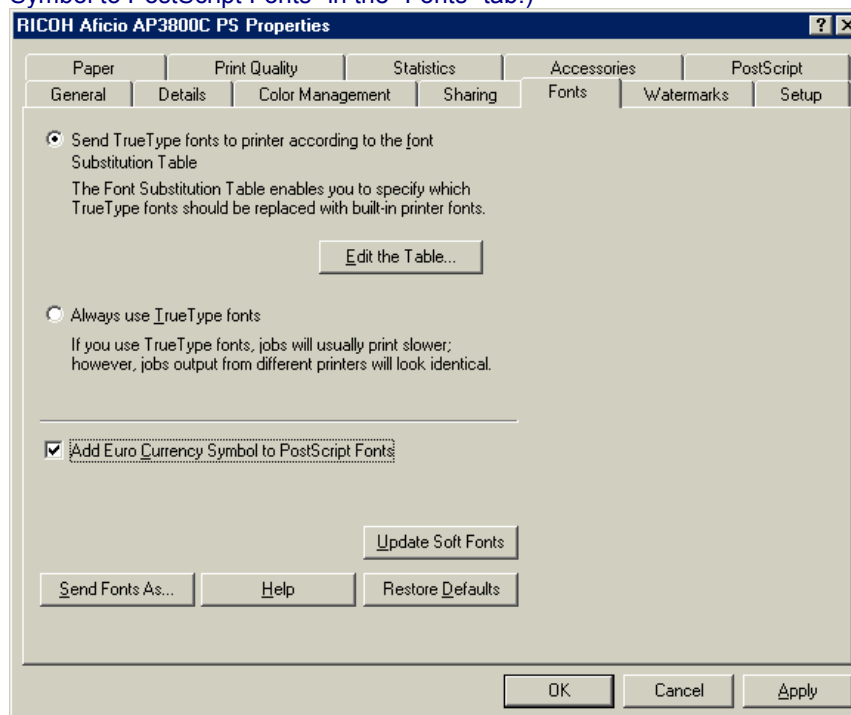
Windows 98 / ME (Note: The AdobePS driver version 4.3.1 or later has "Add Euro Currency Symbol to PostScript Fonts" in the "Fonts" tab.)

Check "Add Euro Currency Symbol to PostScript Fonts" .

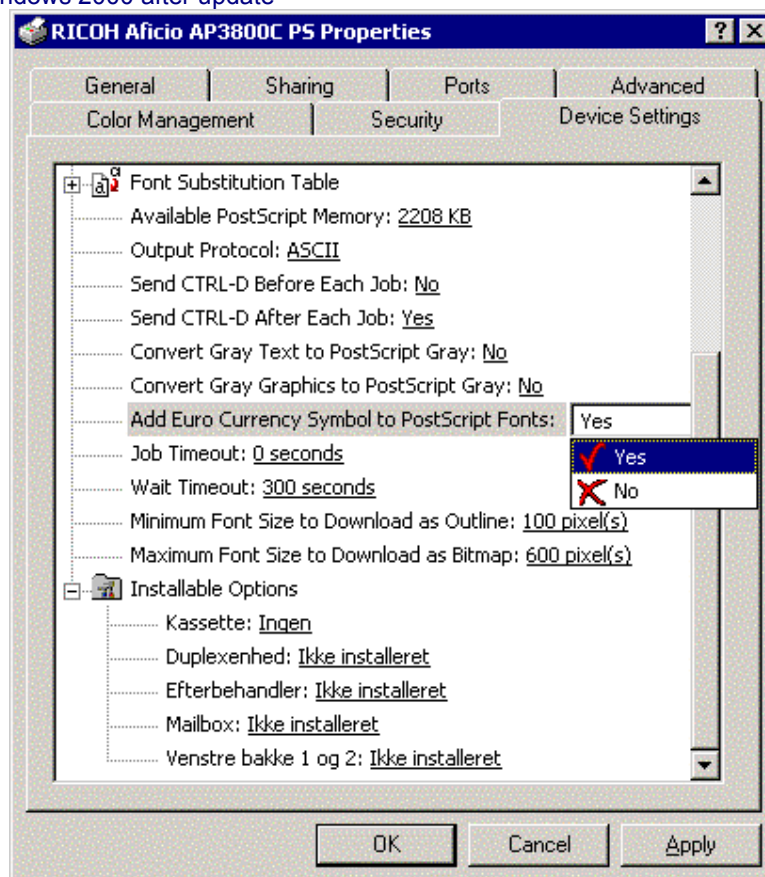
Windows 2000 after update

Check "Add Euro Currency Symbol to PostScript Fonts".
