Model: LFO		Date: 30-Sep-97	No: 001	1/1
Subject: Doctor Blade Replacement Tool			Prepared by: K. Misugi	
From: Technical Service Department			Checked by: S. Fujii	
Classification:	<input type="checkbox"/> Troubleshooting	<input checked="" type="checkbox"/> Part information	<input type="checkbox"/> Action required	
	<input type="checkbox"/> Mechanical	<input type="checkbox"/> Electrical	<input type="checkbox"/> Service manual revision	
	<input type="checkbox"/> Paper path	<input type="checkbox"/> Transmit/receive	<input type="checkbox"/> Retrofit information	
	<input type="checkbox"/> Other ()

Model: LFO		Date: 15-Nov-97	No: 002
Subject: Scanner Lock Release		Prepared by: Y.Tamaoka	
From: QAC Field Information Dept.			
Classification:	<input checked="" type="checkbox"/> Troubleshooting	<input type="checkbox"/> Part information	<input type="checkbox"/> Action required
	<input type="checkbox"/> Mechanical	<input type="checkbox"/> Electrical	<input type="checkbox"/> Service manual revision
	<input type="checkbox"/> Paper path	<input type="checkbox"/> Transmit/receive	<input type="checkbox"/> Retrofit information
	<input type="checkbox"/> Other ()

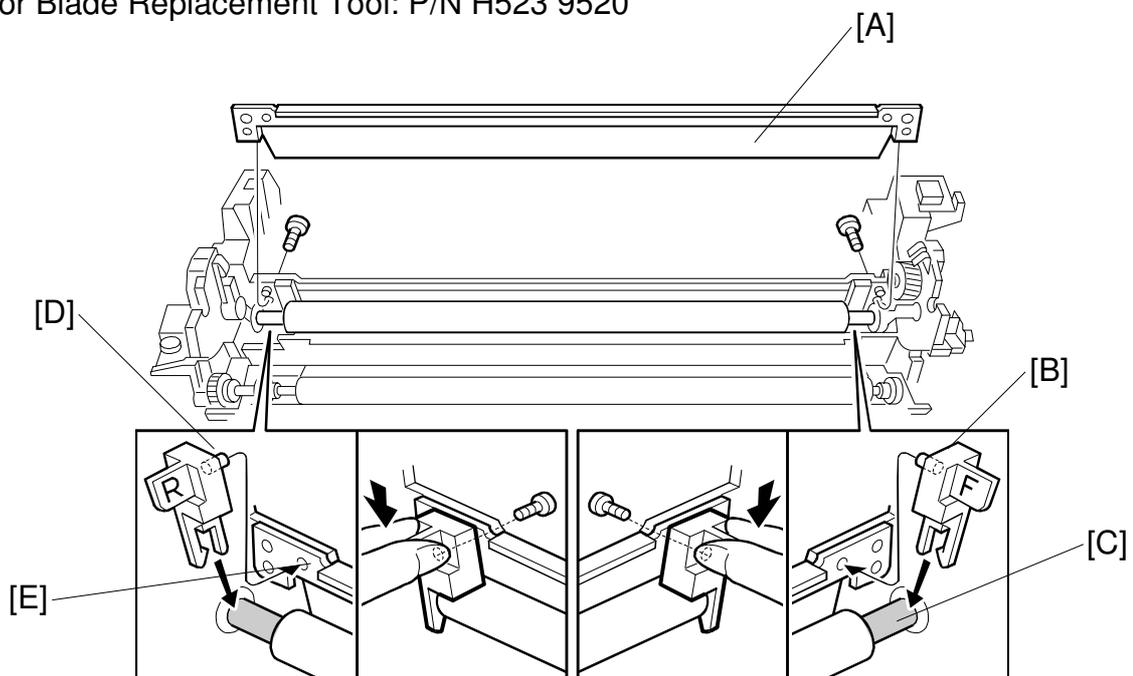
The toner metering blade of the LFO will be available as a service part. However, a doctor blade replacement tool is required for the replacement.

To install a new toner metering blade [A] do the following:
(The following procedures are also required for reinstallation of the blade.)

1. Place a new toner metering blade as shown.
2. Set the blade tools [B] on the development roller shaft [C]. The tool with the marking "F" should be placed at the front side (main motor side) of the development unit.
3. Position the pins [D] into the positioning holes [E] in the metering blade frame.
4. Fasten with the screw each end of the metering blade while holding down the tool [B].
5. Remove the tools [B].

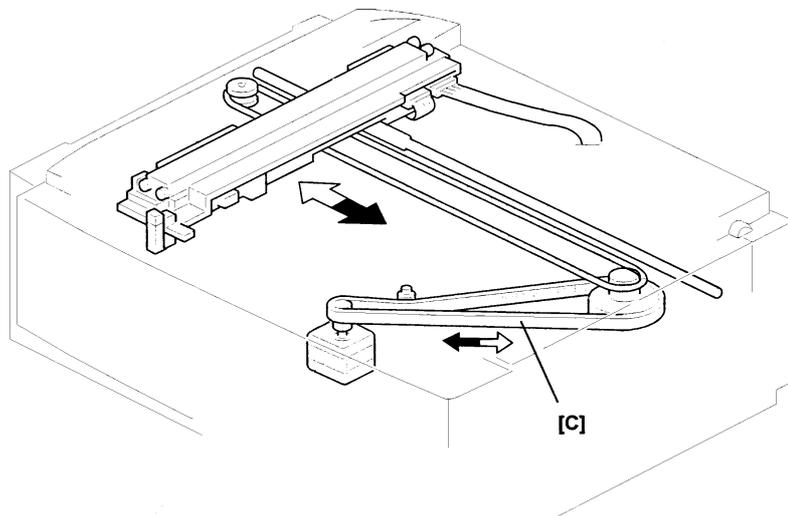
The lock lever cannot be released. (It is very hard to push down.)

The scanner carriage moves and gets under the carriage stopper.

Pull the scanner timing belt to move the carriage and push the release lever down.

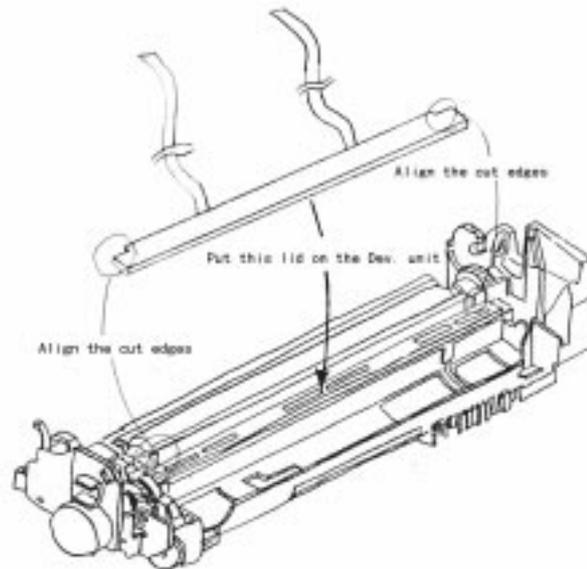
H5239700 Lid - Development Unit – LFO

Toner leakage can be minimized during transportation with this lid even after filling the development unit with toner, but it is not fully guaranteed for all conditions of transportation. (Toner may leak even with this lid, depending on the transportation conditions.)

1. Undo the black tapes
2. Remove the CTM and put on the lid (H5239700) as shown in the drawing below.
3. Put the black tapes on the fusing unit. This tape is just a reminder not to forget to remove this lid at reinstallation.
4. Put the CTM back and close the scanner unit.

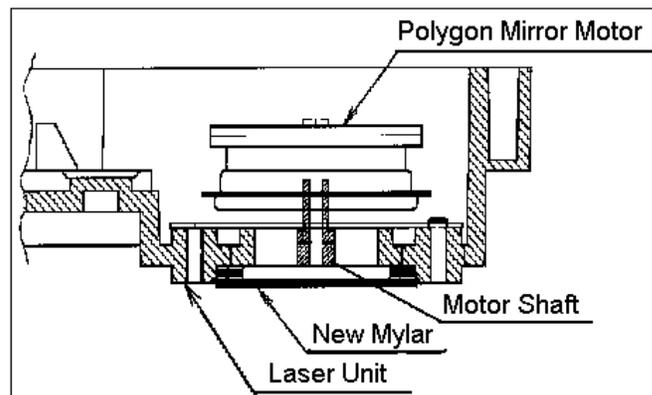
1. When installing for the first time, be sure to replace the new motor and Mylar **together as a set**.
2. The Polygon Mirror Motor itself has not been changed. The new P/N (H5529100) consists of the same motor plus the new Mylar.
3. This symptom does not occur with laser units used on other F/L series products (e.g. FX6/FX4/LSO/LFO), because the motor shaft and Mylar do not contact one another.

Replace with the modified Polygon Mirror Motor, which includes the modified Mylar.
See MB MH551022 for details.
