Model: Model L1b		Date: 30-Oct-02	No.: RH911001
Subject: Printer & Scanner Drivers Type 1100		Prepared by: A. Ishiyama	
From: Technical Services Sec., Service Planning Dept.			
Classification:	<input checked="" type="checkbox"/> Troubleshooting <input type="checkbox"/> Mechanical <input type="checkbox"/> Paper path <input type="checkbox"/> Other (      )	<input type="checkbox"/> Part information <input type="checkbox"/> Electrical <input type="checkbox"/> Transmit/receive	<input type="checkbox"/> Action required <input type="checkbox"/> Service manual revision <input type="checkbox"/> Retrofit information

Model: Model L1b		Date: 11-Dec-02	No.: RH911003
Subject: Scanning Performance with using Blue Ball Point Pen		Prepared by: A. Ishiyama	
From: Technical Services Sec., Service Planning Dept.			
Classification:	<input checked="" type="checkbox"/> Troubleshooting <input type="checkbox"/> Mechanical <input type="checkbox"/> Paper path <input type="checkbox"/> Other (       )	<input type="checkbox"/> Part information <input type="checkbox"/> Electrical <input type="checkbox"/> Transmit/receive	<input type="checkbox"/> Action required <input type="checkbox"/> Service manual revision <i

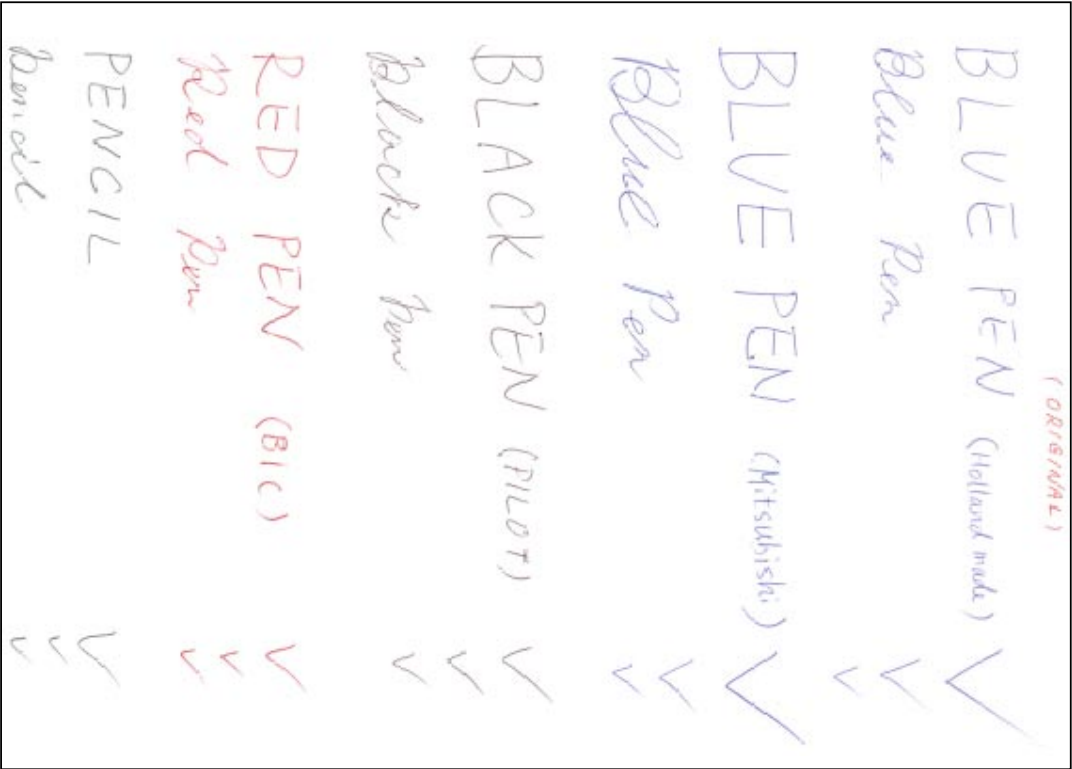
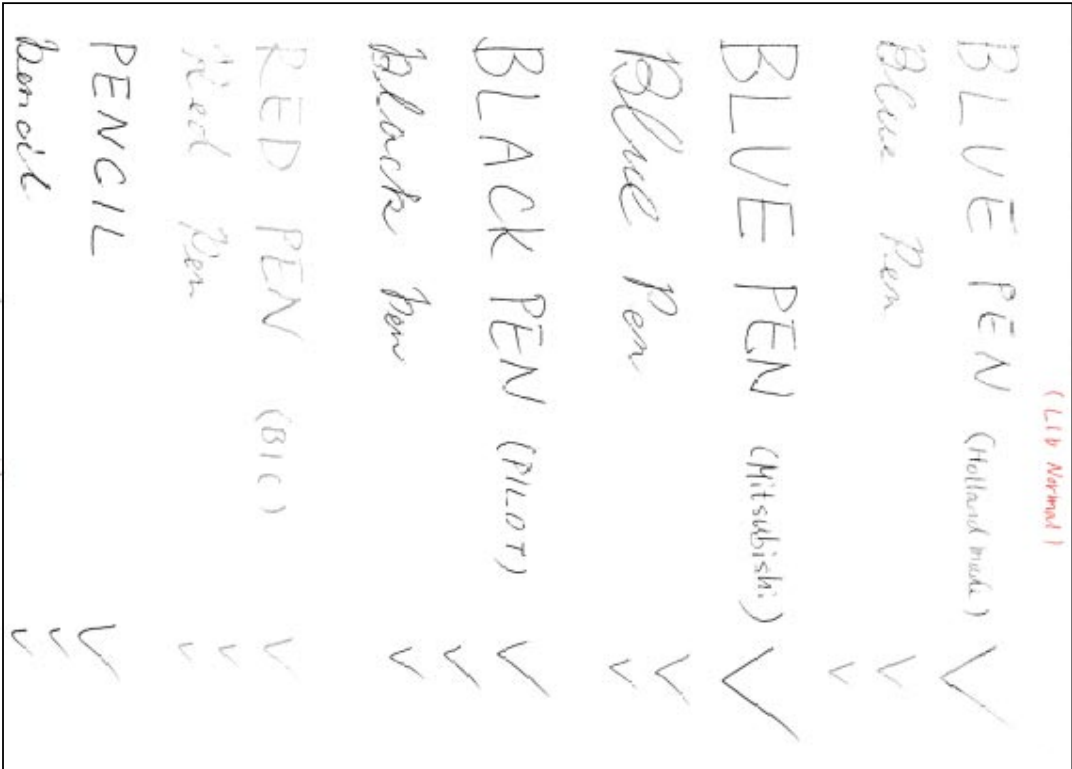
[Printout - Normal]

Poor reproduction of some areas written with a blue ballpoint pen.

The CIS (contact image sensor) in H912 models use blue light for exposure, which can make it difficult to reproduce some blue areas written in pen on the original. As shown on the following pages, some manufacturers produce pens that do not appear well on outputs.

Use the "Darken" setting on the operation panel when sending or making copies of an original containing areas hand-written in blue pen.

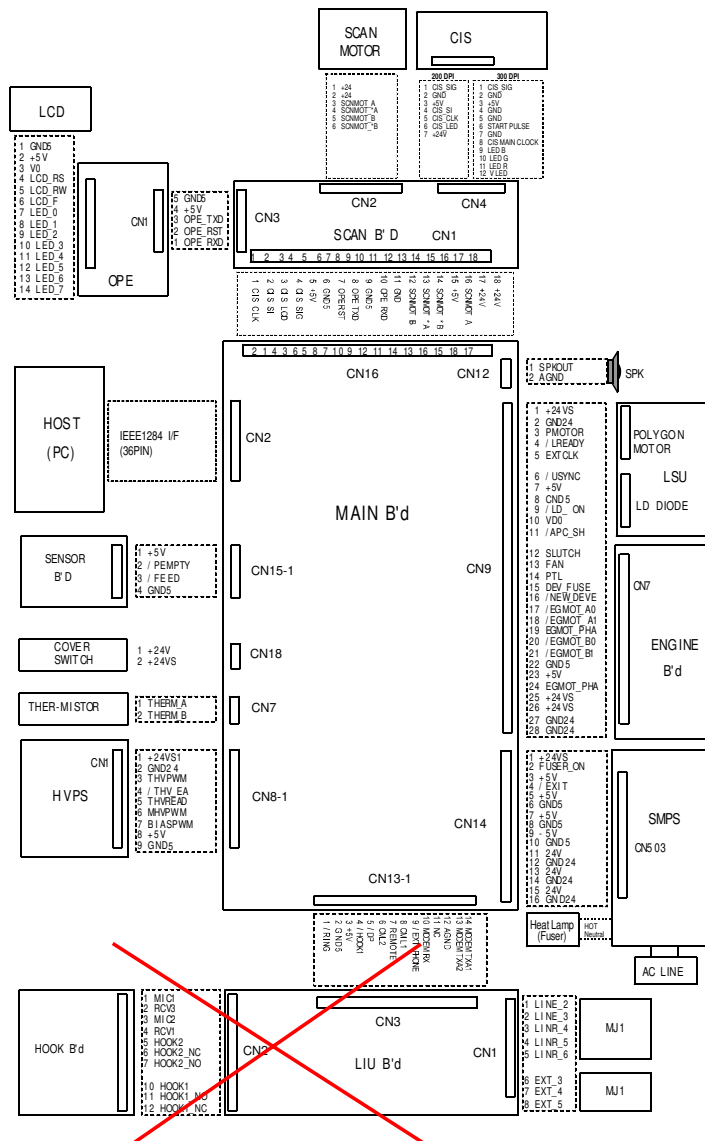
The connector for the handset harness has been removed from the illustration as shown below, because the Ricoh version of this product does not use a handset.
