Model: Model L2a	Date: 9-Sep-04	No.: RH914001b
------------------	----------------	----------------

Subject: Firmware History		Prepared by: T. Shintani	
From: 1st Technical Support Sec. Service Support Dept.			
Classification:	<input type="checkbox"/> Troubleshooting <input type="checkbox"/> Mechanical <input type="checkbox"/> Paper path <input type="checkbox"/> Other (      )	<input type="checkbox"/> Part information <input type="checkbox"/> Electrical <input type="checkbox"/> Transmit/receive	<input checked="" type="checkbox"/> Action required <input type="checkbox"/> Service manual revision <input type="checkbox"/> Retrofit information

Model: Model L2c		Date: 19-Nov-04	No.: RH914004
Subject: Machine firmware updated for NCU change		Prepared by: T. Shintani	
From: 1st Technical Support Sec. Service Support Dept.			
Classification:	<input type="checkbox"/> Troubleshooting <input type="checkbox"/> Part information <input checked="" type="checkbox"/> Action required <input type="checkbox"/> Mechanical <input type="checkbox"/> Electrical <input type="checkbox"/> Service manual revision <input type="checkbox"/> Paper path <input type="checkbox"/> Transmit/receive <input type="checkb

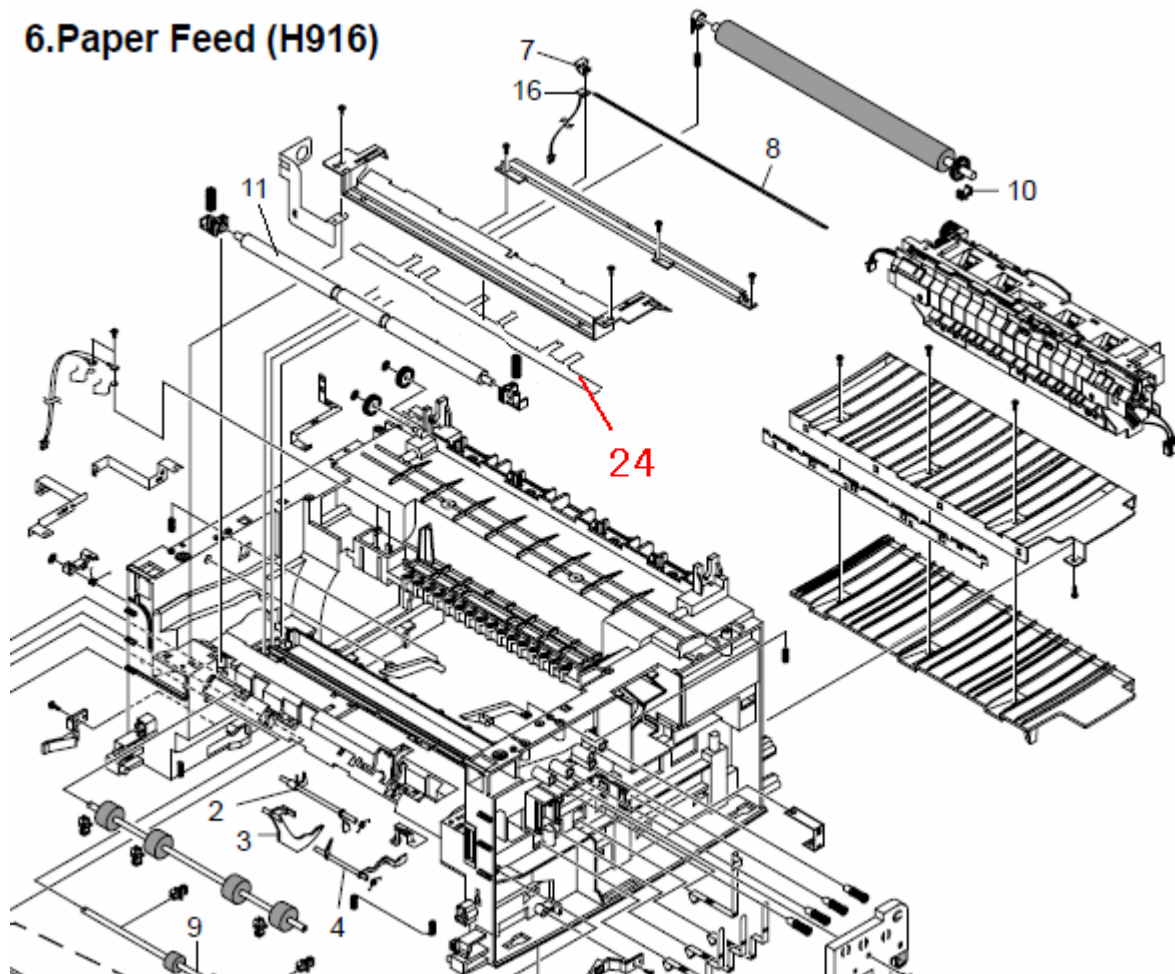
## 6.Paper Feed (H916)

NEW Part	Description	Q'ty	Int	Page	Index	Note
H9169687	Sheet Guide Paper	1	-	11	24

NEW Part	Description	Q'ty	Int	Page	Index	Note
H9169687	Sheet Guide Paper	1	-	13	24

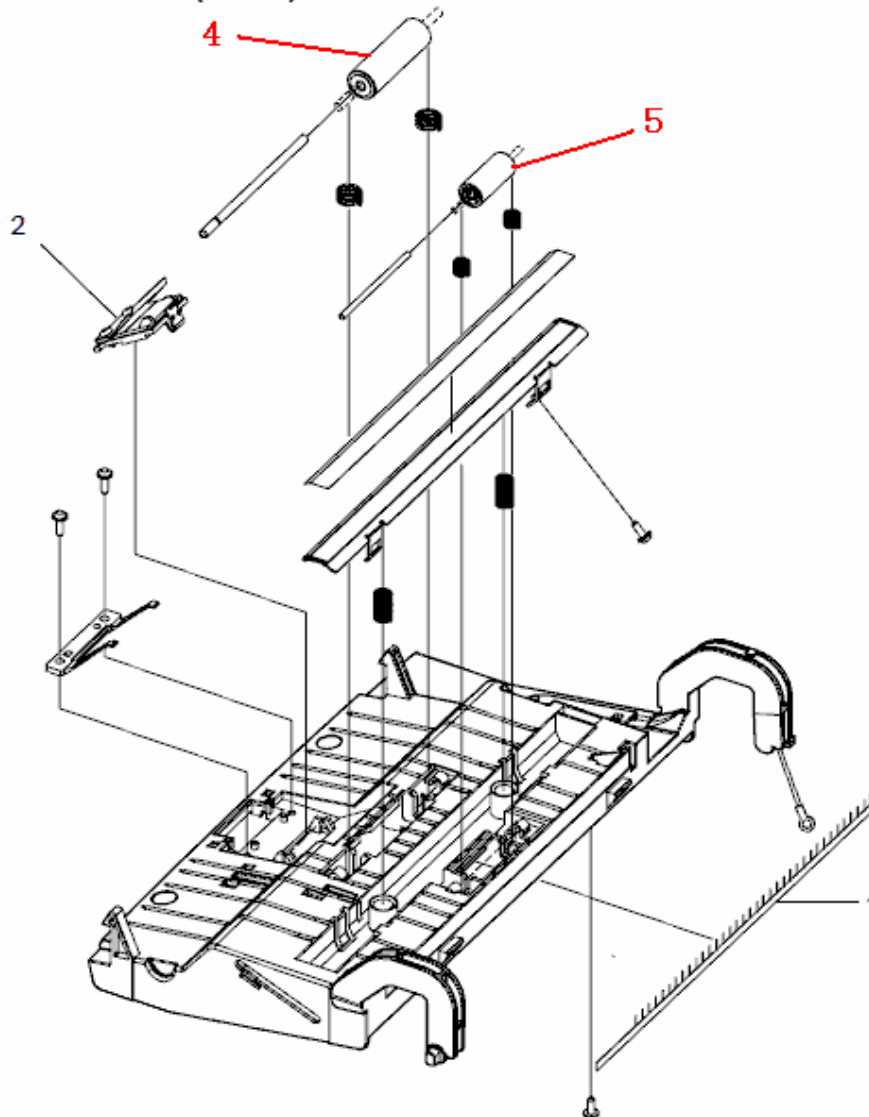
## 4.Upper Scanner (H916)

NEW Part	Description	Q'ty	Int	Page	Index	Note
H9169688	ROLLER IDLE SCAN	1	-	9	4	
G9601197	PINCH ROLLER	1	-	9	5

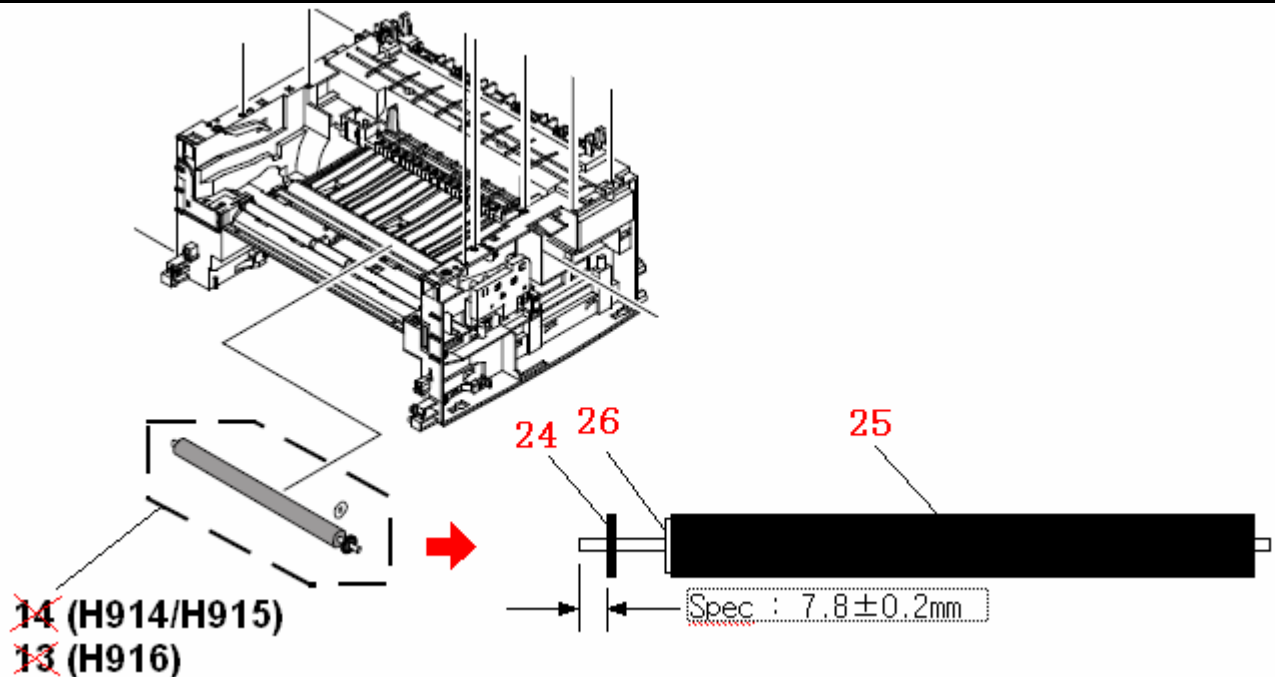
**Change:** P/N B1739513 was divided into three separate parts.

**Reason:** The parts vendor stopped supplying P/N B1739513 as an assembly.

Old Part Number	New Part Number	Description	Q'ty	Int	Page	Index	Note
B1739513	B1739801	GEAR - TRANSFER	1	O/O	3	14→24	
	B1739802	ROLLER - TRANSFER	1			14→25	
	B1739803	SPACER - TRANSFER	1			14→26

Old Part Number	New Part Number	Description	Q'ty	Int	Page	Index	Note
B1739513	B1739801	GEAR - TRANSFER	1	O/O	3	13→24	
	B1739802	ROLLER - TRANSFER	1			13→25	
	B1739803	SPACER - TRANSFER	1			13→26

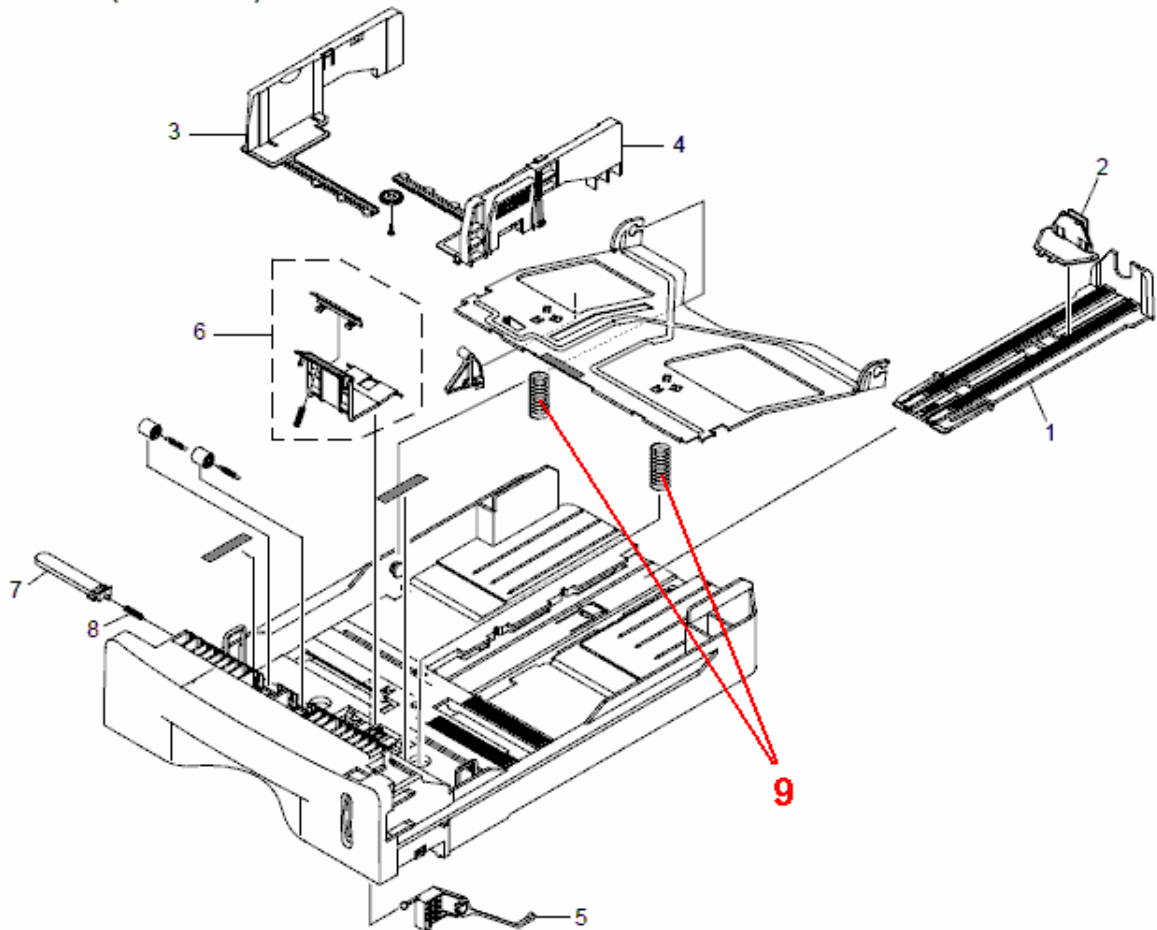
## 8.Paper Cassette (H914/H915)

NEW Part	Description	Q'ty	Int	Page	Index	Note
G9601016	SPRING - CASSETTE	2	-	17	9

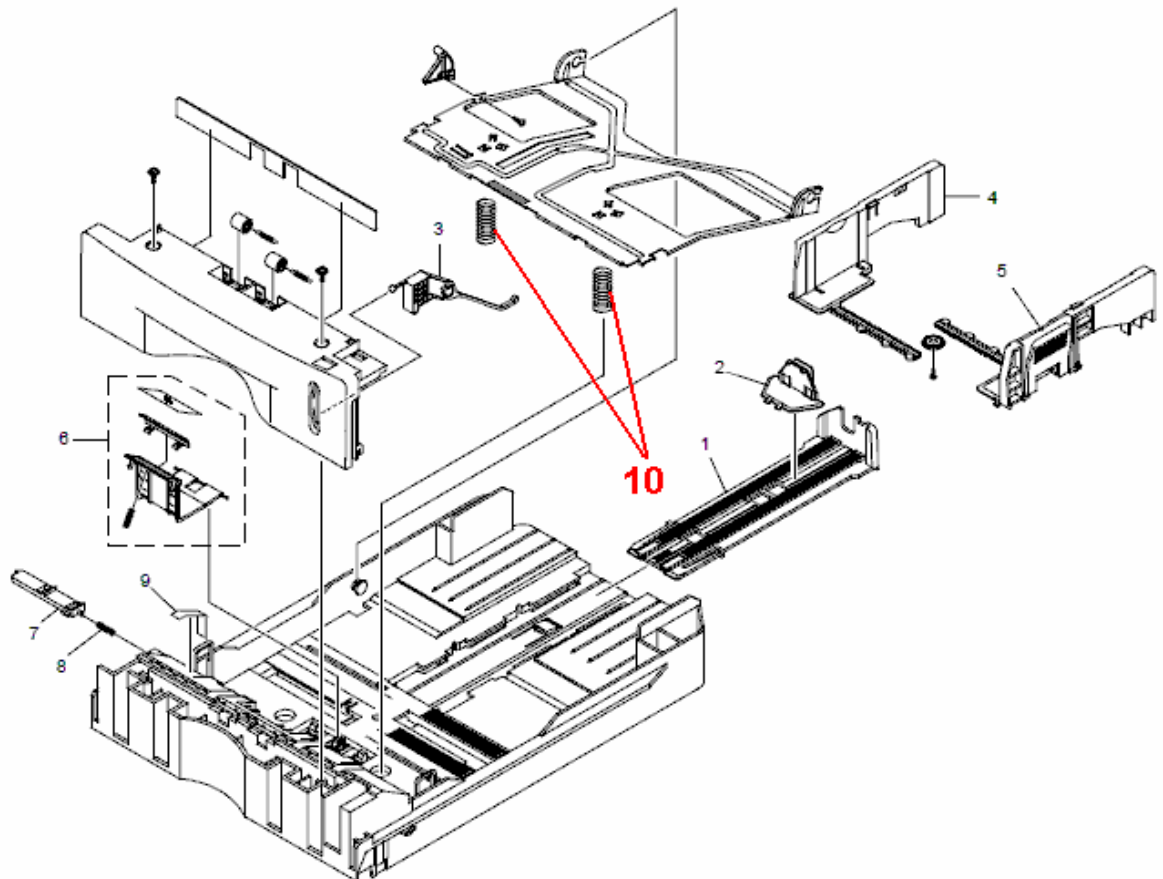
## 9.Paper Cassette (H916)

NEW Part	Description	Q'ty	Int	Page	Index	Note
G9601016	SPRING - CASSETTE	2	-	19	10

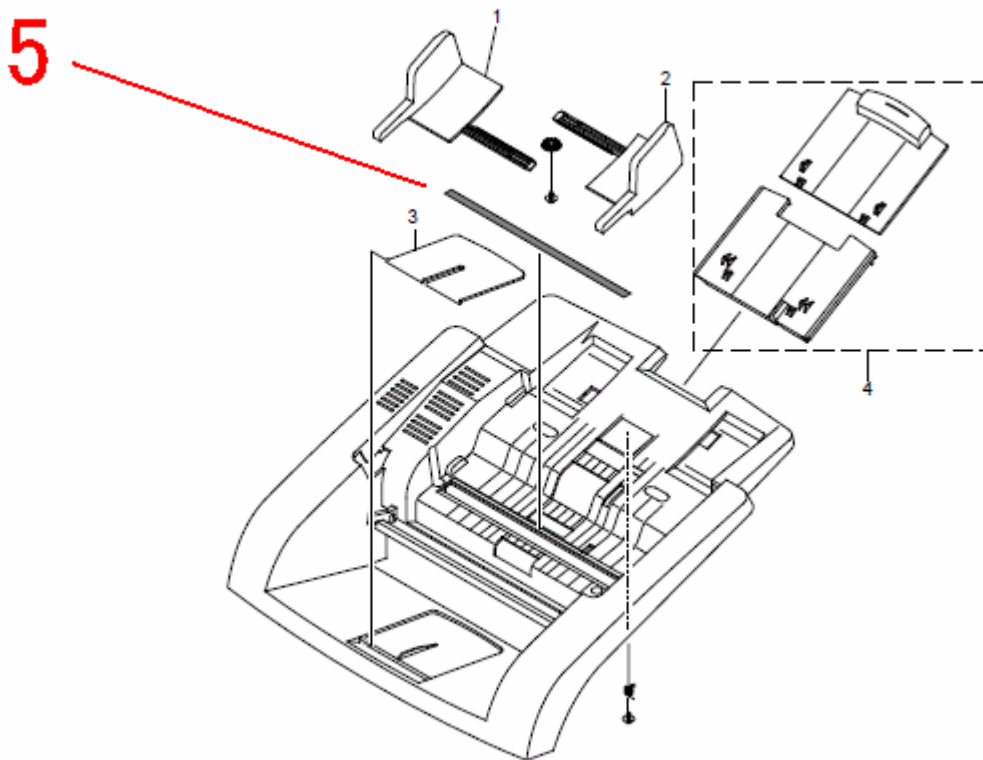
## 2.Top Cover (H916)

NEW Part	Description	Q'ty	Int	Page	Index	Note
H9169689	SHEET-CIS	1	-	5	5

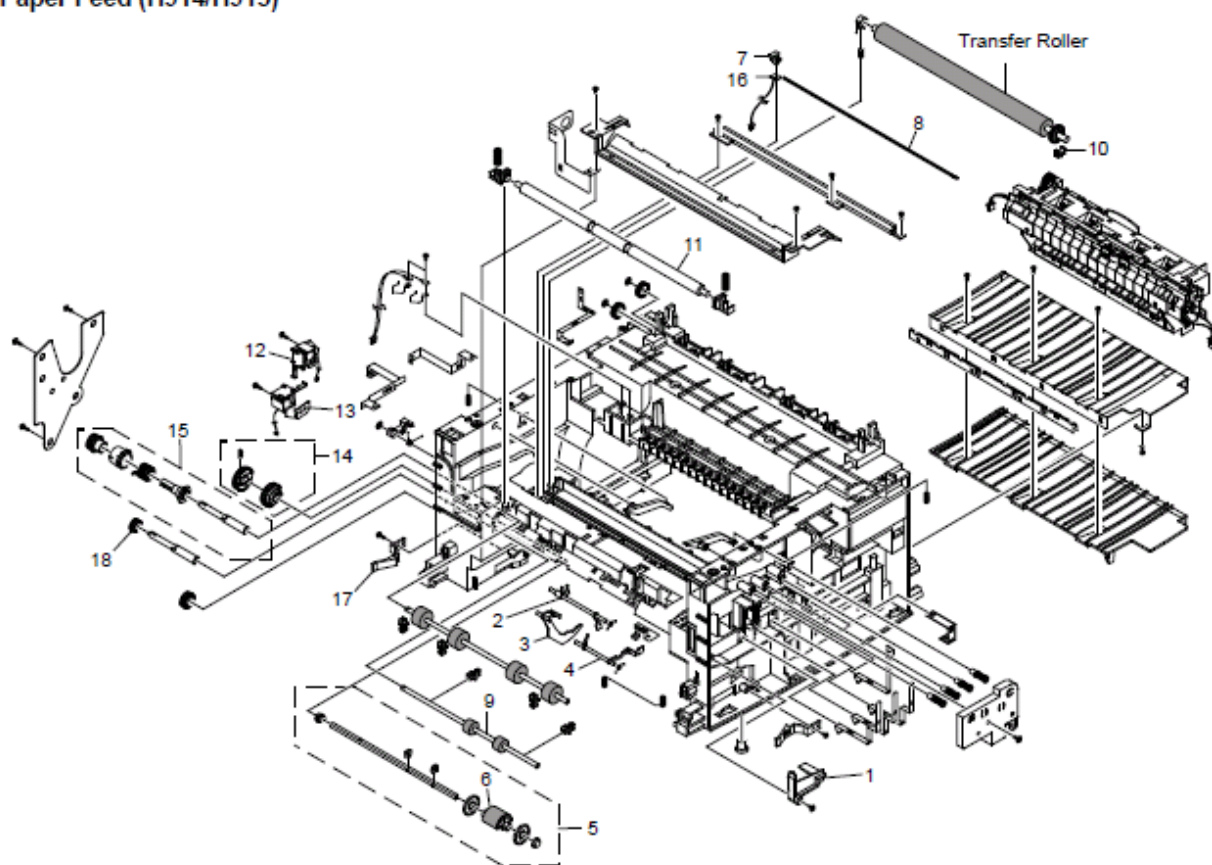
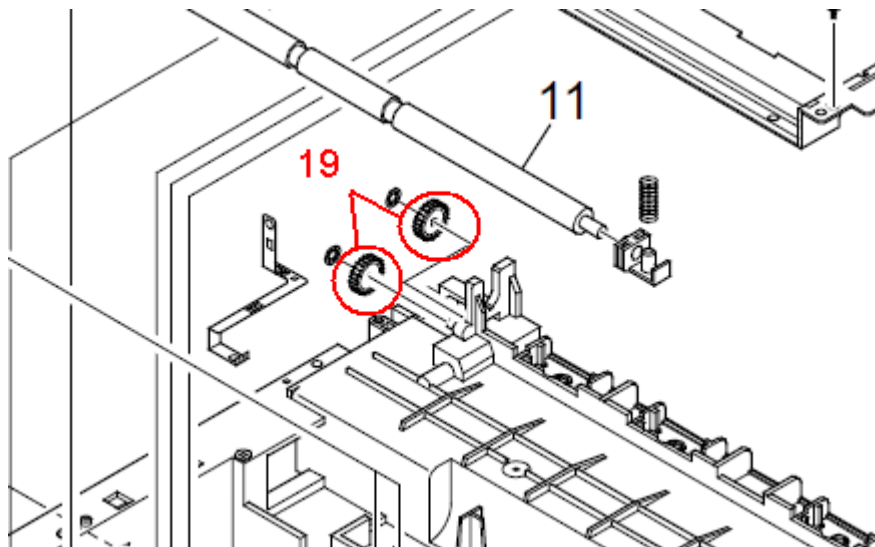
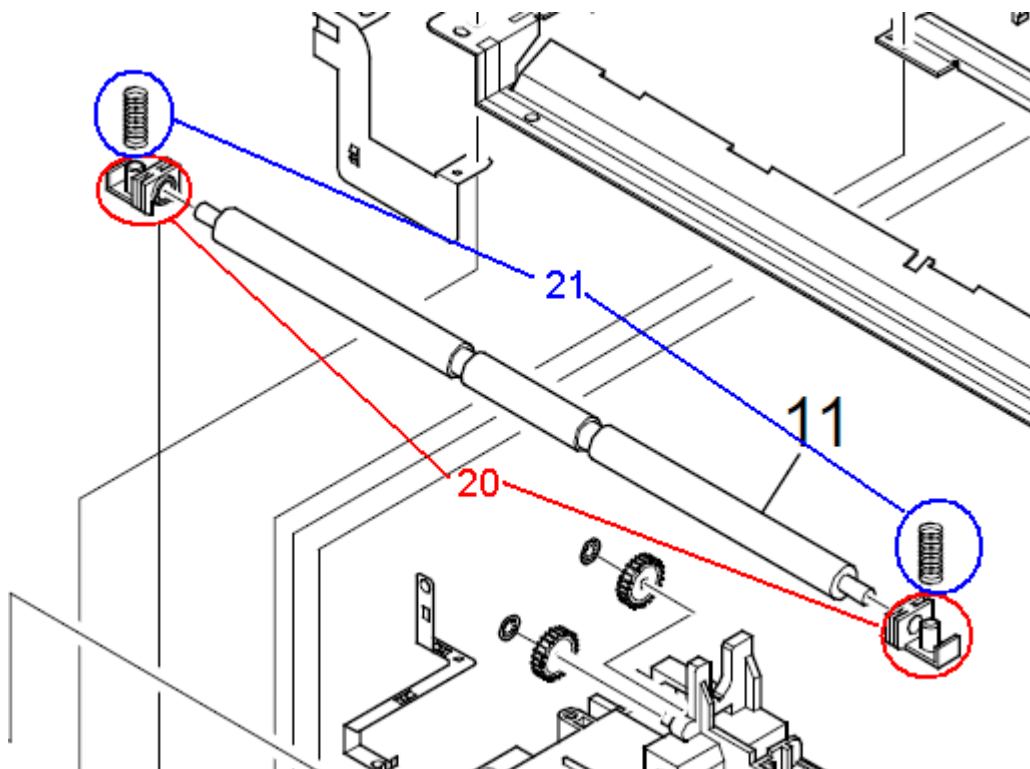
## 5.Paper Feed (H914/H915)

New Parts	Description	Q'ty	Int	Page	Index	Note
B1739804	GEAR DRIVE16	2		11	19	
G1449556	BUSHING-IDLE SHAFT	2		11	20	
G9601080	PRESSURE SPRING	2		11	21

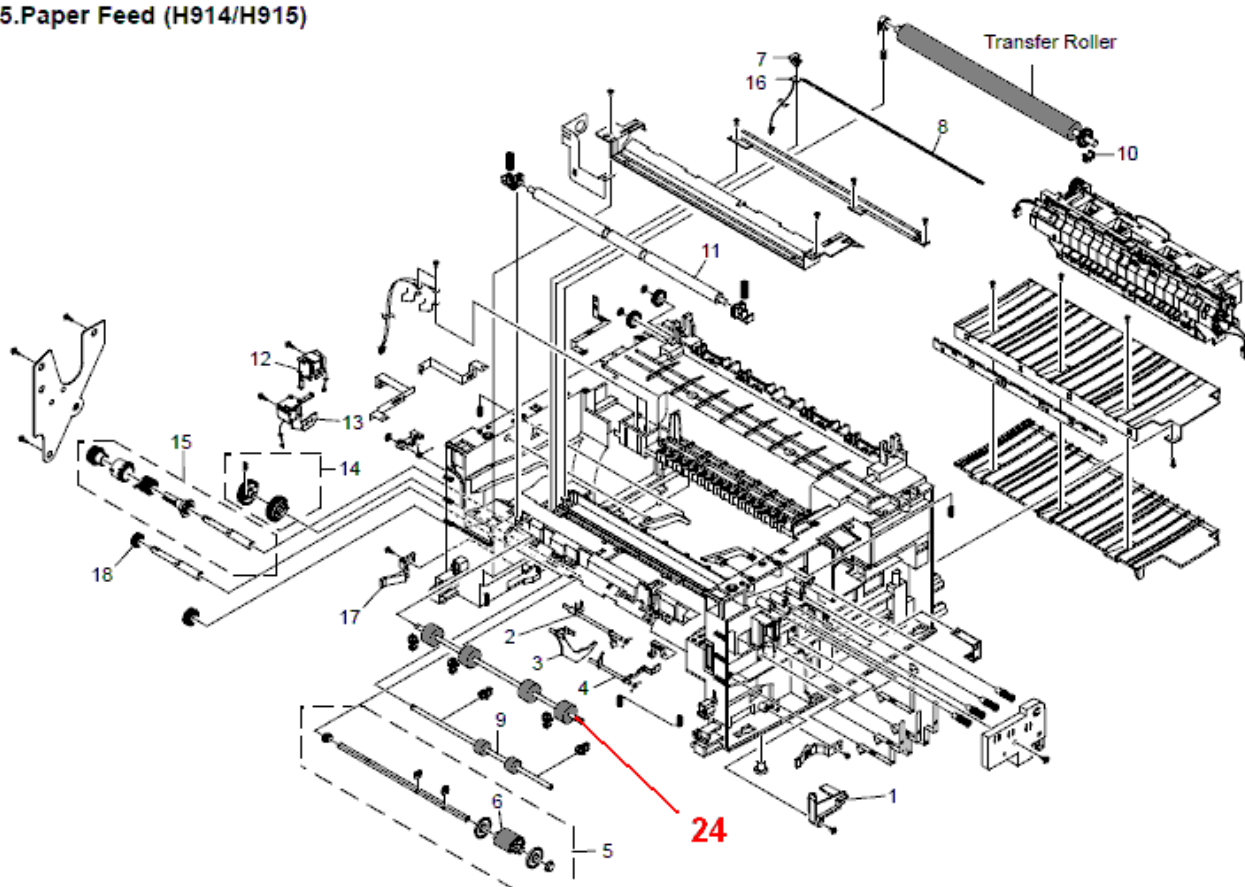
### 5.Paper Feed (H914/H915)

New Part	Description	Q'ty	Int	Page	Index	Note
G9601107	Feed Roller	1		12	24

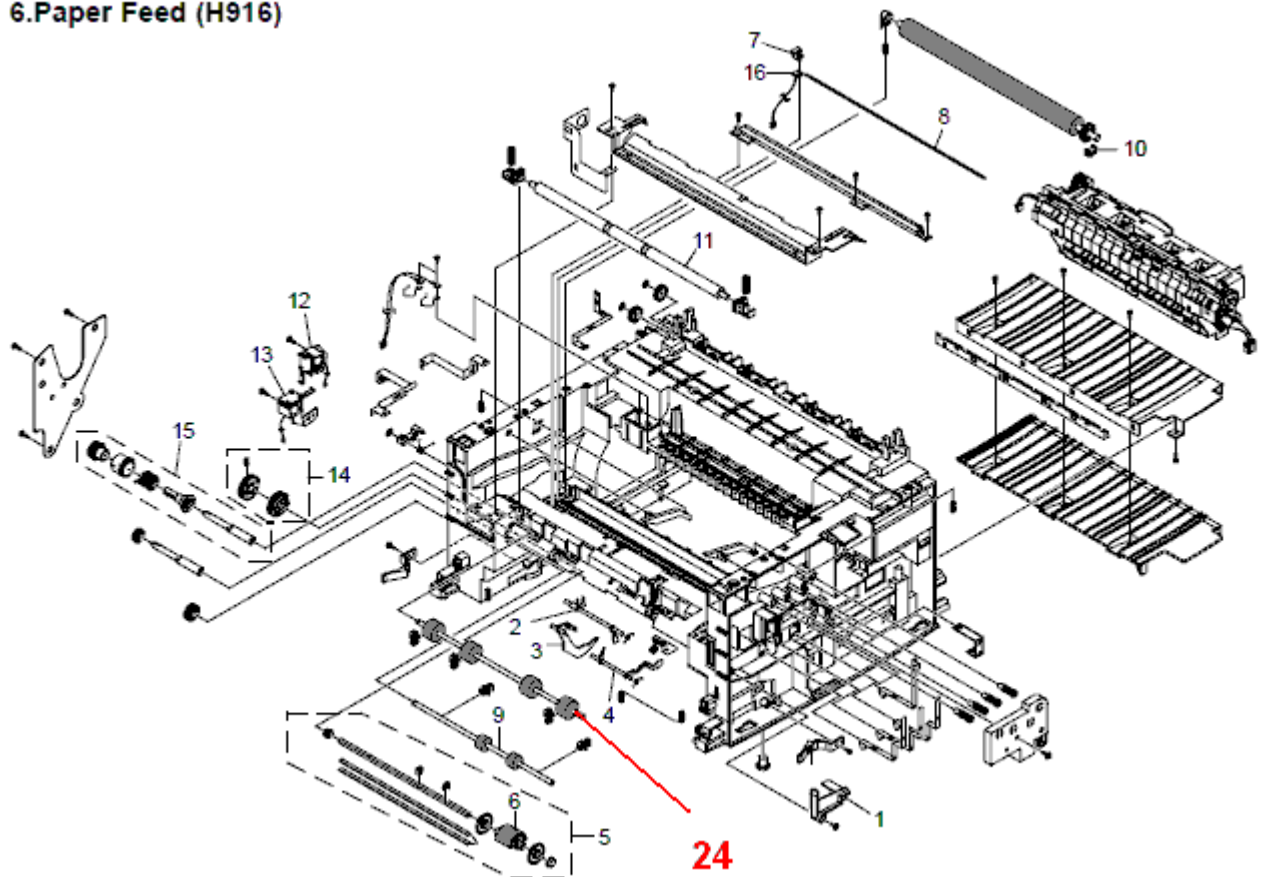
**6.Paper Feed (H916)**

New Part	Description	Q'ty	Int	Page	Index	Note
G9601107	Feed Roller	1		12	24

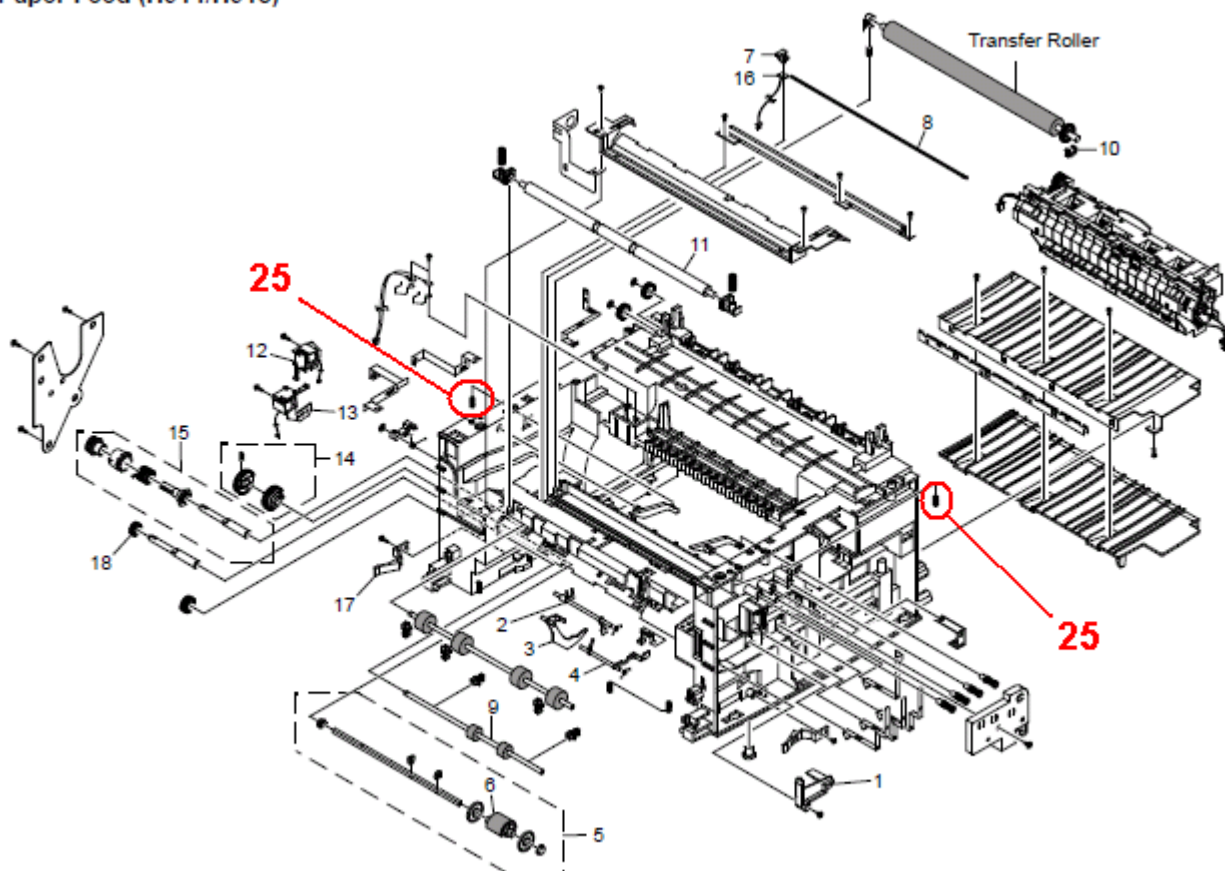
## 5.Paper Feed (H914/H915)

New Part #	Description	Q'ty	Int.	Page	Index	Note
G1861203	SPRING - GUIDE	2	-	11	25

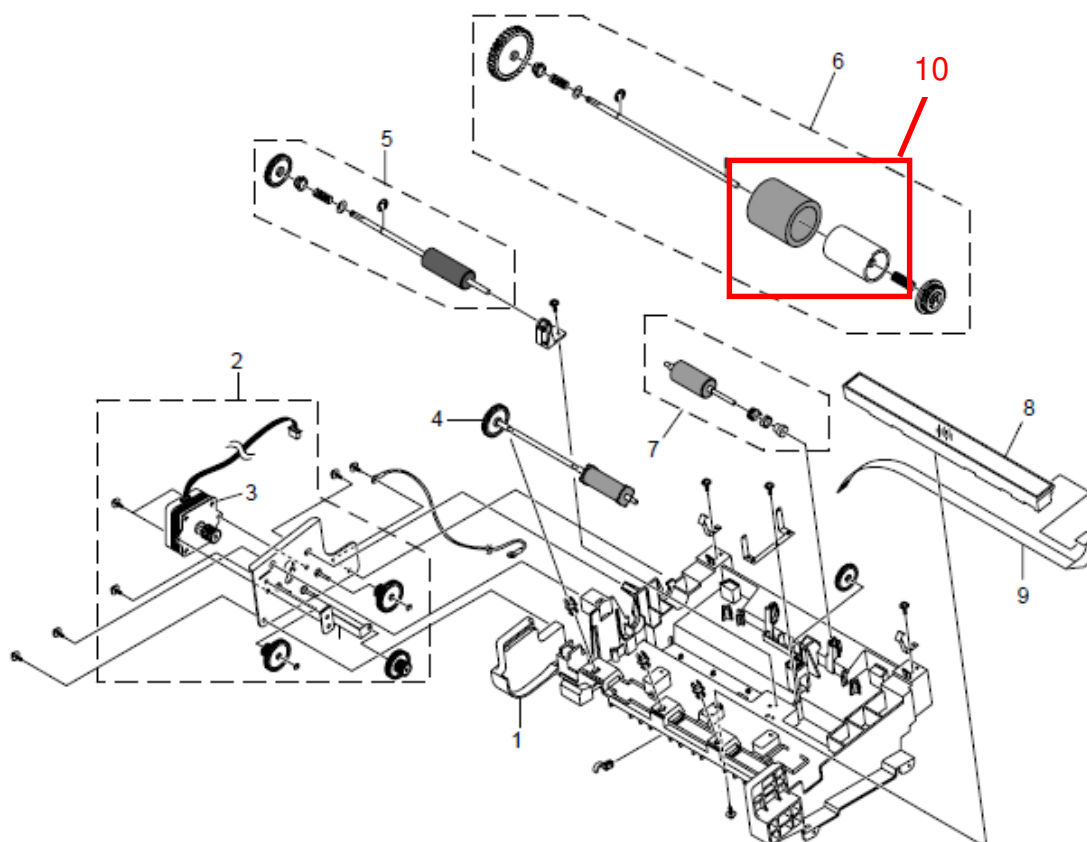
## 5.Lower Scanner (H916)

New Part #	Description	Q'ty	Int.	Page	Index	Note
H9169690	SLEEVE-ADF ROLLER	1	-	11	10
