| Model: PN-Fa | Date: 6-Mar-07 | No.: RH320001d |

| Subject: Firmware Release Note: <b><i>System FW</i></b> | | Prepared by: T. Shintani | |

| Subject : ADF No-feed problem | | Prepared by: T. Shintani | |

| Subject : The image was waved by ADF scan | | Prepared by: T. Shintani | |

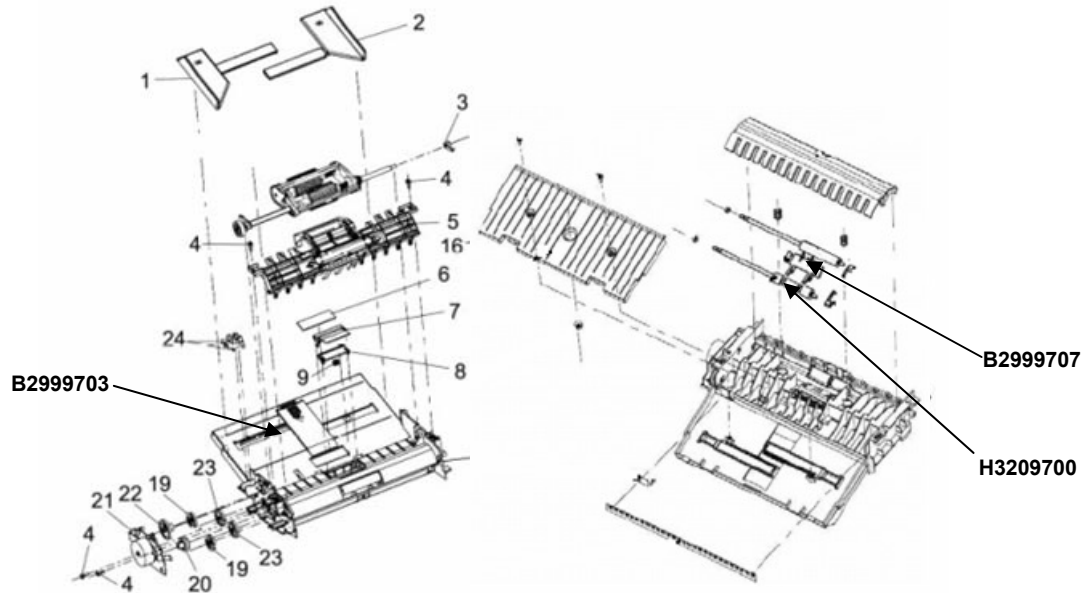
8.ADF Unit 2 (B299)

The document cannot be fed when it is loaded in the ADF.

The paper catches on the ribs of the paper input guide.

If the symptom is reported on a machine produced before the cut-in S/N, replace the paper input guide, paper feed roller foam, and paper deflect guide with the following new parts **together as a set**:

**B2999703**: PAPER INPUT GUIDE

**H3209700**: ANALYSIS ROLLER 2

**B2999707**: PAPER DEFLECT GUIDE

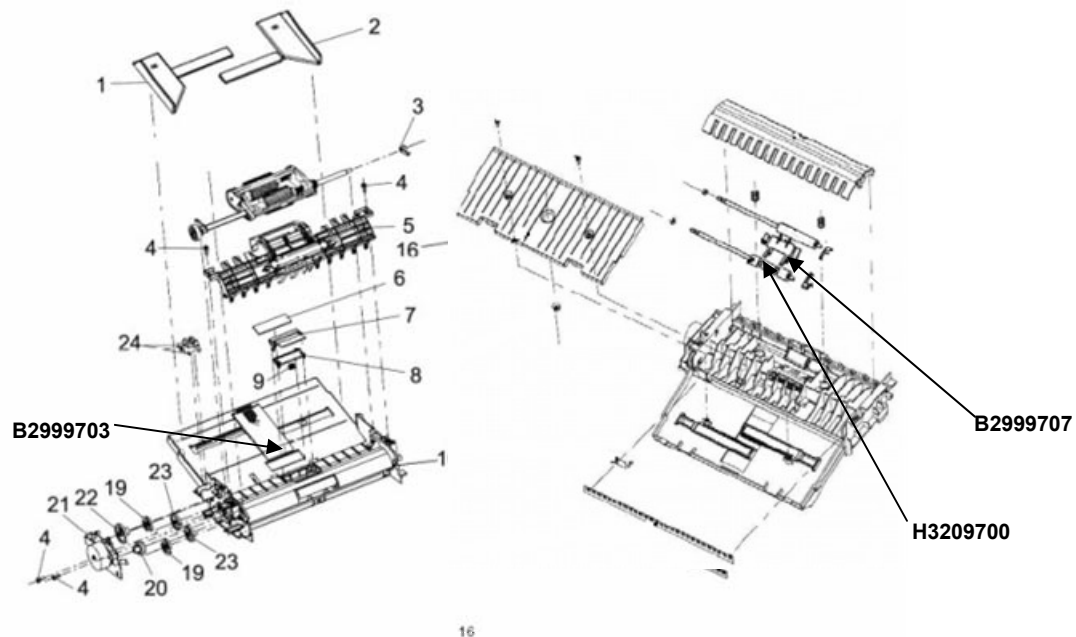
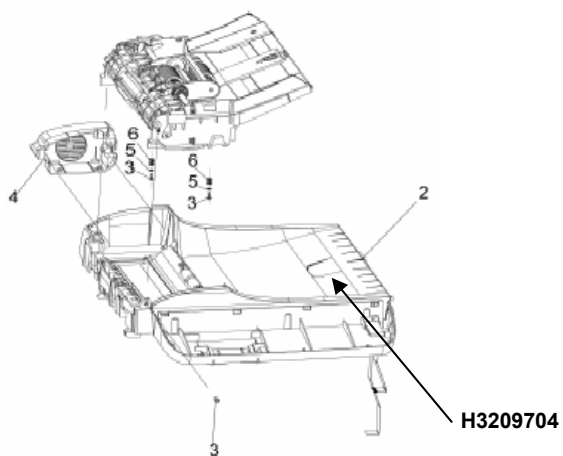
## 8.ADF Unit 2 (B299)

When the document is scanned by the ADF, parts of the image are slightly elongated along the sub-scan direction (at 13mm, 50mm, 230mm from the leading edge).

The document bumps the paper guide and feed rollers during feeding.

If the symptom is reported on a machine produced before the cut-in S/N, replace the ADF exit tray, paper input guide, foam, and paper deflect guide with the following new parts **together as a set**:

**H3209704**: UPPER COVER

**B2999703**: PAPER INPUT GUIDE

**H3209700**: ANALYSIS ROLLER 2

**B2999707**: PAPER DEFLECT GUIDE

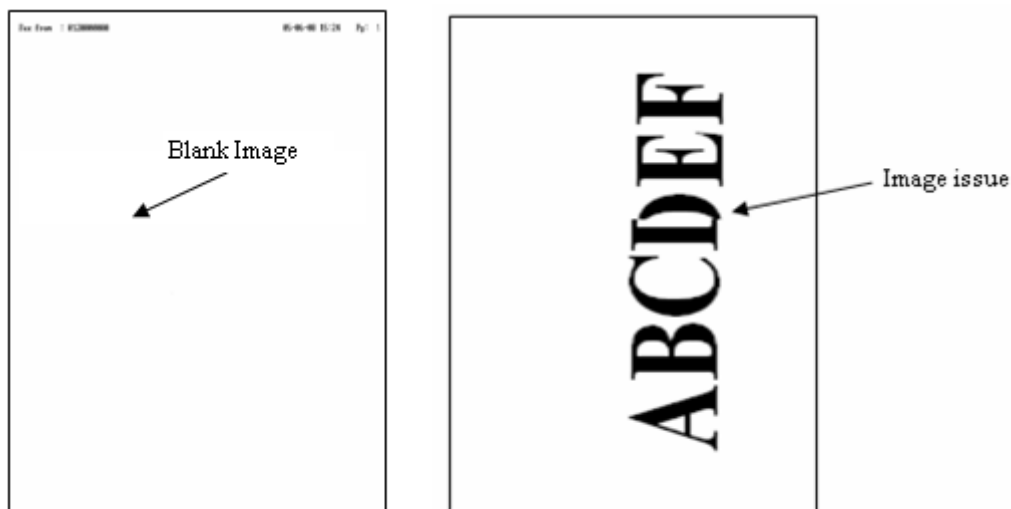
1. An incoming Fax image is blank (but contains the Fax headers)
2. Some parts of incoming Fax Image are shifted or blank.

The Fax line is unstable or electrical noise distorts the Fax line signal.

Try the troubleshooting Procedure on the next page.

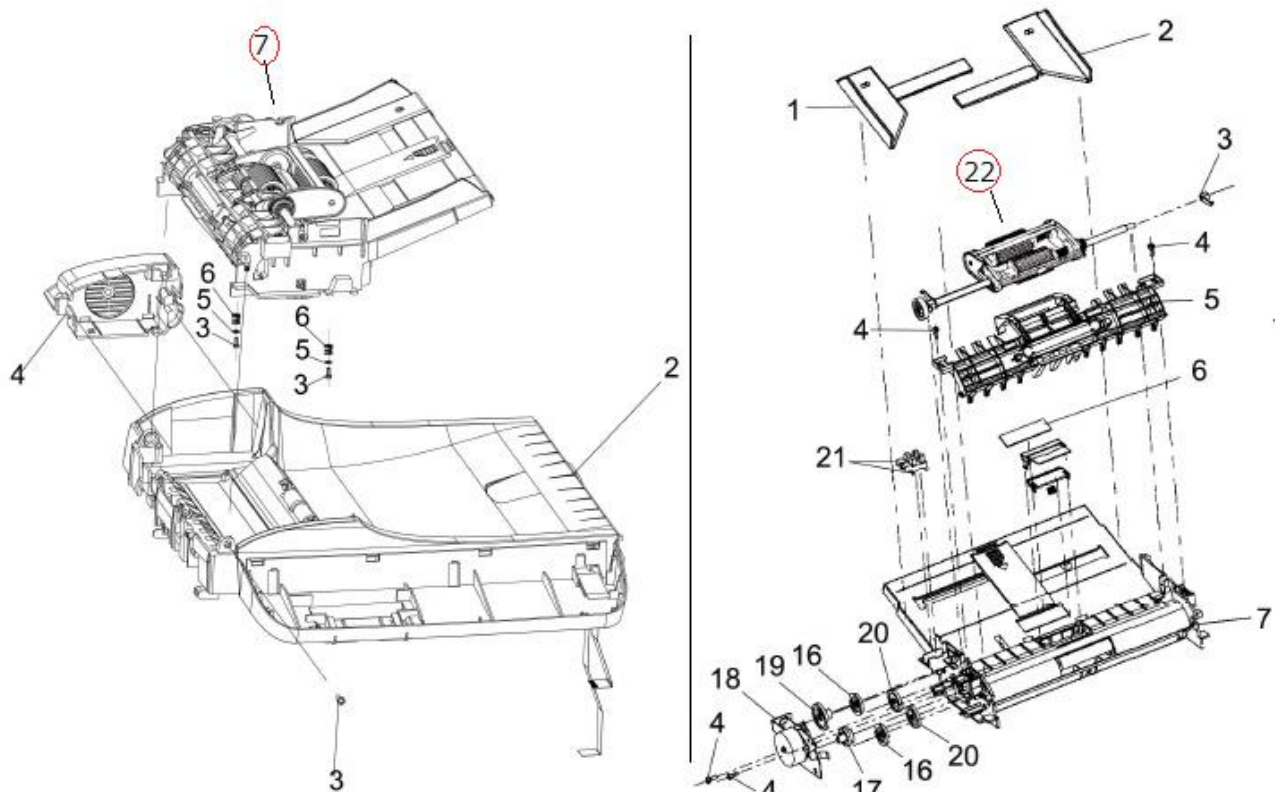
### Change/Reason: Vendor change

Due to a vender change, Paper Roller Ass'y (Index 25) cannot be supplied any more. Please replace the assembly of M0489502 (New Index 7) instead.
