Technical Bulletin

No. ZB - 001

SUBJECT: Cutter Problem

ZB α

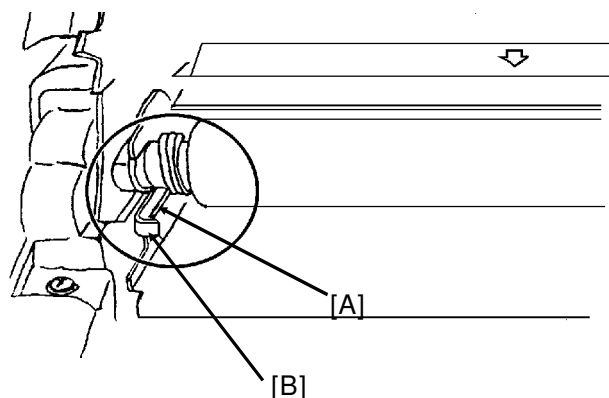
[Problem] The machine may not cut the paper in the correct position.

[Cause] The spring clutch was not lubricated enough.

[Action in the field] Lubricate around the spring clutch.

1. Open the printer cover on the brush.
2. Lubricate the spring clutch with grease (Mobil Tomp 78: P/N 54479078), turning the platen roller forward one rotation by hand.

3. Use alcohol to clean any parts of the platen roller that you touched.
4. Turn the platen roller back to the home position.
(The long end of the spring [A] should touch the under side of the rib [B] of the decurler as shown in the diagram.)

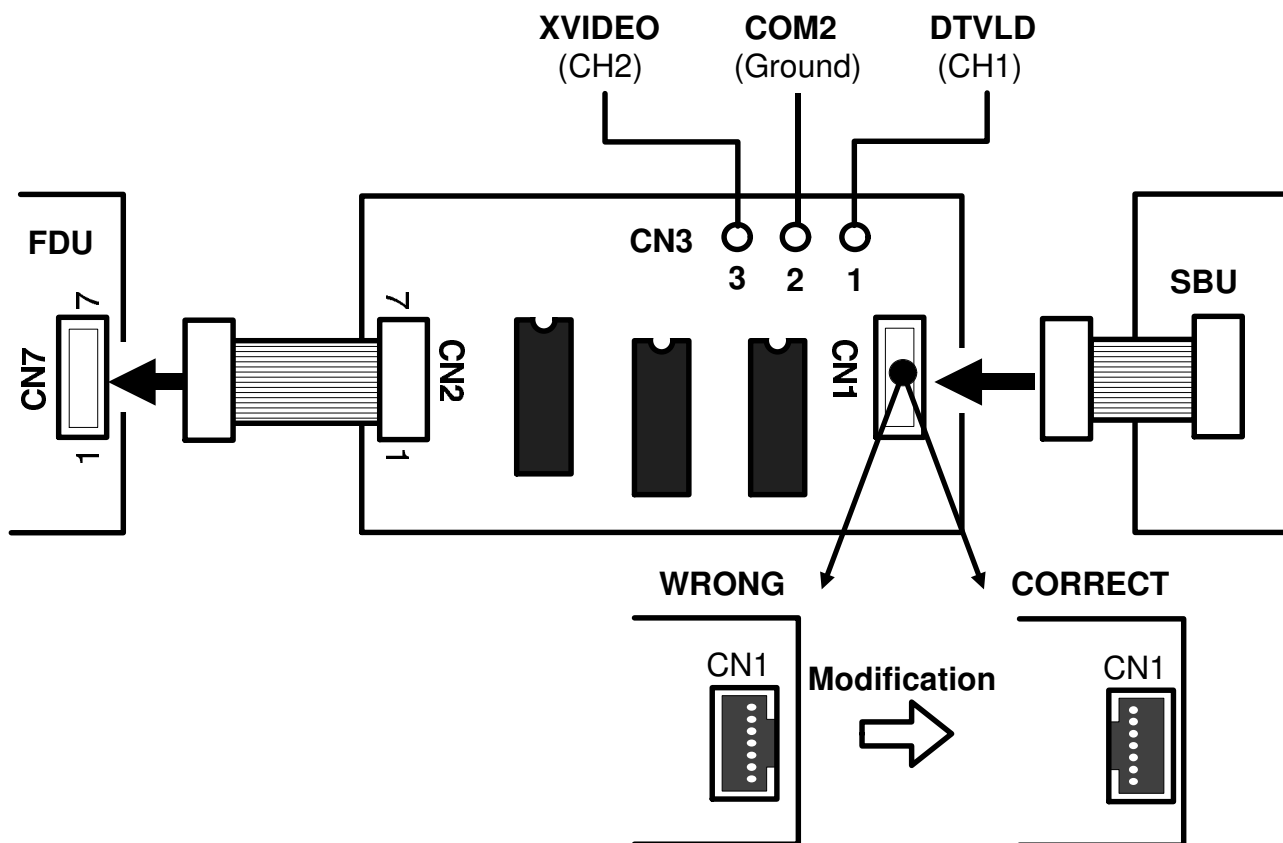
The PCBs produced in early times that have white CN1 connector cannot generate the test signals, as the CN1 is installed in a wrong way.

If the color of CN1 is white, remove it from the PCB and install it correctly on the PCB.

If the color of CN1 is brown, the PCB can be used without modification.

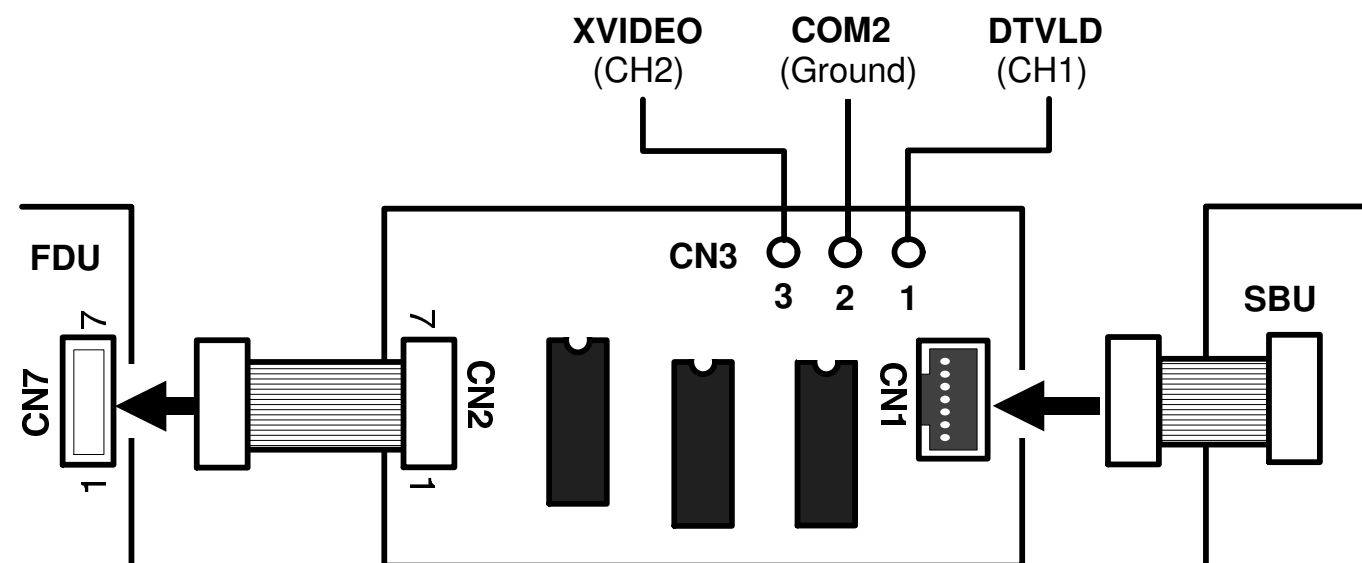
In the service manual section 4-5, the illustration to explain scanner test PCB (P/# H0939650) connection was wrong. **Actually, the PCB cannot be connected as in the illustration, but connecting the PCB as shown in the service manual may cause the SBU or FDU defective.**

So, please find below the illustration for correct PCB connection when adjusting the scanner.

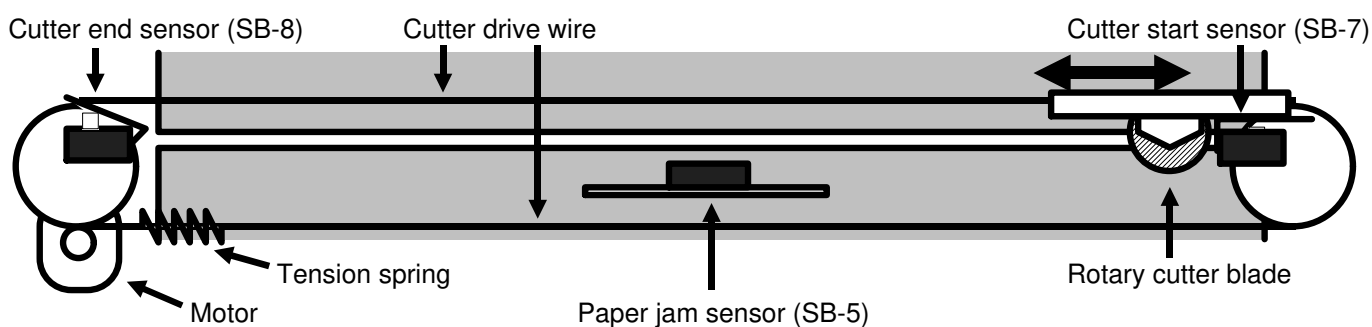
The machines with automatic paper cutter may indicate "REMOVE PRINTOUT / ADJUST FAX PAPER" on the LCD display frequently, and the cutter may not work correctly.

The cutter start position sensor (SB-7) and/or the cutter end position sensor (SB-8) is/are defective.

Replace whole cutter unit or defective sensor(s). The part number of the microswitch which is used as these sensors is;

When replacing the cutter unit, remove the jam sensor (SB-5) from the old cutter, and install it on a new cutter unit.
