# Technical Bulletin

## No. Barbara-001

### Parts List Corrections

FAX RF01/02, FAX240

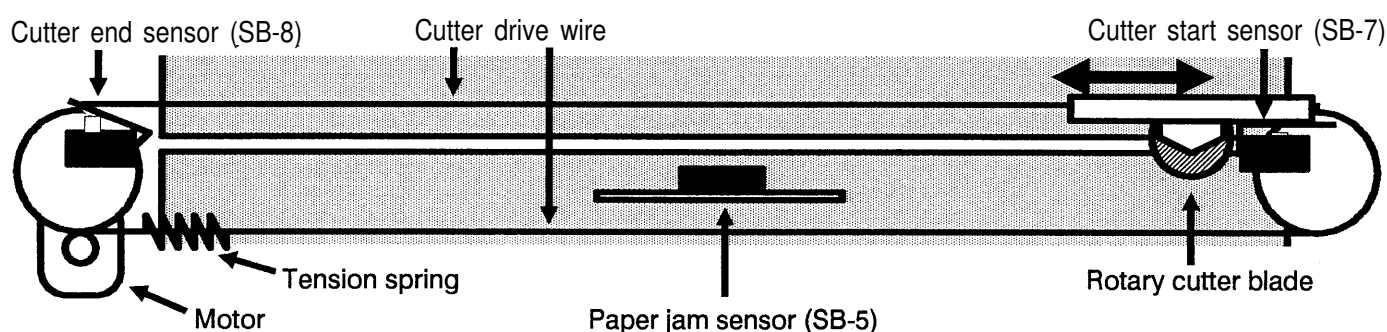
The cutter start position sensor (SB-7) and/or the cutter end position sensor (SB-8) is/are defective.

Replace whole cutter unit or defective sensor(s). The part number of the microswitch which is used as these sensors is;

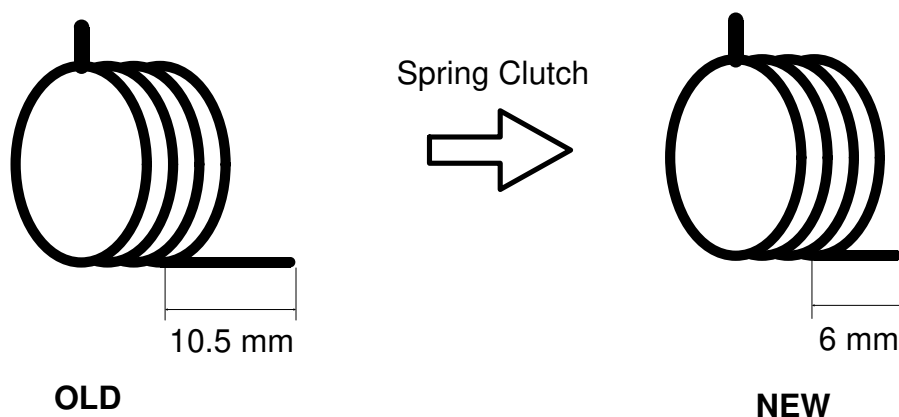
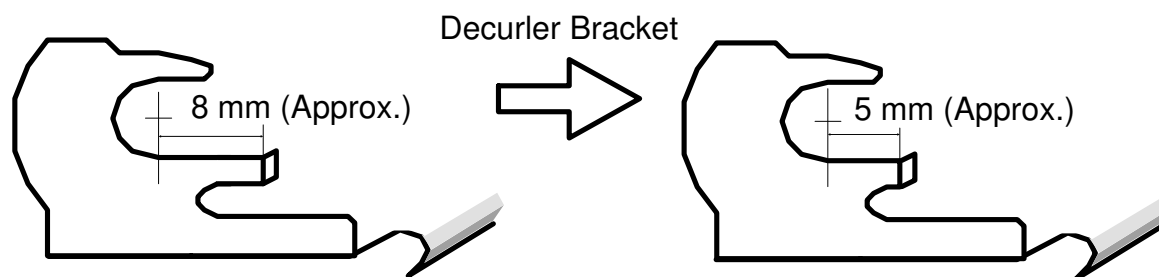
The thermal head surface might be scratched by the spring that is used as spring clutch for decurler.

The decurler bracket and the spring clutch have been modified as follows. Use the new parts as a set for future replacement.

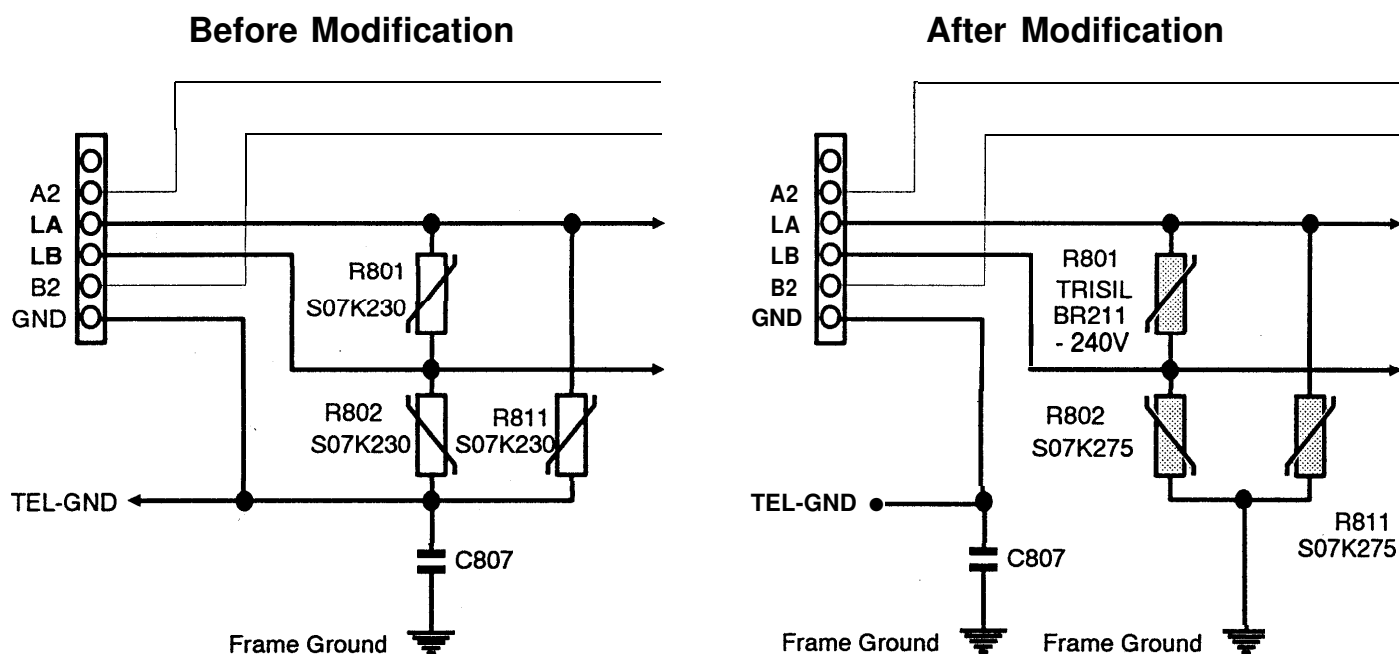
Fig.-1 (Circuit Diagram - R801, R802, R811)

A surge voltage from the line causes ICs on LIU and/or FCE to be defective.

Additionally, the following components have to be added on the LIU board as shown in the enclosed diagrams (fig.1, 2 and 3), to protect lightning damage.
