**SUBJECT:** Service Manual Correction

MODEL: CRO Europe and Asia  
Version

## Technical Bulletin

No. CRO-002

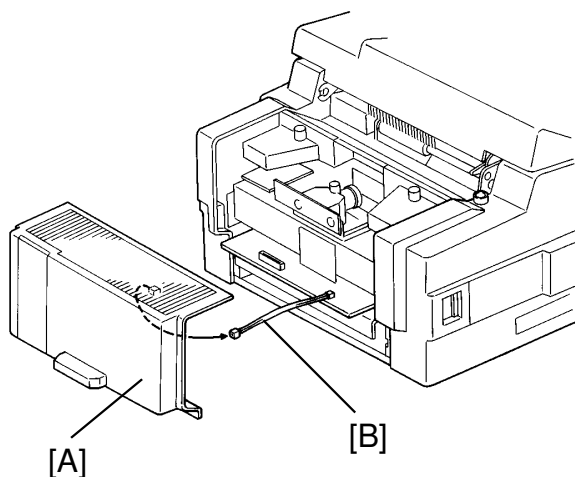
The item 4 has been changed, because the CRO does not have the monitor speaker.

4. Take off the rear cover [A] and  
disconnect the monitor speaker [B].

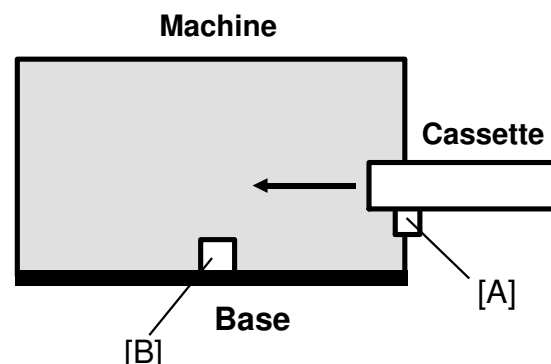
The bottom plate of the A4 (letter) size standard cassette is not lifted up even if the cassette is inserted into the machine.

When installing the cassette, the slider [A] should contact the Boss [B] on the base.

However [A] does not contact [B], because of the warp of the cassette and the base plate of the machine.

Temporary: Insert a washer (t=0.5mm, P/N: 07010030B) between the Boss [B] and the Base plate of the machine

Permanent: The height of the Boss [B] (P/N: H0813561) has been changed from 6mm to 7mm.

- Install a plastic cap (which packed with this RTB) onto the Boss.  
Use a glue for plastic.  
or
- Insert a washer(P/N: 07010030B) or an M4 E-ring (P/N: 07200040E) between the Boss and the Base Plate.

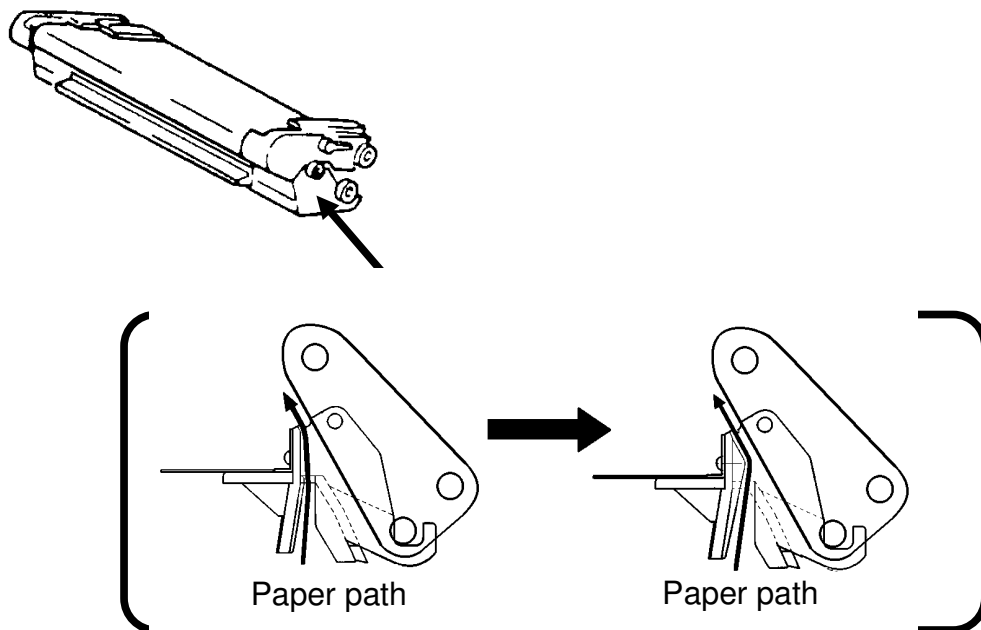
To improve image quality, the OBM (master unit) has been modified, as shown below.

When the paper passes over the master belt, toner sometimes does not transfer to the paper properly.

Therefore, the paper path inside the master has been changed, and the paper makes better contact with the master.

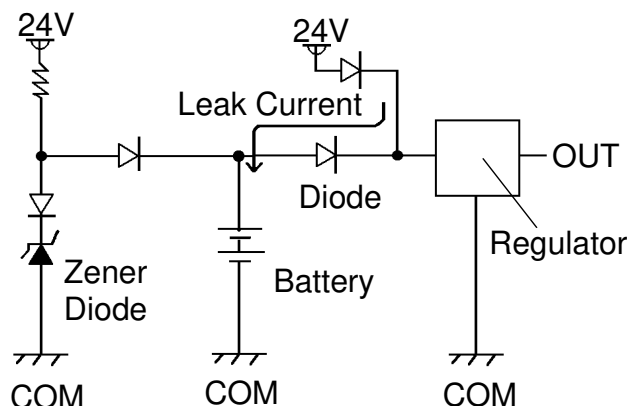
(On CFO / CS1 FCU)

Power loss from the memory back-up battery on FCU caused by excessive charge current, for the following reasons.

(1) Leak current from Diode

The battery is charged after it is already fully charged. This type of battery is damaged if this occurs.

- (2) Excessive charge voltage (CFO, CS1, LHO) The target charge voltage was 6.2V against 6.4V or under which is recommended by the battery maker. This margin was too small for this battery.

See MB C Series-048A.

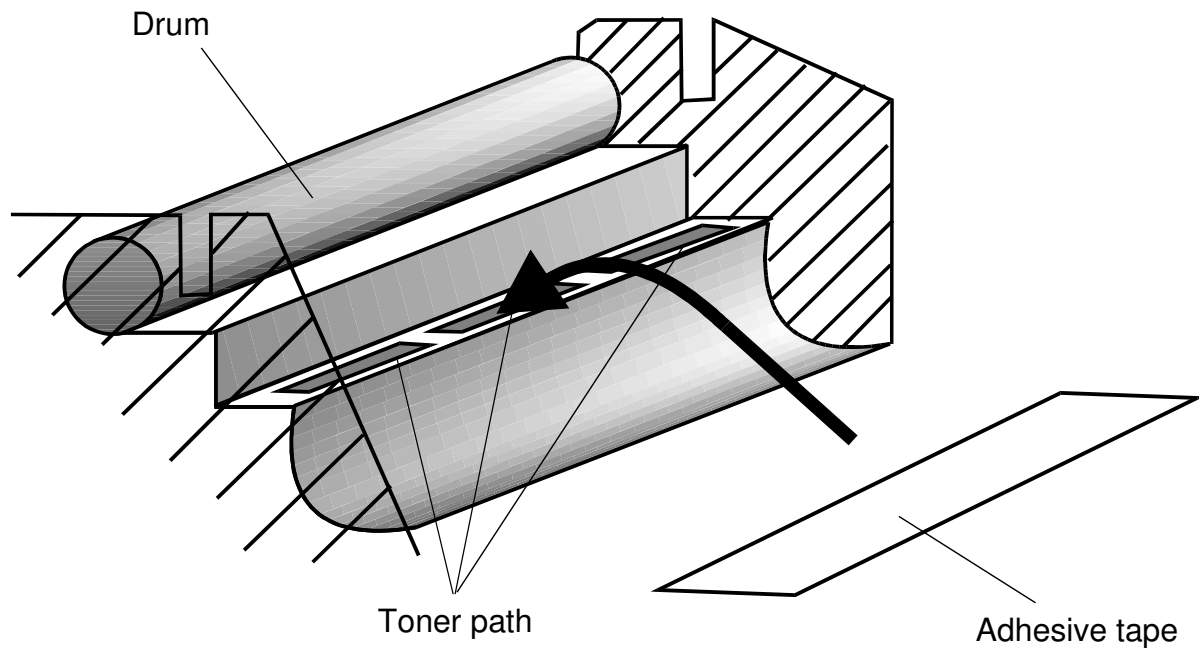
**Inside of FX6 and LSO**

**Cause:** Toner leaked from the development unit, the toner cartridge, or somewhere in the toner path during transportation.

Note: Adhesion of the tape should not be strong. Otherwise, it may not be taken off cleanly from the machine, or the toner path may be damaged when it is taken off.

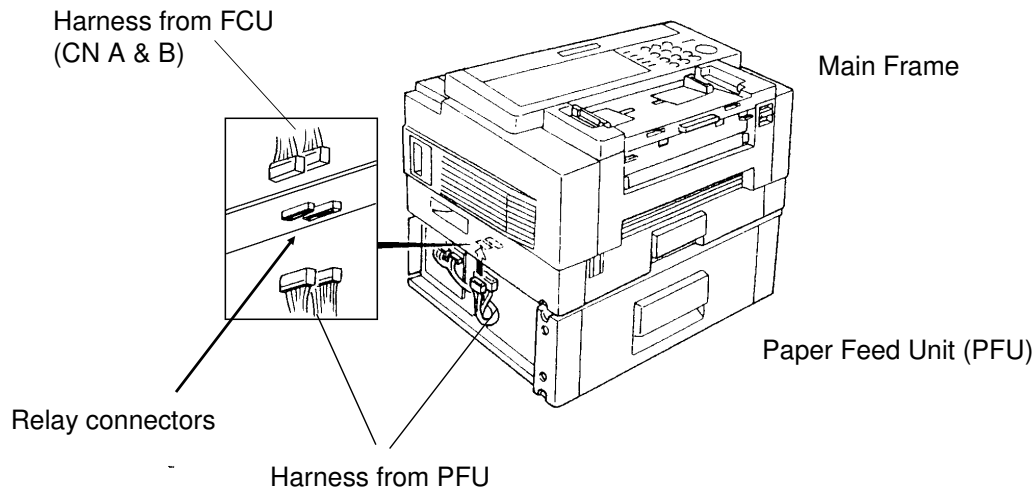
**Cause:** Wires of the harness (H511 5528) from the FCU to the relay connectors for the paper feed unit (PFU) are not allocated properly.

The harness should be checked before the start of the PFU installation because the FCU or the PFU PCB may become damaged.

1. Remove the Rear Cover and Left Cover.
2. Unplug the connector CN28 on the FCU.
3. Unplug the connectors CN A and CN B on the relay connector board located at the bottom of Main Frame.

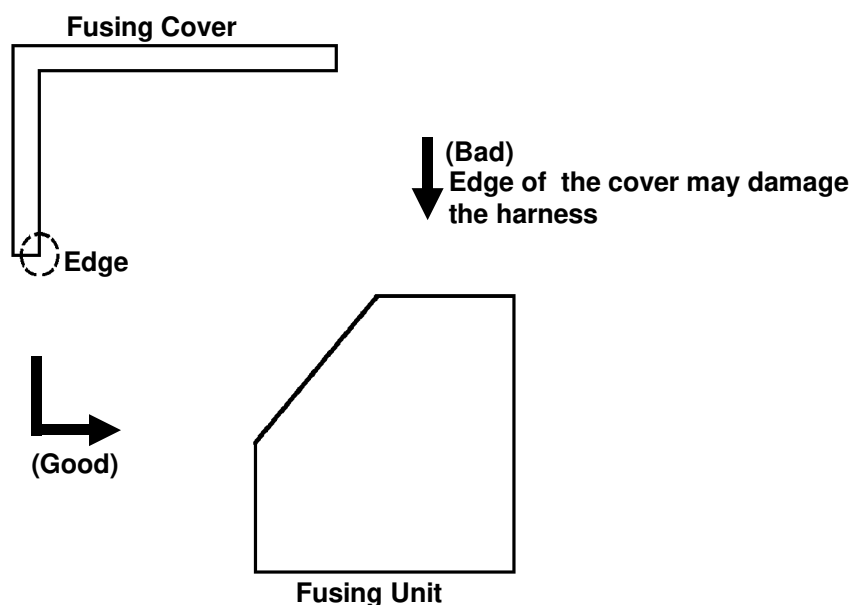
**If the metal wire of the harness contacts the thermistor bracket, a no power condition may occur. Please check the thermistor harness if this occurs.**

**(A): Please refer to the following instructions and fix the cover to the fusing unit and check that the harness is not pinched before installing the fusing unit in the machine.**
