Technical Bulletin No. CFO-001

SUBJECT: Service Manual Correction

MODEL: CFO

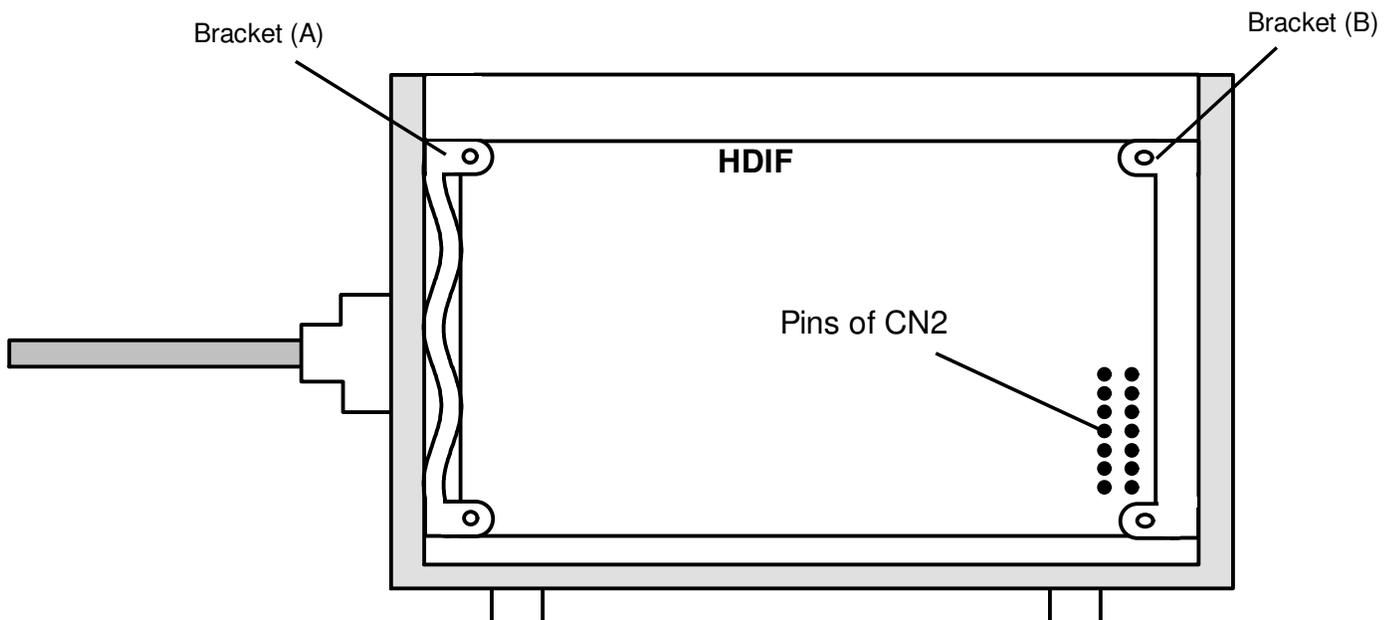
After replacing the HDIF board, the LCD may show "0%" instead of "100%" in the memory space field.

If the bracket (A) is bent, the pins of CN2 on the HDIF board may touch the bracket (B), then the HDIF board will be broken.

- When replacing the HDIF board, make sure that the bracket (A) is not bent, and the pins of CN2 on the HDIF board do not touch the bracket (B).
- For the CFO, when replacing the ROM on the HDIF board at installation, replace the ROM after removing the PSU in accordance with the installation manual. Do not remove the HDIF board.

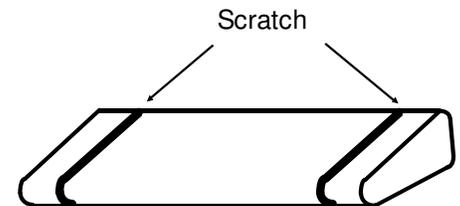
The OPU may be damaged when using the machine, as shown below. However, there is no problem on the printed image.

1. If the above problem occurs, do not replace the OPU, because, there will be no problem on the printed image, in the lifetime of the OPU.
2. Do not adjust and change the position of the OPU guide.

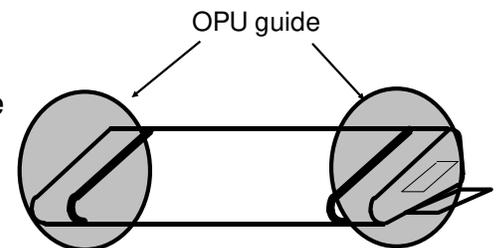
1. Both sides of the development roller may touch the metal blade on the development roller. By this, the shaved corpuscles may get in the space between the OPU belt and the development roller, the both sides of the OPU belt may be damaged.
2. The position of the OPU guide may be changed for some reason, then the OPU belt may touch the plastic pins on the development unit.

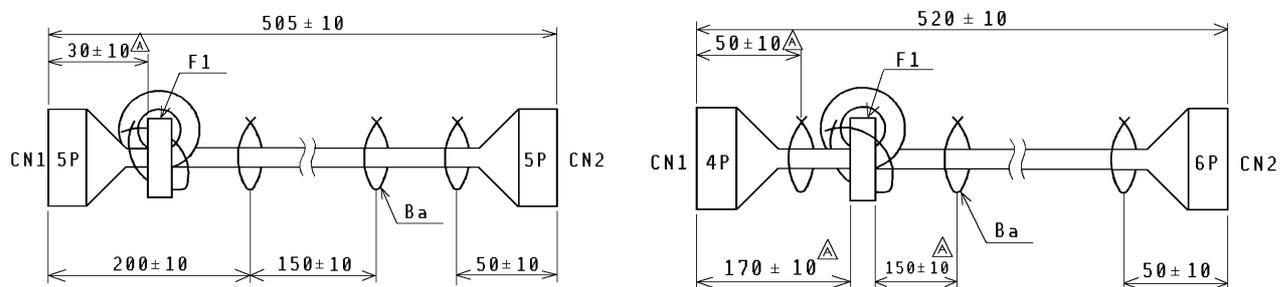
A magnet core has been added on both harnesses.

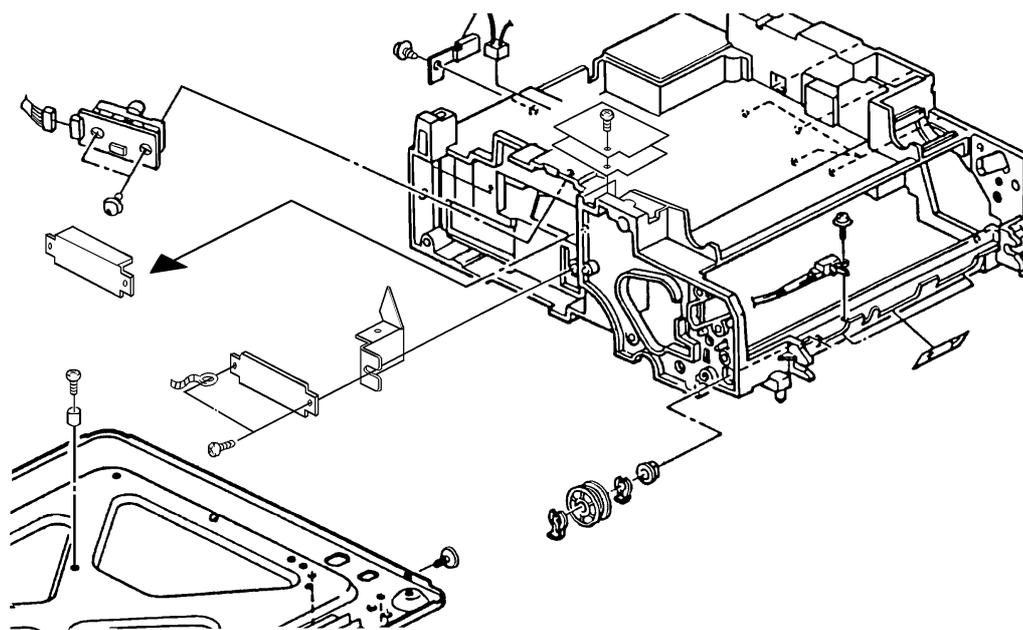
For LD-UNIT, the covers and ground wire have been added.

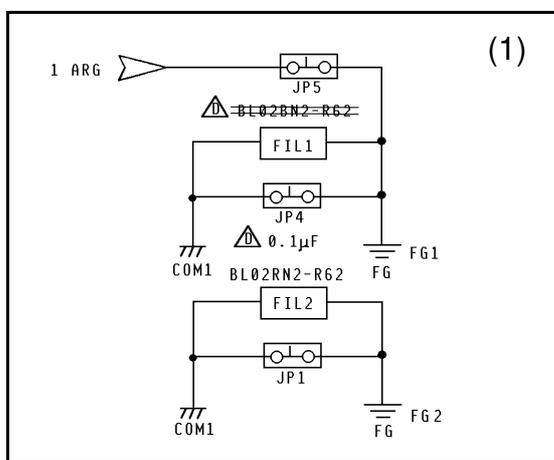
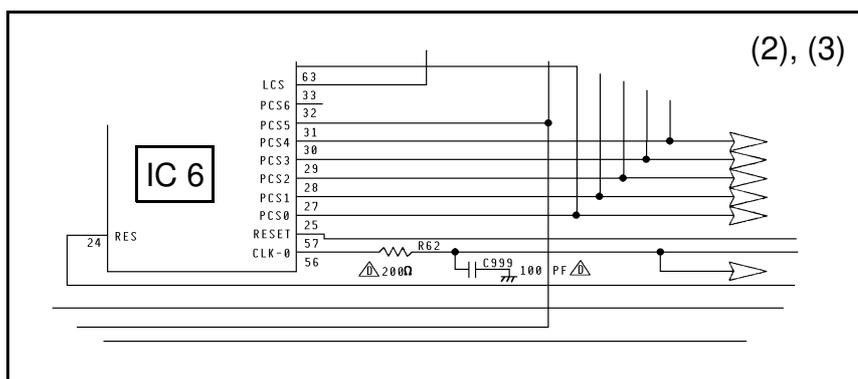
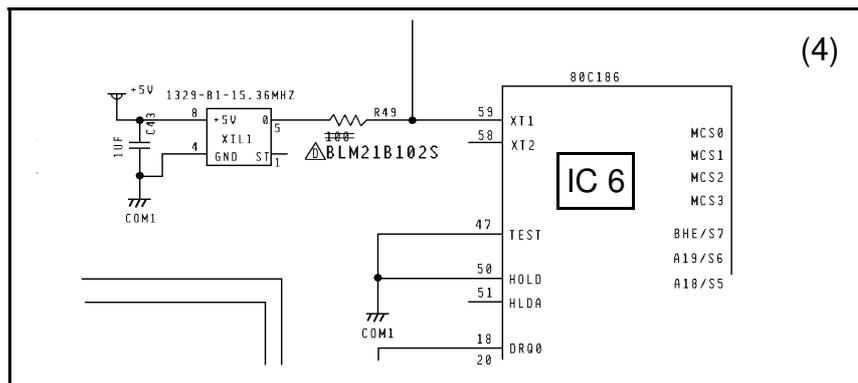
- (1) Fil1 has been removed and a condenser (0.1 μ F) has been added at JP4.
- (2) R62 has been changed from 56 Ω to 200 Ω .
- (3) A condenser (100pF) has been added between R62 and COM1.
- (4) R49 has been changed from 100 Ω to an Inductor.

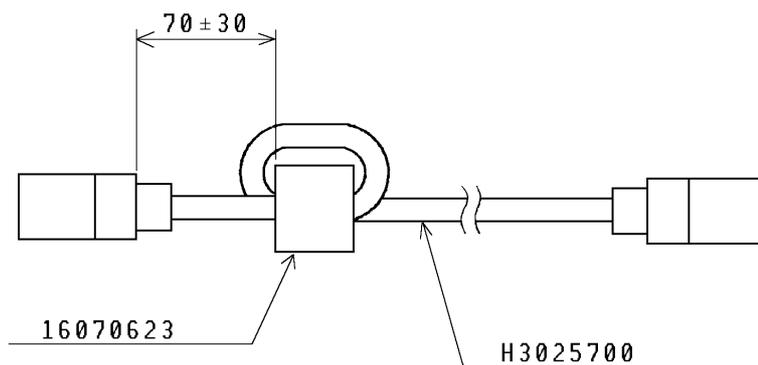
- A filter (magnet core) has been added on the ISDN Cable.

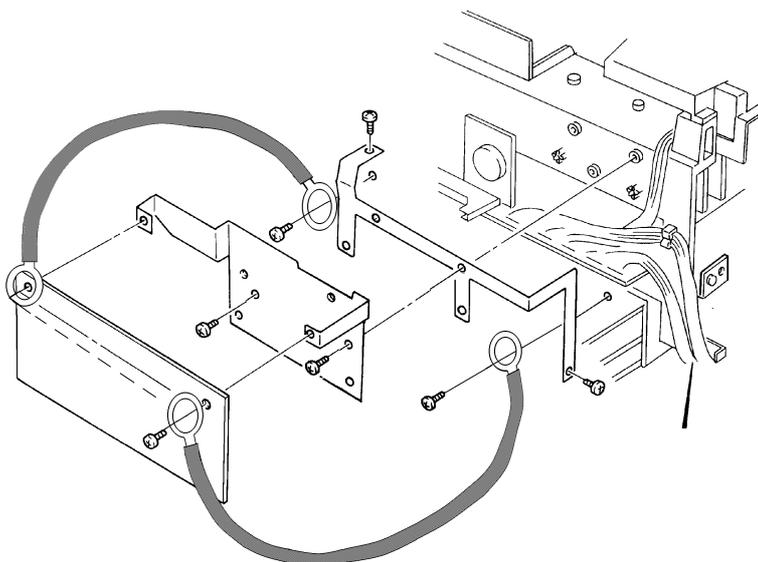
- Two ground wires have been added between the C1G4 Cord and the Bracket.

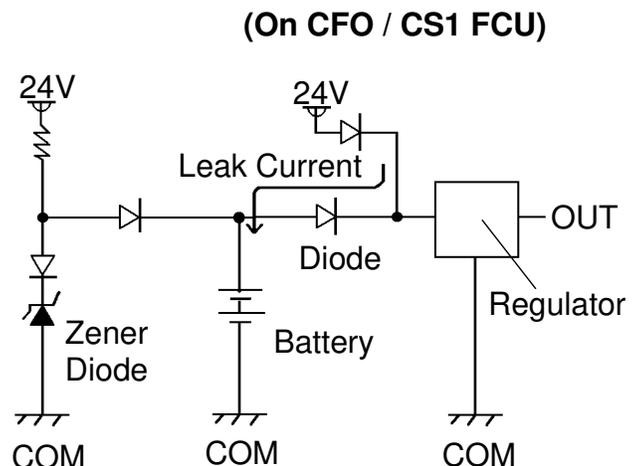
Power loss from the memory back-up battery on FCU caused by excessive charge current, for the following reasons.

- (1) Leak current from Diode
The battery is charged after it is already fully charged. This type of battery is damaged if this occurs.
- (2) Excessive charge voltage (CFO, CS1, LHO) The target charge voltage was 6.2V against 6.4V or under which is recommended by the battery maker. This margin was too small for this battery.
